Structures of masonry walls in buildings of permanent ruin – causes of damage and methods of repairs

Abstract: Currently there is a lot of castles classified as objects of the permanent ruin. In according to conservation doctrine, it is needed to protect this objects and prevent further degradation. Usually one of the most destructed element in this type of object is masonry wall. In this article has been described selected types of the masonry walls of the permanent ruin, causes of their damages and repairs methods.

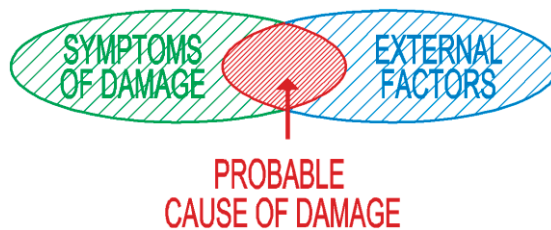
Fig. 2. Scheme of determining the cause of the damage

While making a diagnosis, it is necessary to correctly determine the damage and analyze the external factors that can cause it. The close linking of effects to causes will significantly reduce the scope of the search area.

After finding the common part of causes and effects, a preliminary diagnosis should be made, which should be confirmed by research or structural analysis. Only after confirming the initial diagnosis there is possibility of proper selection of repairs.

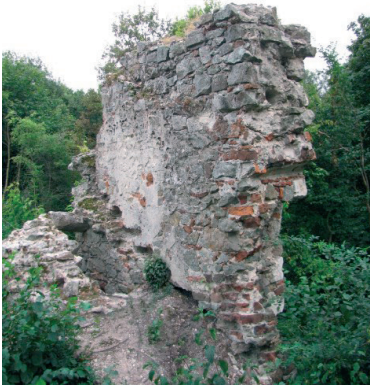
Photo 1. Degradation of the wall due to the environmental factors /Międzygórz castle/

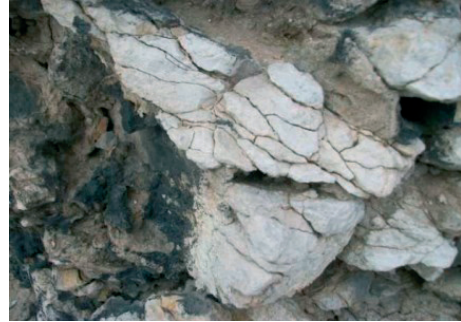
Photo 2. Cracking of a masonry material /castle in Rabsztyń/

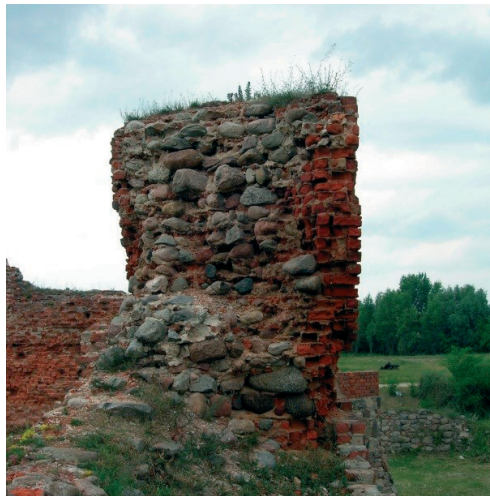
Photo 3. Damages of the "opus emplectum" wall (photographer – Marek Krysiński) /Międzygórz castle/

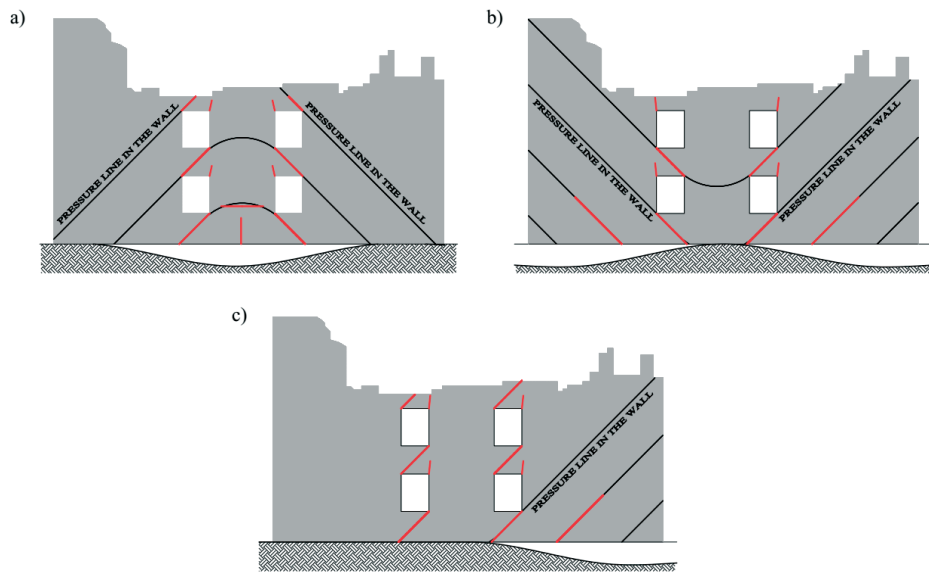
Fig. 3. The ideological course of the pressure line and damage in the wall due to: a) settlement of the central part of the wall, b) settlement of both wall corners, c) settlement one of the corners [3]

• **Uneven settlement of soil under foundations** – by far the most common cause of damage to the masonry structures. Depending on the way the foundation settles, the cracks may have a different course and character. Defects in structures always arise in the most strenuous places – those in which the stresses in the material are the greatest. These stresses will have a diversified distribution, which depend not only on the part that deforms ("settles") but also on the proportions of the structure's elements (width, height, and thickness), proportion, type of the wall elements, number of holes, previous damage, and even earlier repairs. Exemplary, ideological stress distributions are shown in Fig. 3 as pressure lines in the masonry wall. In addition, places were also marked where scratches and cracks appeared.

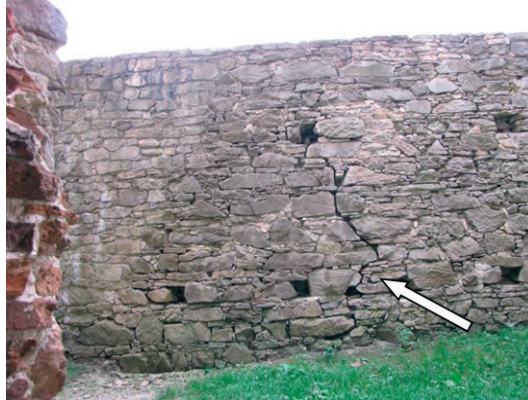
Photo 4. Damage caused by uneven settlement /Krzyżtopór castle in Ujazd/

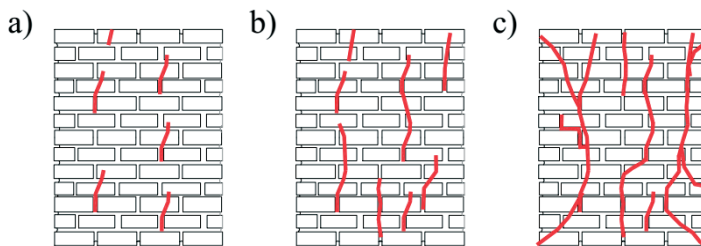
Fig. 4. Phases of the wall destruction: a) first phase – appearance of small cracks, b) second phase – widening of cracks, merging of cracks and appearance of the first scratches, c) third phase – connection of scratches and cracks – the construction failure [4]

The phases of destruction of the brick wall are shown below in Fig. 4. In the case of constructions made in another technology, the destruction phases will be similar.

The first phase of destruction of a masonry structure does not threaten the safety of its use, however it may herald further damage to the element. It is therefore a signal of the possibility of danger when the loads will be increasing or steps are not be taken to repair or strengthen the structure. After observing even small scratches and cracks of a character as in Fig. 4, a permanent monitoring of the structure is recommended. Using the simplest feeler gauges, gypsum seals or glass plates, information will be received whether it is subjected to further damage, and whether it is possible to move to the next phase of the wall destruction. The next phase may already threaten the safety of the facility's use. In the event of the second or third phase, immediate steps should be taken to secure or reinforce the structure.

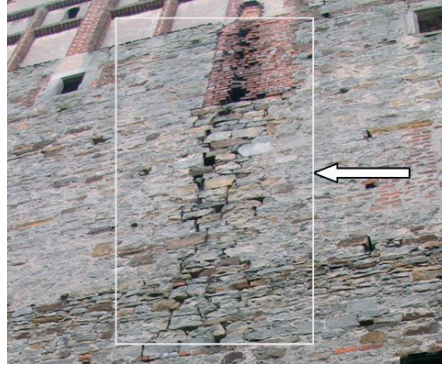
Photo 5. Damage to the masonry structure /castle in Drzewica/

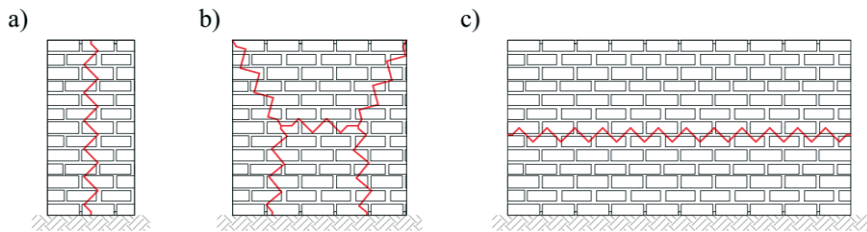
Fig. 5. Damage to the brick elements caused by excessive horizontal force (perpendicular to the element's plane) depending on the proportion of the element: a) slender elements, b) similar height and length, c) elements with a significant length in relation to the height [2]

- **Excessive horizontal loads (perpendicular to the wall's surface)** – damage due to excessive horizontal loads occurs mainly due to the effects of wind or inadequate use of the object. As unsuitable use, it is understood that the walls are loaded by covering with soil or disturbing the balance of forces by, e.g., digging out an underground part of the wall on one side only. In the case of objects in ruin, walls with a significant slenderness (e.g., slender attic) are exposed to external loads.

In the case of appearance of similar cracks, as in previous cases, the permanent monitoring of the structure should be carried out, and in the case of free-standing elements, also geodetic surveys of the wall's verticality should be performed.

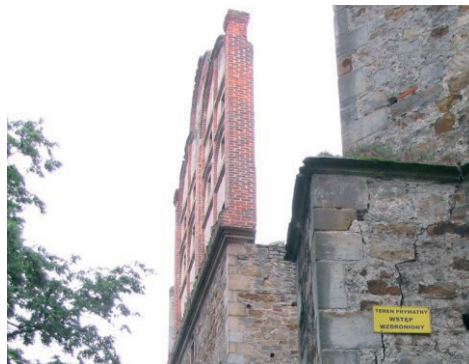
Photo 6. Examples of cracks in a slender attic wall /castle in Drzewica/

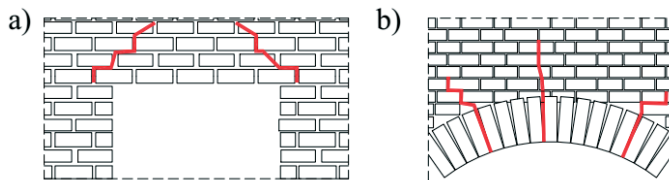
Fig. 6. Damage to the window head's elements: a) flat window head, b) arched window head

The only exception is the situation where the window head itself has been damaged. The window head damage may occur due to the exhaustion of its load bearing capacity caused by an excessive load or corrosion, and destruction of the materials from which the window head is made. Depending on the window head's type, the cracks may have a very different course. In the case of arched window heads, the damage is usually perpendicular to the arch, while in the case of flat window heads – directed towards each other (Fig. 6).

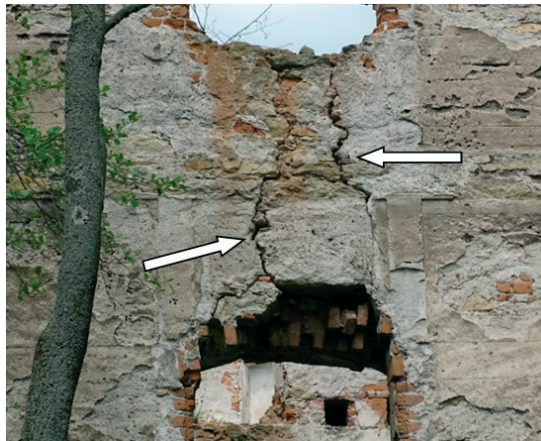
Photo 7. Example of the window head's damage /Panków castle/

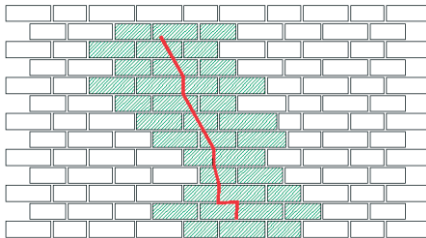
Fig. 7. Scheme of the wall rebuilding

- **Rebuilding of the structure's fragments** – very often used and in some cases the only possible method. The fragments of the wall should be rebuilt in the case of highly damaged walls, severely degraded or so damaged that all other methods are not justified technologically and economically. With the help of rebuilding it is possible to almost completely get rid of the damaged material, and replace it with a new material – completely healthy. Unfortunately, this treatment is associated with the depletion of the historical material in the element itself. There are situations in which it is possible to rebuild or supplement a damaged part of the wall with historical material originating from another part of the building, however, due to the high value of such material and often insufficient technical condition, these are rare situations.

Before proceeding with the rebuilding, an appropriate technical documentation should be made with the determination of the technology of conducting the works. The procedure itself may seem relatively simple, but its unskillful performance may result in negative consequences in the further operation of the facility. Materials used for the rebuilding process should be chosen by a suitably qualified person. The selection of not suitable materials (e.g., a cement mortar or too strong masonry material) can lead to acceleration of the masonry degradation process or even its complete destruction.

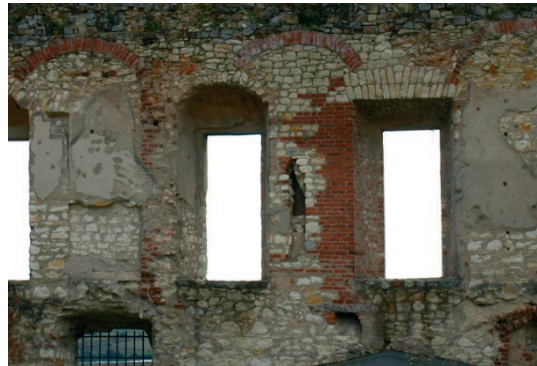
Photo 8. Fragments of the wall rebuilt /castle in Janowiec/

In the degraded element, not only the damaged parts should be rebuilt but also elements in the immediate vicinity. This will ensure better cooperation and binding of the wall's construction.

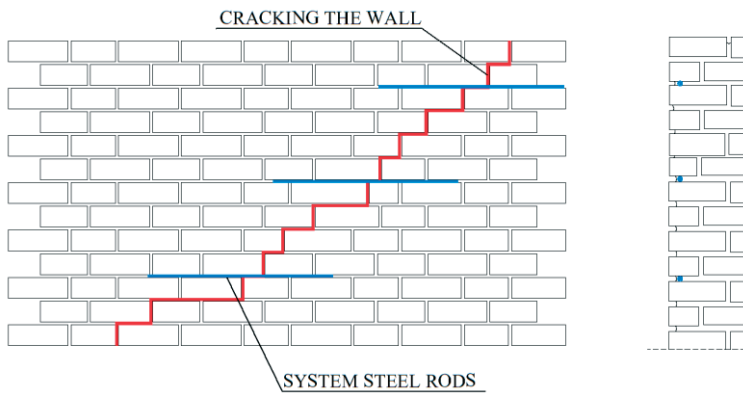
Fig. 8. Scheme of the wall's structure repair by using system steel rods

The wall stitching is carried out by making a cut or crushing the joint to a depth of usually about 3-4 cm. The joint should be properly cleaned with compressed air, and then moistened so that it does not absorb water from the repair materials, which is necessary for the hydration processes. After cleaning, a primer preparation (about 1-2 cm) should be introduced into the joint. Then, in the joint and the unbinded primer preparation a system steel rod is introduced. Information on the type, diameter of the rod, vertical spacing, and a furrow's width are dependent on the nature of the damage. They should be included in the design documentation.

An exemplary scheme for repairing a cracked wall using system bars is shown in Fig. 8.

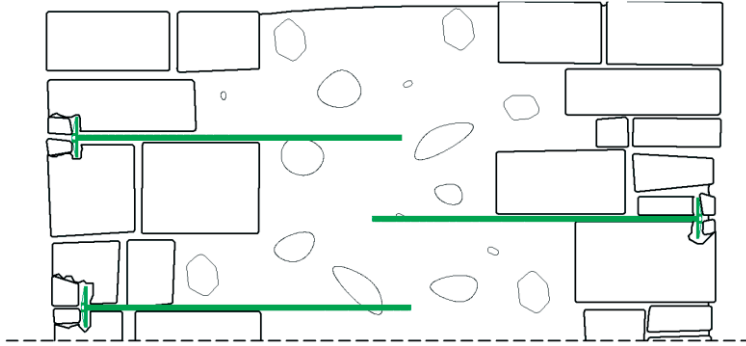
Fig. 9. Scheme of nailing with the supplementation of the wall's face of the „opus emplectum” type

- **nailing** – the method is mainly used to stabilize walls of large thickness (most often erected in the "opus emplectum" technology). Strength parameters of the masonry structure, after its delamination, are significantly reduced. Deterioration of these parameters may result in further damage or even failure of the entire structure. To prevent the walls' delamination, various types of anchors are used. As a rule, these are steel anchors, sometimes with retaining elements (blocks, sheets, special shapes). The anchors are inserted into the pre-drilled holes filled with injections causing adhesion to the material. Depending on the wall's type and the technology chosen, mainly resin or mineral injections (microcementses, special cement pastes) are used.

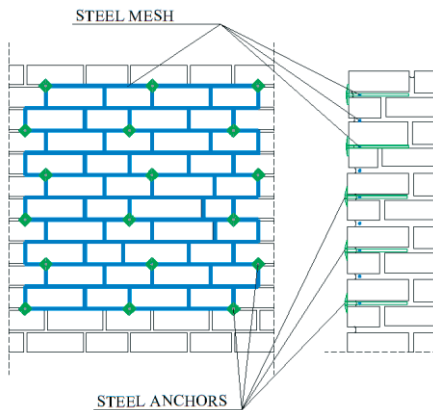
Fig. 10. Scheme of the wall's repair using an anchored steel mesh

- **nailing with meshing** – a method similar to the traditional nailing, with the difference that a steel mesh is also installed for reinforcement or protection purposes. Steel mesh can be made and fastened mainly in two ways. The first consists in the appropriate furrows making, and then the embedding of the pre-prepared mesh and restoring the joint (embedding technology is identical as in the case of the stitching method). The second method applies only to the protection of the wall's face. Between the anchors and the face of the wall, a steel safety mesh is mounted (photo 6).

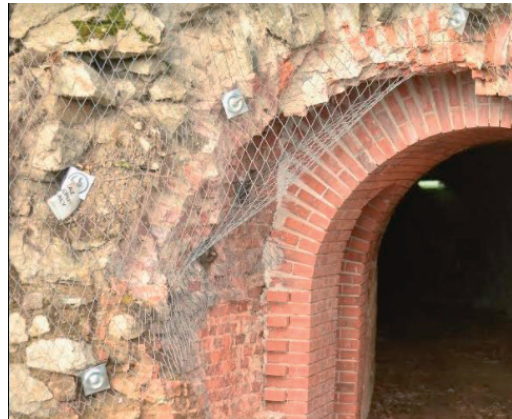
Photo 9. Protection of the damaged wall's face with a steel mesh mounted by the anchors (photographer – Grzegorz Basiński)

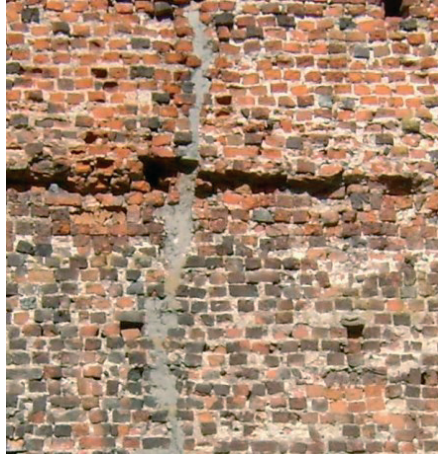
Photo 10. Injection into a crack with a cement mortar (photographer – Sylwester Zieńczuk) /castle in Liwa/

- **injection into cracks and scratches** – consists in inserting the injection solution into the very narrow slits. It is important that the modulus of elasticity of the preparation should be significantly greater than the material being repaired that no secondary dilatation-like cracks occurred. The strength of the material should not be less than the strength of the masonry material – the combination of the injection with the wall elements should monolithise the structure. Depending on the width of cracks, stabilization of the structure, and its moisture level, various types of injection materials are used:

- In the case of cracks with a width of less than 0.3 mm, only resin injections may be used; in the case of the cracks' widths of 0.3-0.5 mm, it is also allowed to use the microcements and cement pastes. In the case of cracks with significant widths
