ANALYSIS OF INJECTION SYSTEMS TYPES USED IN AGRICULTURAL MACHINES

Department of Power Industry and Transport Means, University of Life Sciences in Lublin

The paper presents analysis of the processes taking place in fuel systems which lead to damage of injection devices in farm machines. The most frequent reasons of failure of traditional injection systems and Common Rail high pressure systems which are caused inter alia by an improper quality of diesel oil were described and discussed. Microscopic tests of the surface of worn plungers of the plunger and barrel assembly of Motorpal injection pumps used in Zetor tractors were carried out. Types of damage to elements of the injection pump and electromagnetic injectors used in Common Rail systems CP4 type based on the tests on the group of 126 on-site repairs were assessed. Repairs were made in the repair centres in Podkarpackie Voivodeship and centres dealing with repair of injection systems. Metallographic tests were carried out in the Laboratory of Materials of Rzeszow University of Technology with the use of electron scanning microscope Hitachi S-3400N.

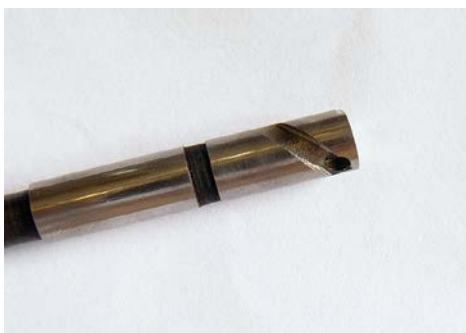
Metallographic microscope tests were carried out for the plunger and barrel assembly from the multi-sectional injection pump with combined sections. The micro-structure of the plunger and barrel assembly was tested including the groove controlling the fuel dose. Motorpal plunger used in Zetor tractor after 3000 motohours was the object of investigation.

Figure 1. Plunger from Motorpal pump of Zetor tractor after 3000 motohours of operation

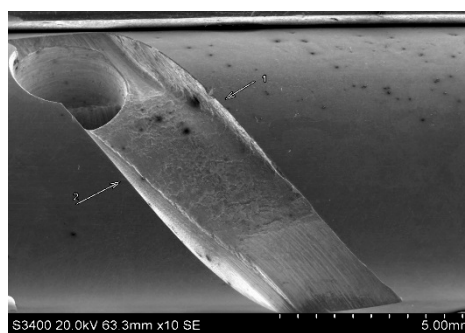
Figure 2. Plunger enlarged 10x with a view on the groove controlling fuel dose

Metallographic tests were carried out in the Laboratory of Materials of Rzeszów University of Technology with the use of a scanning electron microscope Hitachi S-3400N which is designed for testing the morphology of the surface of solid bodies. Research was carried out with the use of enlargement: 10x, 150x, and 600x. Figures 1-4 present research results. The wear of the plunger in the area of the groove which controls the fuel dose was reported. Numerous indentations and pits were observed. Adsorption phenomenon and accumulation of carbon deposit and waxes which cause irregularity of fuel doses and decrease the tight-

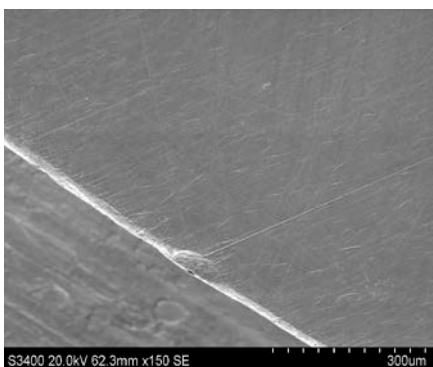
Figure 3. Plunger enlarged 150x with a view on the groove controlling fuel dose

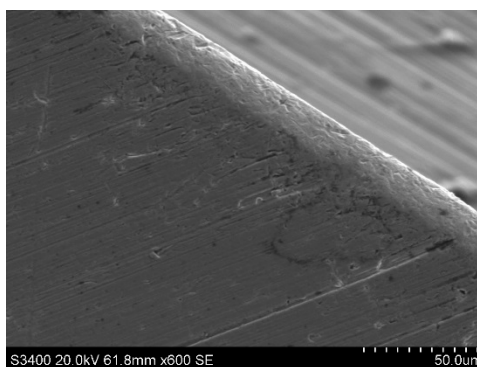
Figure 4. Piston enlarged 600x with a view on the groove controlling fuel dose

ness of the plunger and barrel assembly was reported. Metallographic images show the effects of friction wear and chemical corrosion as a result of the surface oxidation of metal. Figure 5 and 6 shows places where intensive consumption of elements during exploitation takes place in the DPA injection pump by CAV.

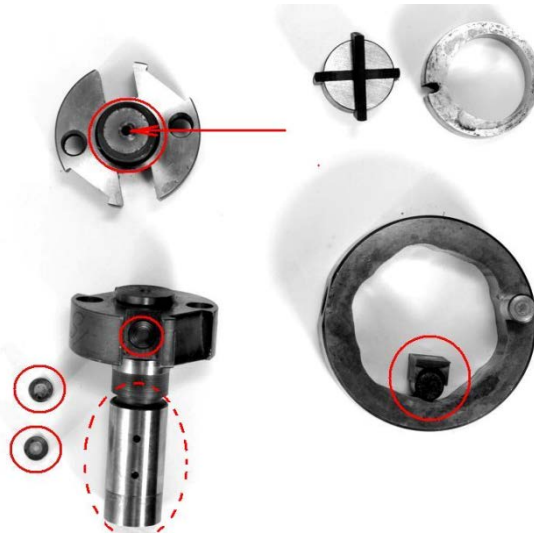
Figure 5. Selected elements of the injection pump DPA by CAV which are subject to intensive wear during exploitation

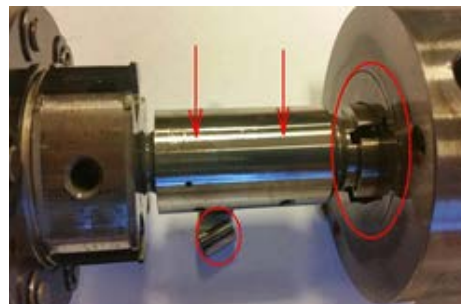
Figure 6. Rotational distributor of DPA injection pump by CAV with indicated spots of intense wear during exploitation

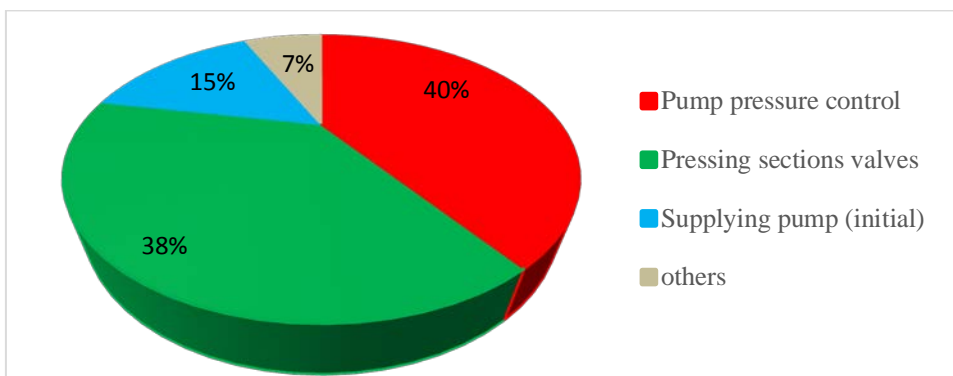
Analysis of documentation of technological processes performed during 126 repairs and information obtained in the form of a direct survey with employees of the repair department enabled estimation of the percentage participation of damages of particular elements of Common Rail type CP4 injection pumps. The highest level of damages was reported in case of a pump pressure controller and working elements namely pump pressure valves. Damages of the supplying pump or other damages, e.g. wear of the camshaft in the pump was considerably less often (Fig. 7).

Figure 7. Distribution of particular damages of elements in the injection pump Common Rail type CP4 used in farm tractors

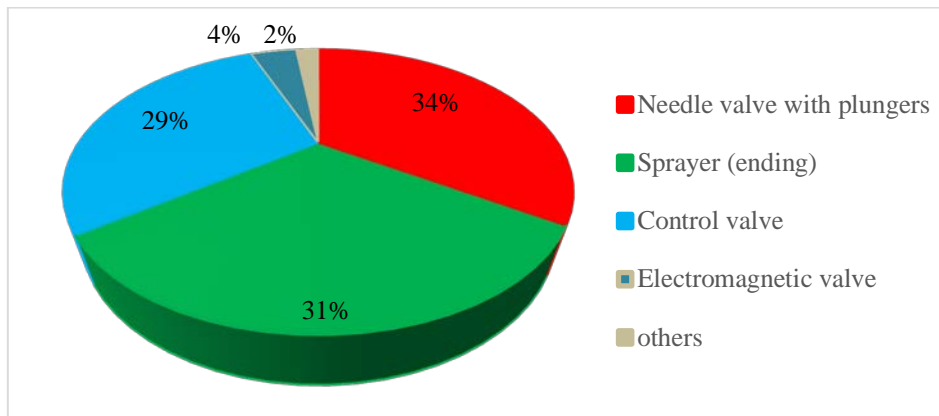
Injectors are the most impermanent elements of the Common Rail injection system, which directly influence the engine performance, capacity, fuel consumption and emission of hazardous oxides to atmosphere. Their consumption is related to direct impact of the pulsation pressure of 200 MPa and thermal loading. The highest level of damages was reported for the needle valve, sprayers and control valves (Fig. 8).

Figure 8. Participation of particular damages in electromagentic injectors used in the high pressure Common Rail systems

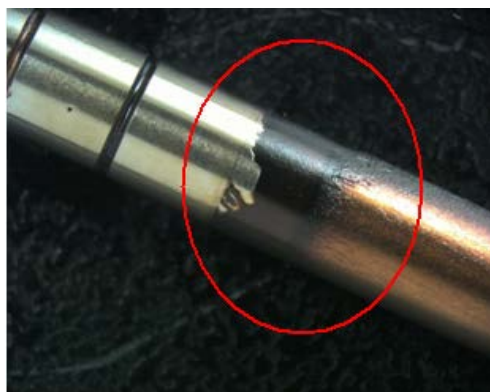
Figure 9. Corrosion pits on the knife-edge follower from Common Rail -Bosch sprayer

Microscopic images of advanced changes in the condition of the cone surface of the needle and seat were made with a digital microscope Optical Smart with a specialist fibre-optic lighting (Fig. 9-12).

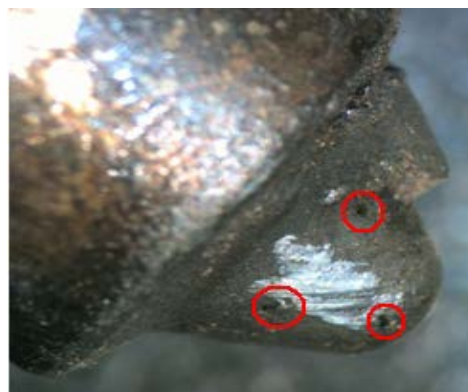
Figure 10. Overheating and change of the structure of the Common Rail-Bosch sprayer ending

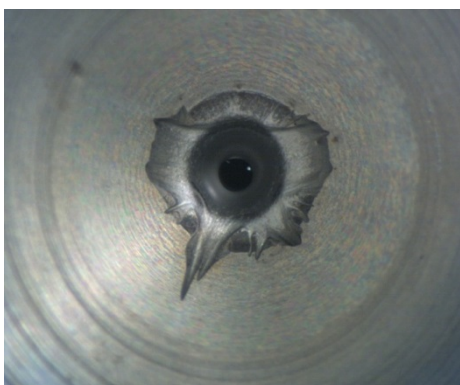
Figure 11. Damage to the control valve set of Common Rail-Bosch

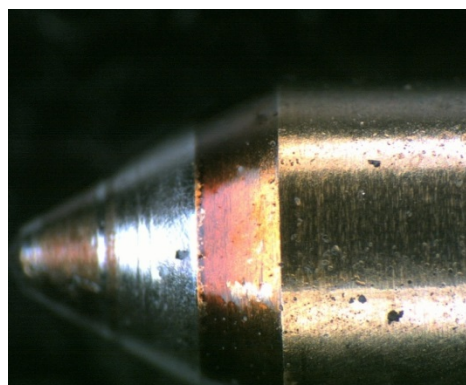
Figure 12. Corrosion pits and the change in the shape of the Common Rail-Bosch sprayer cone

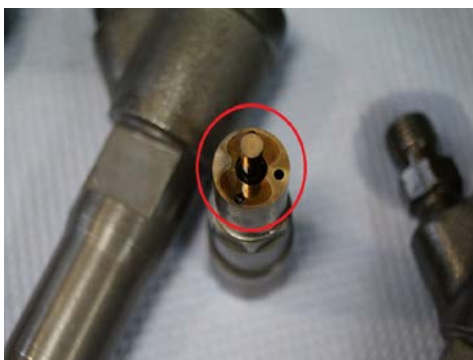
Figure 14. Corrosion pits on the injector sprayer which occurred affected by sulphur and water compounds in fuel

The tests which were carried out on components of the injection system confirmed that the wear of the surface of elements as a result of friction and corrosion is a frequent phenomenon (Fig. 9-17). This type of damage occurs in the plunger and barrel assembly although these elements are adjusted, smeared and cooled. Sprayers exposed to the simultaneous impact of several factors (pressure, temperature, combustion processes) and the so-called cavitation erosion work in particularly difficult conditions. Endings were often blocked with coke which disturbed the process of fuel injection. The problem occurs particularly in case of diesel oil with addition of fatty acids methyl esters (FAME) used as bio-components (Czechowski et al., 2006; Dzieniszewski, 2008; Klimkiewicz et al., 2013).

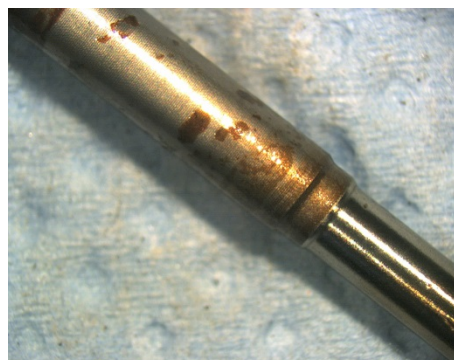
Figure 15. Corrosion pits on the needle which affected by sulphur and water compounds in fuel

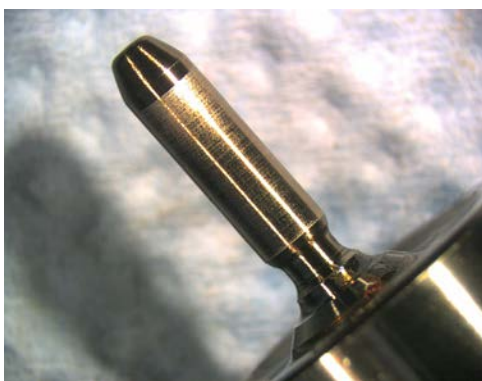
Figure 16. Friction and corrosion wear of the control valve piston (Common Rail)

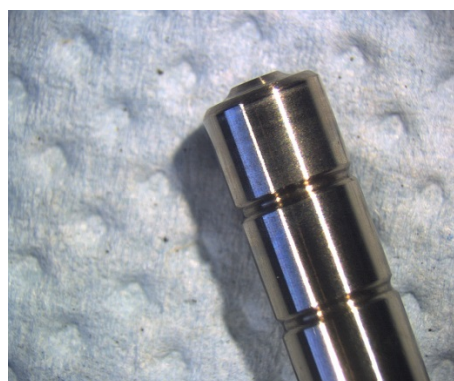
Figure 17. Friction and corrosion wear of the knife-edge follower (Common Rail).
