Jewish pre-burial houses in Silesian Voivodeship – state of preservation

dr inż. arch.
KAROLINA CHODURA
Politechnika Śląska
Wydział Architektury
ORCID: 0000-0003-3476-9697

Research results – state of preservation of Jewish pre-burial houses in the Silesian Voivodeship

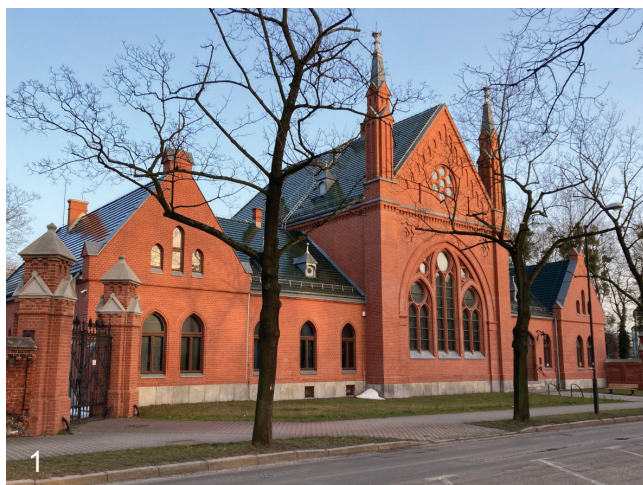
Pre-burial house at the cemetery in Gliwice at Poniatowskiego Street was designed by the Viennese architect Max Fleischer [3] in neo-Gothic style. The building was built in 1903, using traditional techniques and materials - it is made of brick, on a brick foundation, external walls are made of face brick, the roof truss is wooden, covered with ceramic tiles. It is an magnificent building that houses many functions. In the main, central part there is

a prayer room, and in the symmetrical wings there are: a morgue, rooms for the tahara ceremony, service and technical rooms (in the south wing) and the caretaker's apartment (in the north wing). Such spatial and functional organization of interiors was typical for metropolitan pre-burial houses - among others, funeral houses in Bielsko-Biała and Tarnowskie Góry were designed similarly. Today it presents the best technical condition among the pre-burial houses in Silesia Voivodeship, which is the result of the revitalization carried out between 2013 and 2015 [4]. The building has undergone renovation of the roof, facade, replacement of window and door joinery, replacement of electrical, sanitary and water supply systems, replacement of ventilation, adaptation to the needs of the disabled, recreating the original elements of the decor, on the basis of the few preserved fragments of the original the polychrome, stained glass windows, floor tiles [5].

Fig. 1. Jewish pre-burial houses in Gliwice (1), Bielsko-Biala (2,3) and Czeladź (4), photo: author

Jewish pre-burial houses in the Silesian Voivodeship are an extremely valuable architectural and cultural heritage, moreover, most of the buildings have a high adaptation potential. Based on the research on the state of preservation of the buildings, it can be concluded that a significant part of the buildings requires immediate conservation intervention, actions to stop the destruction and comprehensive renovation, which will allow the buildings to be used in the future. The pre-burial houses in Gliwice (old cemetery), Katowice, Zawiercie, Kromotów and Pyskowice are in a particularly bad condition. Buildings in Bytom, Cieszyn, Pszczyna, Tarnowskie Góry, Sosnowiec and Lubliniec also require general renovation. Pre-burial houses can be adapted to many functions — the buildings could house, for example, museums, lecture halls, educational spaces, exhibition halls, concert halls, libraries or reading rooms. An example of positive practice in this field may be the adaptation of the pre-burial house in Gliwice to a museum, which took place in 2013-2015.

Currently, the Upper Silesian Jews House of Remembrance (a branch of the Museum in Gliwice located in the former pre-burial house) hosts numerous cultural, scientific and educational events promoting the heritage of the Jewish culture. Due to the poor technical condition of most of the former pre-burial houses and the increasing degradation, the coming years will decide whether they will be preserved for future generations. The protection and adaptation of this heritage should be a priority.

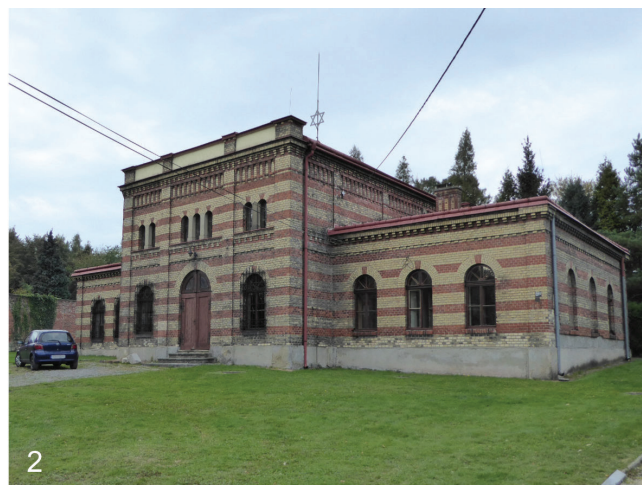
In good condition, although in need of refreshment, is the pre-burial house in Bielsko-Biała, designed by Carl Korn, local architect, constructor and entrepreneur. The building was erected in 1885, the form consists of a higher central part and slightly lower side wings - both the functional division and the materials used are similar to the above-mentioned pre-burial house in Gliwice. The building stands out from the others discussed in the article with its façade with neo-mauretanian motifs. The building has survived to the present day without any changes in the structure or in the form. In the 90s, building underwent a major renovation, including replacement of the roof, windows and doors, and

drying of the walls [6]. Currently, the façades of the building require refreshing, but except the wall on the west side, which is in a worse condition, no damage have been observed. It should be emphasized that extremely valuable historic ceiling polychromes have been preserved in the building.

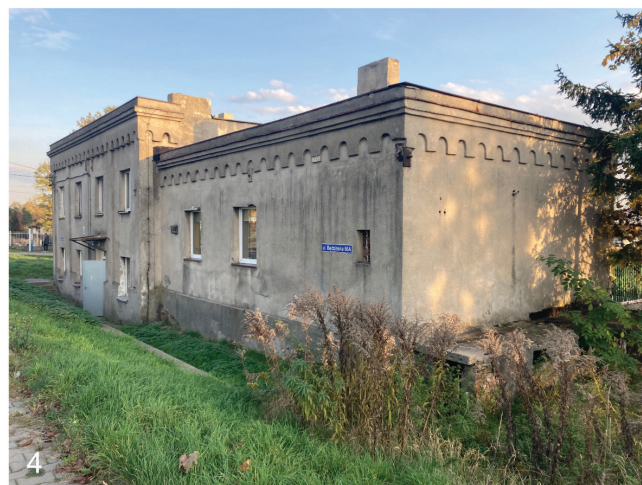
Some of the Jewish pre-burial houses were adapted to new functions during the World War II, or afterwards, for example to a residential building (Czeladź), a driving school (Lubliniec) or a upholstery workshop (Pyskowice), as a result many of them were significantly transformed. In the opinion of the author pre-burial houses in Czeladź, Lubliniec, Sosnowiec, do not currently have any aesthetic or artistic values, although they present a relatively good technical condition. The building in Czeladź was adapted to residential function, as a result of which the original structure of the building, designed by Bolesław Donat-Szleifstein in 1938, was completely transformed. Originally the building consisted of two parts - the upper, two-story part, which housed the prayer room, and the lower part, which housed the morgue. The form of the building is simple, but the façade is decorated with elements drawn from history - imitation of frieze and cornice and pointed

arch windows. During the adaptation of the building the high gate leading to the former prayer room was bricked up, and the high, pointed arch windows of the building were replaced with smaller ones of different sizes. The high prayer room was divided into two floors. The windows in the lower part, which originally housed the morgue, were partially bricked up and partially replaced. Also the façades of the buildings in the cemeteries in Sosnowiec and Lubliniec were distorted by changes in the composition of window and door openings. Both of the above-mentioned buildings are characterized by a simple form, divided into the central part and lower side wings and use of traditional materials. The architects of the buildings are not known and the lack of archival materials makes it impossible to determine precisely the original functions in the buildings.

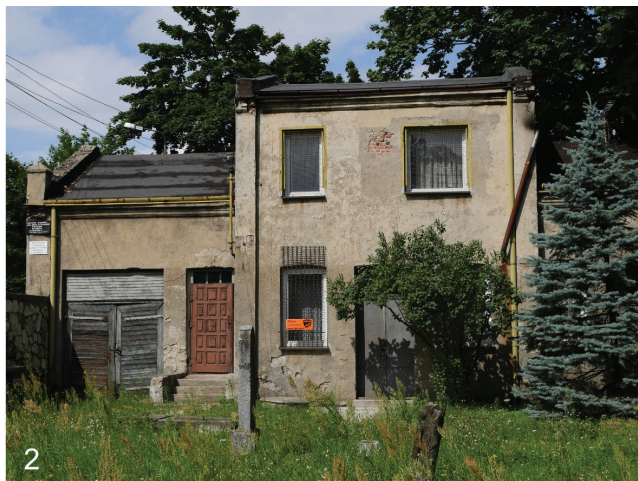
Fig. 2. Jewish pre-burial houses in Lubliniec (1), Sosnowiec (2), Tarnowskie Góry (3) and Pszczyna (4), photo: author

Buildings in Pszczyna and Bytom also require a thorough renovation. Both objects have preserved their original shape. The building in Pszczyna is an example of a small, single-space building with a simple, symmetrical form made of brick and covered with a pyramid hip roof. The construction of the roof was made of wood and covered with roofing felt. The author, Ernst Betz, a local builder, designed it in 1888. Slight defects were observed in the lower part of the brick walls. In the front elevation brickwork intervention is visible. Elements of the original window

and door joinery have not survived to present day. Original wooden gates were replaced with the temporary ones, and the windows were covered with boards from the inside. The building in Bytom is in a similar condition. The form of the building is simple, on a rectangular plan, made of brick, covered with a gable roof with a wooden structure. Defects in the lower part of the brick walls were observed. Original windows and gates (partially glazed) have been preserved from the side of the cemetery. Some of the windows on the northern elevation are bricked up. There are numerous plaster defects and humidity-related damage in the interior.

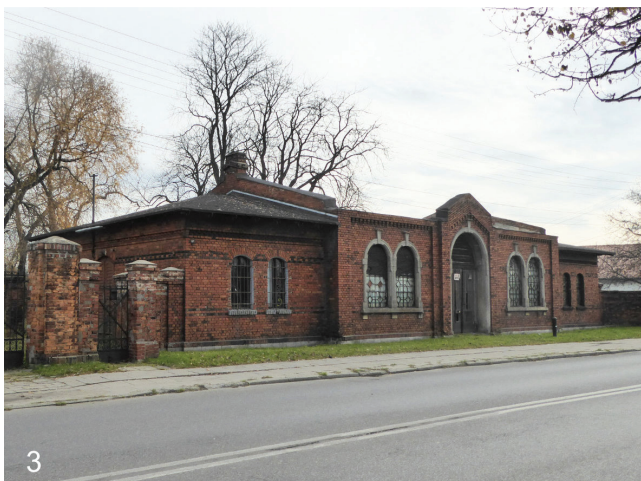
The pre-burial house in Tarnowskie Góry, designed by Johannes Kindler in 1893, has survived without any changes in the structure of the building - only the roof over the prayer room was pulled down due to poor technical

condition. The symmetrical form of the building consists of a higher, central part, formerly covered with a gable roof, and two lower wings covered with a hipped roof. The facility housed a prayer room, a morgue, a tahara ceremony room and a cemetery caretaker's apartment. The building was erected using brick, the ceilings and the roof truss were wooden and the roofing was made of roofing felt. No defects in the walls, e.g. cracks were observed, but the walls are partially damp. Fragments of stained glass windows in the prayer room and one of the gates have been preserved. Importantly, fragments of polychromes, partially covered with white wall paint, have been preserved in the interiors.

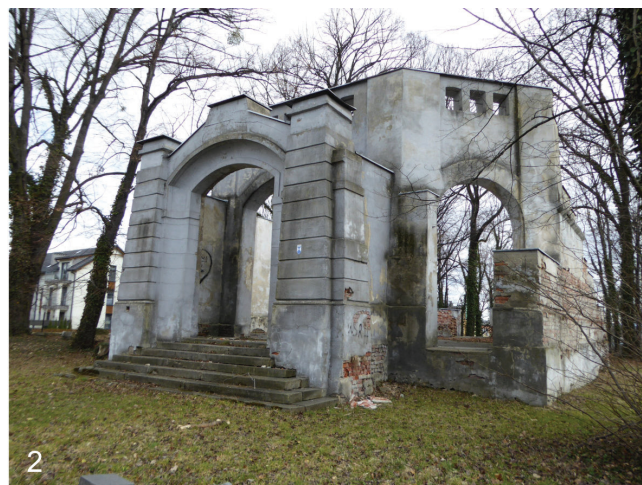
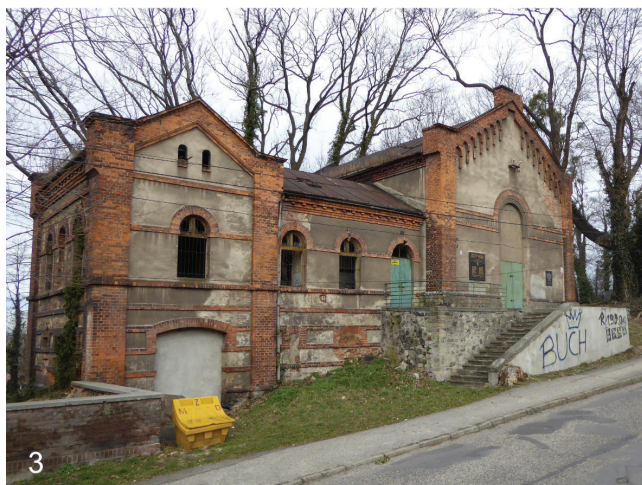
In Cieszyn, at Hażłaska Street, there are two Jewish cemeteries, pre-burial houses are situated on both of them. The technical condition of younger, once very interesting building designed in 1906 by Jakob Gartner [7], a Viennese architect, located on the new Jewish cemetery requires conservation works. The building served as a prayer room. The form of the building was compact and consisted of a higher central part on an octagonal plan, and lower entrance parts from the side of the road and the cemetery. Originally, the main part of the building was covered with a steel structure dome, which, due to its

poor technical condition, was pulled down in the 1990s. Remained brick external walls of the building were preserved as a permanent ruin. The present condition of the remains of the building is poor - there are defects in the construction material of the walls and in the plaster visible. There are also multiple signs of vandalism. The building in the old cemetery requires more urgent conservation intervention. Its original form and structure has been preserved and it has a great potential for adaptation. The form of the building consists of three segments covered with a gable roofs - the highest of them used to be the prayer hall. During in situ studies, losses of the lower part of stone walls, brick walls and plaster were observed. The original gates have not survived. The high opening leading to the former prayer room has been partially bricked up, and a new metal gate has been set up in the lower part. Similarly, the entrance openings from the side of the cemetery and the tall windows of the main hall were bricked up.

Fig. 3. Jewish pre-burial houses in Bytom (1), Cieszyn (2,3) and Katowice (4), photo: author

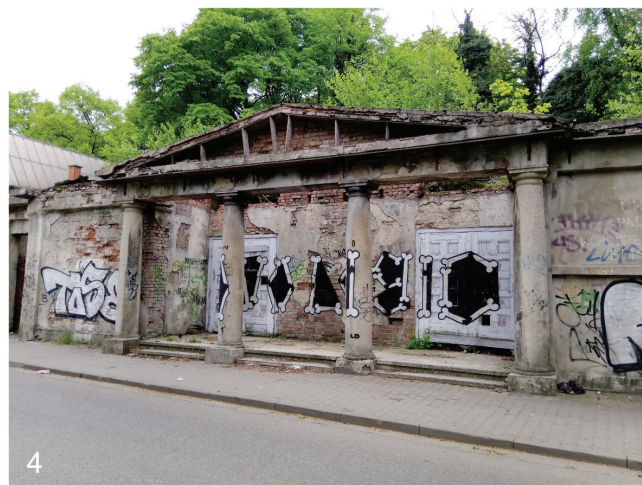
The pre-burial house in Katowice was built in 1869, originally it was a simple brick build-

ing covered with a gable roof. The present-day appearance of the pre-funeral home in Katowice is the result of transformations carried out in 1890 and 1927-28. The latter, in the neoclassical style, was designed by the Ignatz Grünfeld Baugeschaft office. Currently, the building consists of the main part on a rectangular plan, covered with a gable roof and an entrance area added from the street side, lower than the rest of the building and covered with a shed roof. The building is made of brick, with a wooden roof truss, and the roof covering is made of roofing felt. Both interior walls and elevations were plastered. A characteristic element of the building is the neoclassical portico in the front part. The technical condition of the pre-burial house in Katowice is very bad - the structure of the building is damaged. There are cavities in the walls, the roof of the building is leaky, and above the front part it is completely collapsed, which leads to the degradation of the walls and the dampness and delamination of plasters. The neoclassical portico is destroyed, also there are significant defects in the facade plaster. Additionally, the structure of the building may be threatened by numerous self-seeding trees. The form of the building, despite its current bad technical condition, has not under-

gone any major changes. The front elevation has retained its original shape, but the remaining ones have been transformed as the window openings have been bricked up. Unfortunately, the interiors have been heavily transformed and devastated. The ceilings, internal plasters and wall paintings preserved in fragments are damaged. Numerous traces of vandalism are visible.

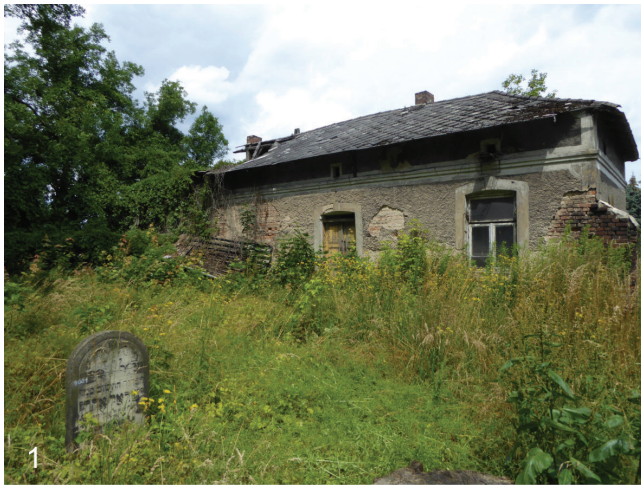
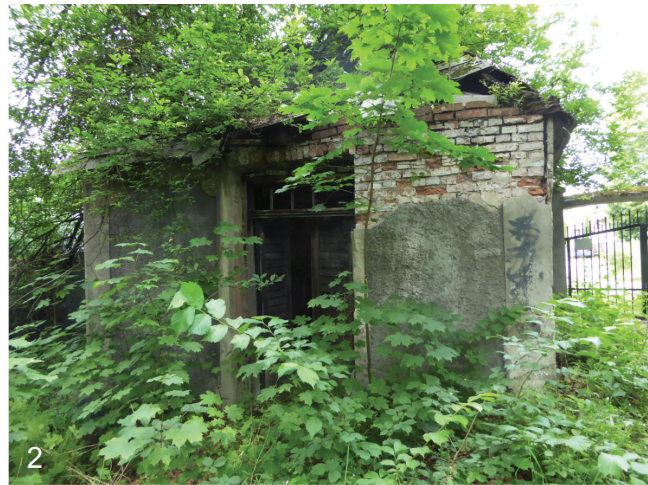
The complexes of buildings in Zawiercie and Zawiercie Kromotów are examples of a different spatial and functional structure than other pre-burial houses in the voivodeship. The complexes consist of two buildings connected by a gate - in one of them there was a prayer room, in the other there was a caretaker's apartment, a morgue or technical spaces. The objects were made with the use of traditional materials and techniques - the walls were made of brick and the roof construction was wooden. Unfortunately, the archival documentation has not survived and the designers are unknown. The pre-burial house in Zawiercie is a simple form on a rectangular plan, covered with hipped roof. The building in Kromotów was built on a square plan and is covered with a pyramid hip roof. In the case of both buildings, there are visible defects in the wall structure, and the roof

structure is significantly damaged, partially collapsed. The facades of the buildings are badly damaged, the gaps in the plaster reveal brick walls.

Fig. 4. Jewish pre-burial houses in Zawiercie (1), Zawiercie Kromolów (2), Pyskowice (3) and Gliwice (4), photo: author

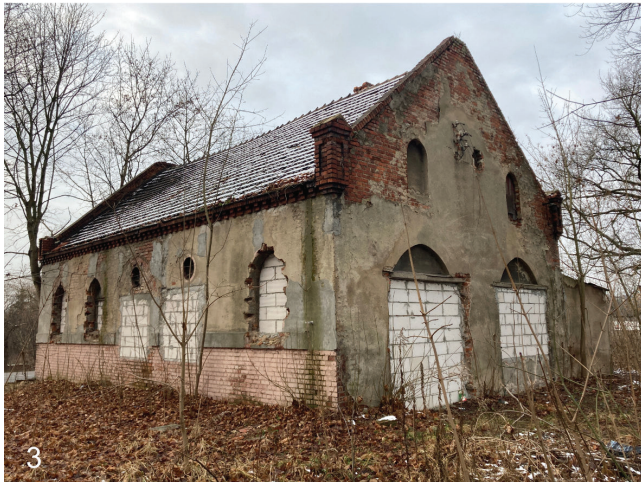
The heavily transformed pre-burial house in Pyskowice also requires urgent intervention. The author of the project is unknown. The building was built of brick, on a rectangular plan, covered with a gable roof. In later years, numerous extensions were built on the front side. There are numerous defects in the structure of the walls. The building's elevations have been transformed by bricking up the original windows and inserting new openings of a different shape. The entrances to the building have been widened and steel beams have been inserted. Also the interiors of the building have been rebuilt and devastated.

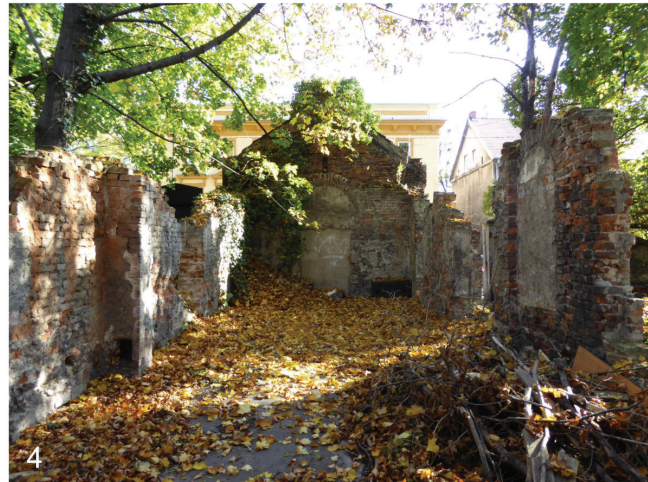
The pre-burial house in the old cemetery in Gliwice is in the worst technical condition - only the front wall and fragments of side walls have survived, the entrance in the front wall is bricked up. No elements of the roof, windows or doors have remained. The original shape was compact, built on a rectangular plan using brick, covered with a gable roof. Due to the degree of destruction of the building and the lack of archival design documents, the functional partition of the

building is not clear. The author of the project is unknown.
