Building and Conservation Works in the Castle Church in Malbork (2014–2016) As the Culmination of Half a Century of Its Restoration

Keywords: Castle in Malbork, Gothic art, war damages, conservation project, protection of monuments

This paper presents the last stage of the reconstruction of the religious complex at the castle in Malbork, consisting of the Church of the Blessed Virgin Mary, the burial chapel of St. Anne and Klesza Tower, which suffered significant damage during the Second World War in 1945. First, the post-war history of the religious complex and its reconstruction from the end of the 1950s, through construction activities recreating the body of the temple in the 1960s, to restoration works on the interior design and furnishings in the 1970s, are discussed briefly. The main focus was placed on the final stage of the reconstruction of this important fragment of the Malbork Castle (implemented in 2014–2016), which ended over five decades of efforts to restore it to its proper form. The paper discusses the criteria and reasons that guided the creators of the reconstruction from the point of view of one of them. The final works were carried out thanks to the support o

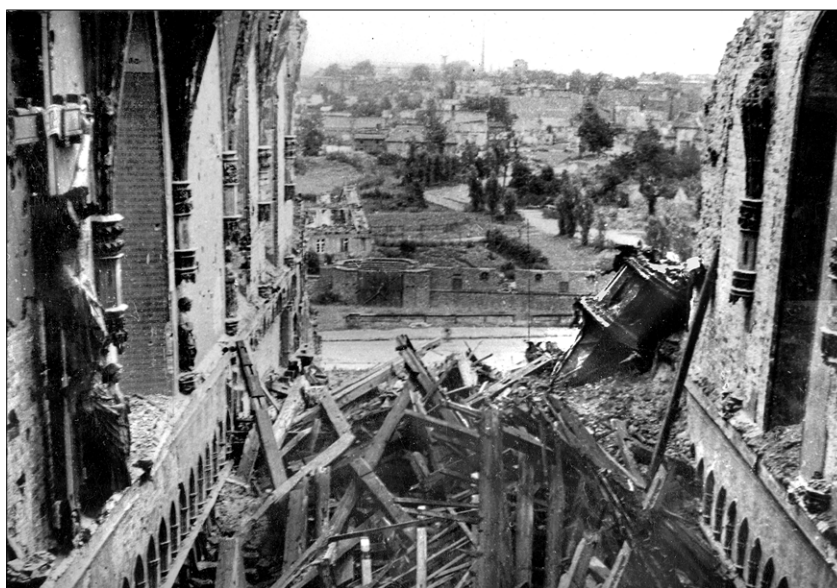
The figure of the mosaic Madonna from the outer niche of the presbytery broke up into a dozen or so segments that were buried in the rubble of the church complex together with a number of medieval elements and sculptural details constituting the decor of the castle church.

The remains of wooden roof trusses, hanging over the walls, threatened to collapse at any moment. Damaged roofs and broken windows made it possible to adversely affect the weather on the remnants of the surviving décor and interior equipment (Fig. 1, 2).

Fig. 2. The interior of the Church, view of the presbytery after war damages, 1945; reprod. by L. Okoński.

Only part of the northern wall, up to the height of the defensive porch, and a fragment of the lower part of the southern wall have survived from the body of the temple. Luckily, three Gothic portals survived, protected by a mass of thick walls—the Golden Gate and two portals of the Chapel of St. Anne. A mass of rubble filled the interior of the church to the height of the window-sills and went down to the breach in the defensive wall of the eastern moat.²

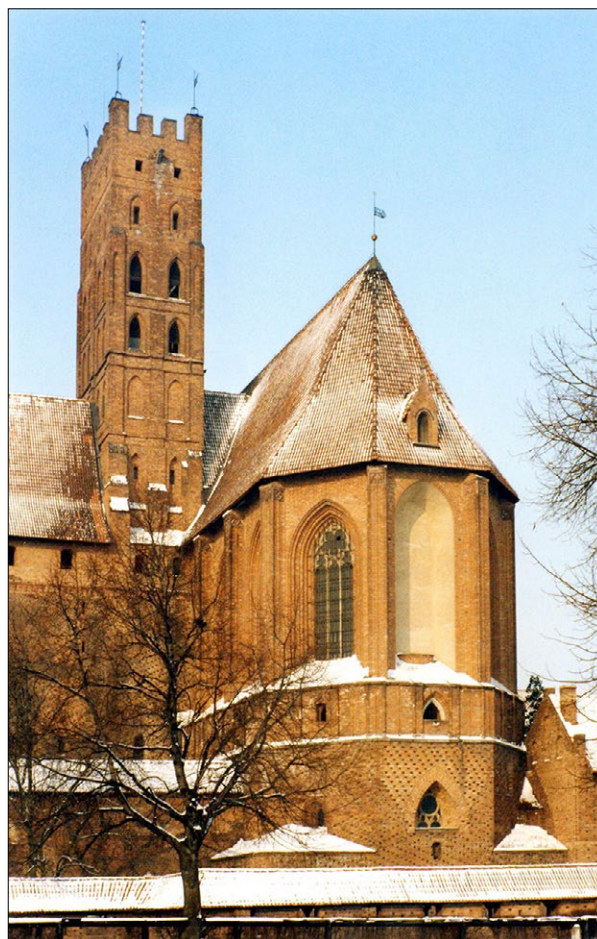
Based on the new assumptions, in 1966, the concept of rebuilding the church itself and building a permanent roof over it was started. On the polygonal closure of the chapel, reconstructed in the years 1958–1961, the walls of the presbytery of the church were erected with four sacristies located in the thickness of the wall. After the main walls were brought out to their full height, they were fastened at the top with the preserved fragments of the former northern

Fig. 3. The Church and the main tower after reconstruction in 1968; reprod. by L. Okoński.

wall, with a reinforced concrete rim poured over the crown. The surface of the ceiling above the interior of the church was covered with reinforced concrete slabs. The last element of recreating the body of the church was the erection of a high saddle roof based on a metal truss and covering the roof with monk-nun tiles. The works were completed by 1968. Practically from that moment the church ceased to be practically a war ruin (Fig. 3). At the same time, it must be assumed that a multidirectional conservation project was initiated at that time, aimed not only at the liquidation of war damages, but also to restore the former shape of a unique historical and architectural monument. The project ended in 2016.

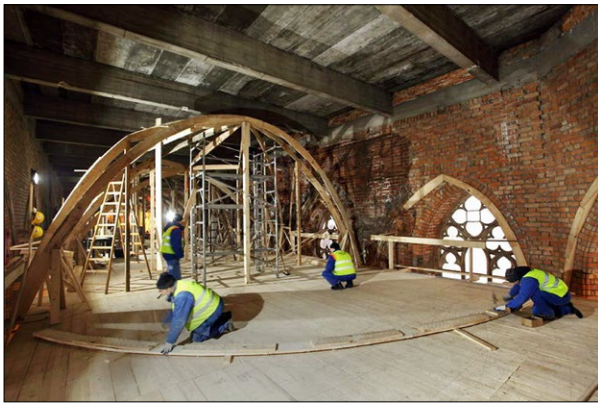
Fig. 7. Installation of centring for the reconstruction of the vault under the existing reinforced concrete ceiling, 2015; photo by L. Okoński.

- the brick stellar vault was reconstructed by removing the ribs from the remains of the original and reconstructed vault caps. The proposal to apply the theoretical concept of Bartel Ranisch regarding the reconstruction of the vault and the method of calculating its geometry was not reflected in the actual condition of the preserved elements of Malbork vaults and could not be used in the reconstruction.²⁰ The works were carried out following medieval construction techniques, raising the ribs on traditional centrings and filling the vaults manually (Fig. 7);

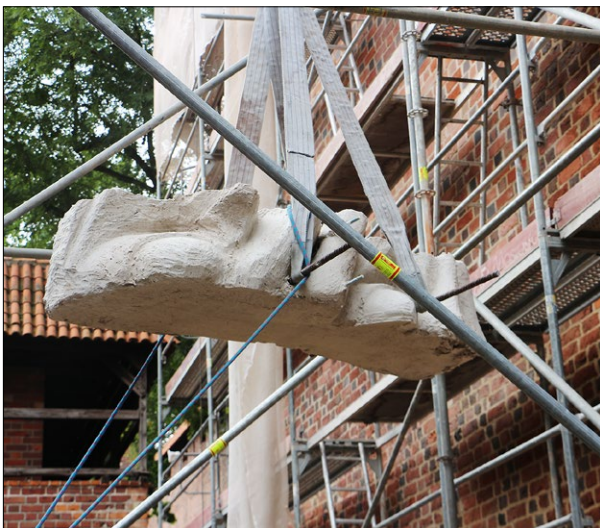
Fig. 9. Transport of the finished segments of the Madonna statue to its place in the outer niche of the presbytery, 2015; photo by L. Okoński.

The final position developed by the Museum in the course of numerous discussions assumed the anastylosis of all the preserved elements of the statue and putting them in appropriate (original) places for the figure to be re-cast in segments. The exception was the original right hand of the Madonna with fragments of the mosaic preserved in situ, which was left in the museum lapidarium for research and exhibition purposes. The remaining original fragments, excavated from the

rubble after the war and surviving to this day, became part of the statue again (Fig. 9). After the statue was assembled on the spot, in the recess of the church, the whole thing was covered with a colorful glass mosaic, the technology and colors of which were developed on the basis of studies of surviving tesserae, and which were made in Italian and Polish workshops (Fig. 9). In this way, not only the most important element of the external decoration of the church was restored, but one of its most important elements, necessary for understanding this unique place and the cultural values protected in it, was reclaimed for the castle (Fig. 10).

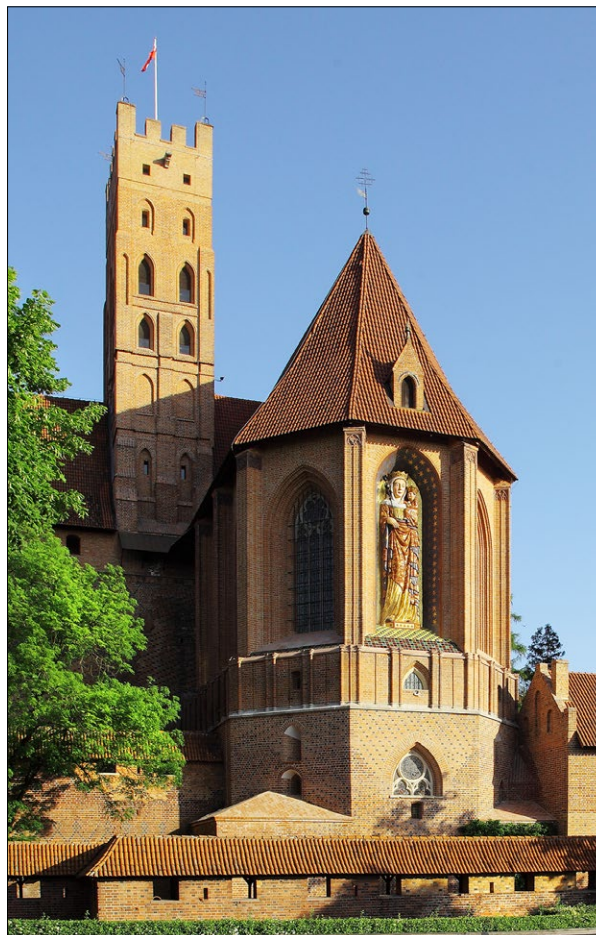
Fig. 10. View of the Church from the east, 2016; photo by L. Okoński.
