CHARACTERISTICS OF THE POST-SMELTER AREA UNDER ANALYSIS

CASE STUDY

Abstract: The process of transformation in the Polish economy, transforming it from a planned economy into a market economy, has resulted, among others, in the liquidation of many heavy industry plants in the Upper Silesian Industrial Region (GOP). GOP cities, which grew up on the basis of heavy industry, were spatially planned according to the needs of mining and metallurgical plants. Liquidation of the plants resulted in the creation of degraded, unused post-industrial areas, scattered over various city districts. Their location is often very attractive, but with many drawbacks, such as degradation, contamination by harmful substances or unclear legal status, potential investors are reluctant to take interest in them. Detailed documentation of the land's characteristics, the effects of the activity previously carried out here, the community's expectations regarding the use and development of such land, will make it easier for the investor to take a decision on the re-development of the area. The article is an example of a preliminary analysis of a selected post-industrial area, which helps to outline the directi

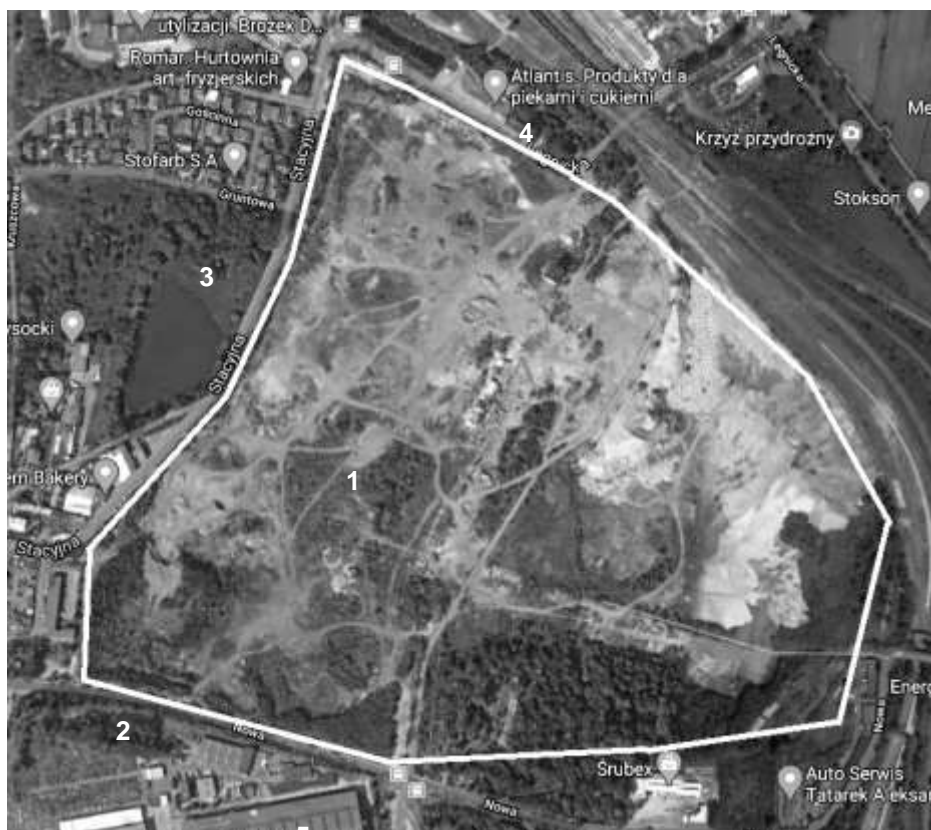
Fig. 1 View of the Chorzów II post-smelter area:

1. Degraded post-smelter area, 2. Nowa Street, 3. Stacyjna Street. 4. Legnicka Street
Source: based on (Google Maps, 2020)

The analyzed area is located in Chorzów II (Fig. 1).

- The western border partly runs along the Stacyjna Street,
- The southern border partly runs along the Nowa Street,
- The north-eastern border partly leads along the Legnicka Street.

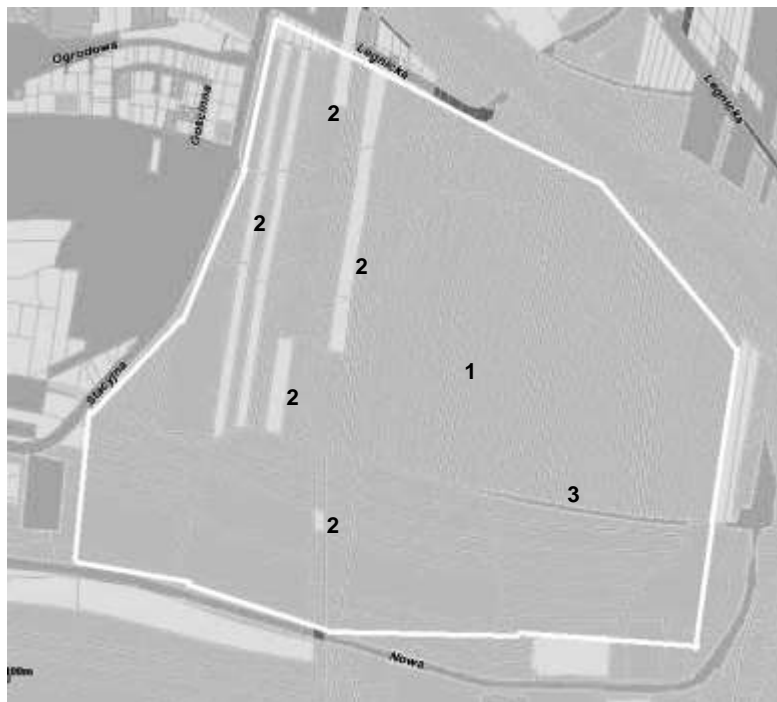
Fig. 2 Ownership structure of the post-smelter area. 1. Ownership by the State Treasury with perpetual usufruct, 2. Ownership by natural or legal persons, 3. Ownership by the City of Chorzów without perpetual usufruct

Form of ownership	Share in ownership (in % of the land area)
State Treasury	94.8%
Local government unit (communal, county or voivodeship)	0.2%
Legal or natural persons	5%

The structure of ownership is illustrated in Figure 2.
