STUDIES ON THE EFFECTS OF COLD STARTS OF THE SHIP MAIN ENGINE

This article presents the influence of various ship's operational conditions occurring during manoeuvres related to entering and leaving the ports and mooring operations. Frequent starts and stops of the ship's propulsion unit are then required, which affect the variability of the energetic loads of the ship's power plant, causing accelerated, non-design wear of the ship's main propulsion engine. The effects of cold start-ups of the main ship engine are the subject of this study. Conditions of the engine inlet valve damage process are discussed. The physics of the degradation process leading to air inlet valve damage was considered. Laboratory tests of structure continuity and their results are discussed, and the valve material defects were excluded as the cause of the damage. The causes of repeated damage to the inlet air valves were identified. The effectiveness of the performed corrective measures was confirmed by a documented control test of the engine start-up. The article is a utilitarian premise for the requirements of the Classification Society.

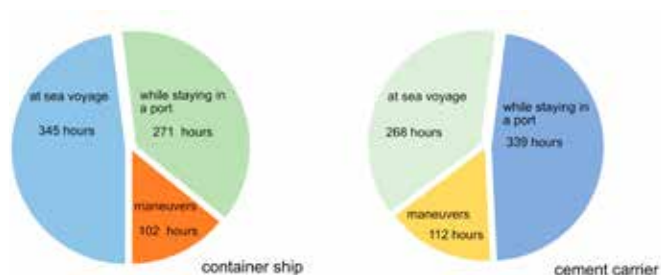
Fig. 1. Total times of operating states of a container ship and a cement carrier realized in one month [own source].

The ship main engine is responsible for keeping the ship in motion in all operational conditions: during sea passage, in port and in limited water passage, as well as at anchor and in port. Continuity of ship operation in all operational states provides for steady operational conditions and also transient processes, acceleration and load deceleration, as well as engine shutdown. For the purpose of this study, operational documentations of a container ship and a cement carrier were used. Mutual relations of the steady condition operation time to the number of manoeuvres are shown in Fig. 1. During 102 h of sailing of a container ship in a month, 44 start-ups were made during the manoeuvres, while on a cement carrier, 20 start-ups were made during 112 h of manoeuvres.

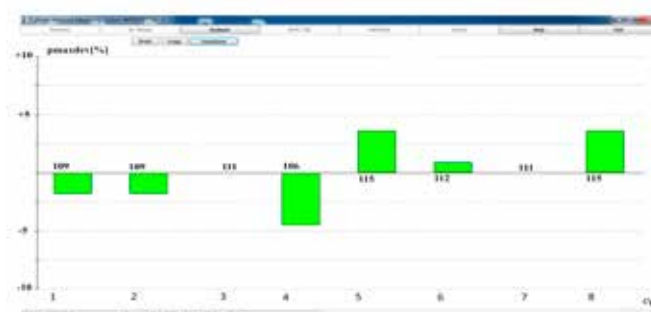
Fig. 2. Deviations from the mean value of the combustion pressure at the beginning of the first stage of the engine start-up.

The runs were recorded using an electronic indicator LEMAG Premet C XL made by LEHMANN & Michels GmbH and equipped with the WPREMET software, enabling the analysis of the measurement results. In Fig. 2, at the time of observation, three units 4, 5, and 8 in operation showed differences of several percent from the average value of the combustion pressure, three other units 1, 2, and 6 initiated operation, while two units did not start the combustion process at all, creating differences in the load of the piston-crank systems.

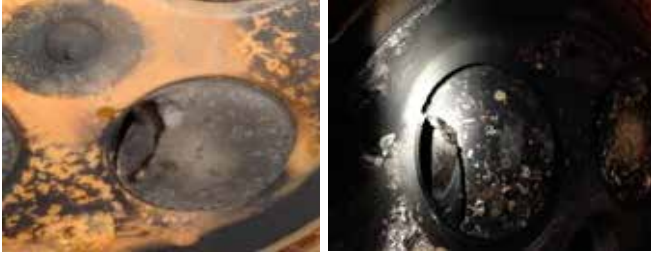
This process occurs with irregular frequency and causes different forms of tribological wear of inlet valves. Fig. 3 shows endoscopic images of a damaged inlet valve mounted in the cylinder head of a Deutz 68M628 main power engine of 1715 kW.

Fig. 3. View of a defective inlet valve of the Deutz 68M628 main power engine.

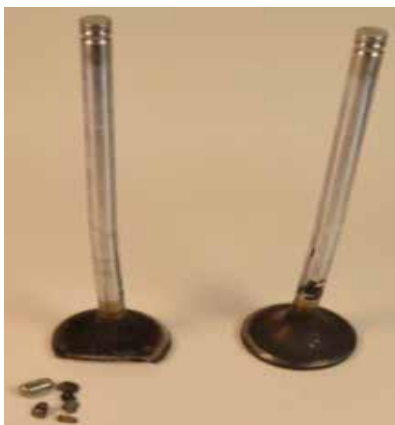
Organoleptic examination of the first valve revealed a bent stem and scratches in its upper part. These proved the existence of resistance to motion in the valve stem guide and defective operation of the “rotocap”. The second valve also had a bent stem and a partly broken off head. The view of the tested valves is shown in Fig. 5.

Fig. 5. View of studied damaged valves.

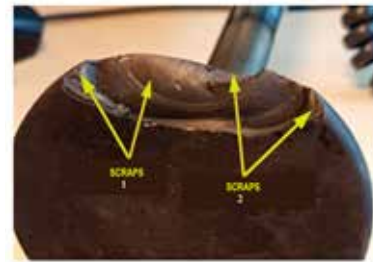
The examined separation surfaces (scrap) of the damaged valve show two different breakthroughs in Fig. 6. The first breakthrough (1) shows furrow lines characteristic of fatigue scrap. The second breakthrough (2) is the separation scrap that resulted from the sudden breaking off of the part of the valve that was no longer cohesive. The nature of the scraps indicates that the process of destruction progresses over time.

Fig. 6. View of the place of separation of the missing part of the inlet valve with visible separation lines: 1 - fatigue scrap; 2 - separation scrap.

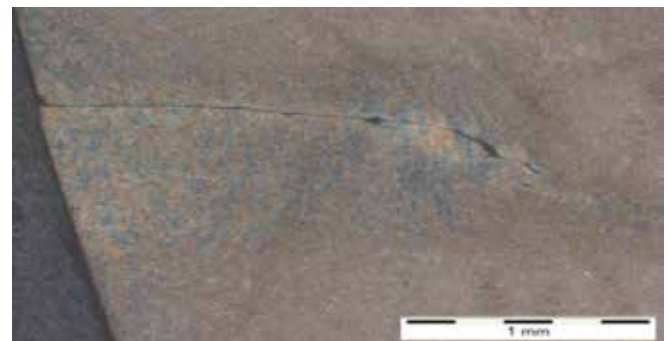
During the visual inspection of the examined valves, a micro-crack was found, which was the beginning of the propagation of further destruction proceedings. The microcrack was a result of thermal stresses that occurred in the second phase of the cold engine start-up [28, 31, 32]. The crack expansion was probably caused by a cyclic action of varying mechanical loads resulting from the repetition of transient engine operating states. The location of the micro-crack is shown in Fig. 7 [32].

Fig. 7. View of a microcrack on the working surface of the damaged valve 2.

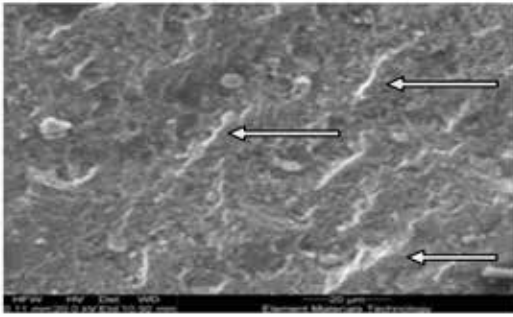
Circumferential cracks in the valve head found during examination using scanning electron microscopy revealed the formation of areas of local corrosion at the microcrack site, as shown in Fig. 8 [32].

Fig. 8. Microscopic image of the surface of the tested valve.

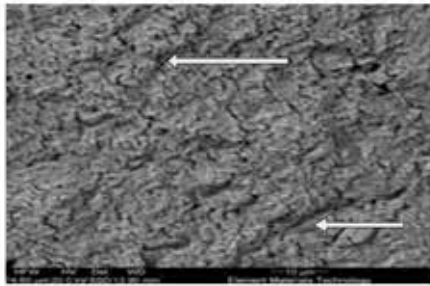
At the same time, the structure of the valve material at the place of the fracture showed lines formed by fatigue crack growth. This phenomenon is documented by the electron microscope image shown in Fig. 9 [32].

Fig. 9. Scanning electron microscope image of the surface of a cracked valve.

The revealed microcracks are the result of thermal stresses occurring during the process of exchange of the working medium [17].

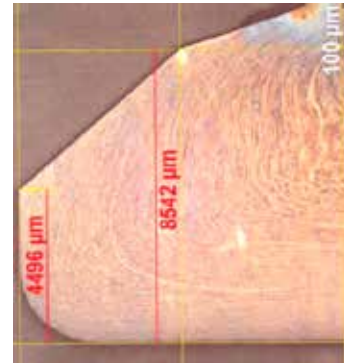
the measurement of the valve thickness and angles showed that the permissible thickness loss exceeded the design value by 1 mm. This indicates repeated regeneration of the valve by grinding-in. The measurement of the valve thickness is shown in Fig. 11 [31], and the angle measurement location is shown in Fig. 12 [31].

Fig. 11. Valve thickness measurement in the faying section.

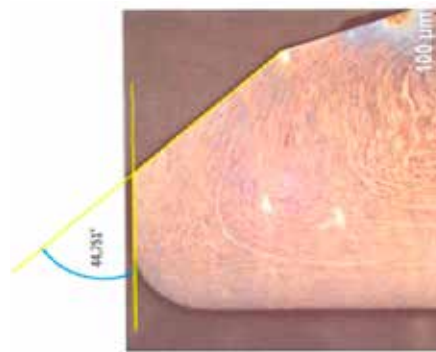
Fig. 12. Angle of faying face inclination measurement.

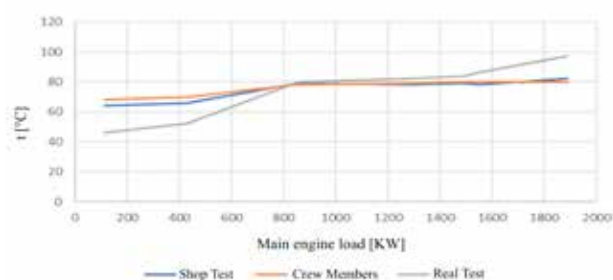
oil purifying system and, consequently, the engine energy state, it was found that the temperature of the heating water and, therefore, the temperature of the engine before the start-up was only 20–25 °C. Starting of the engine in such a defined energy condition is known as the so-called “cold start”. The correct temperature of the low-temperature cooling circuit (LT – Low Temperature) of 60 °C, compliant with the operational documentation, was established only after 20 min of engine work at its load corresponding to about 50% of its nominal power. Looking for the correctness of the process course, Fig. 13 shows comparative diagrams of the engine cooling water temperature variation as a function of load. Diagrams were made during shop tests, by the crew of the ship, and for the purpose of verifying the engine cooling circuit functionality during the manoeuvres and sea passage (after the transient start-up process).

Fig. 13. Dependence of cooling water temperature on the main engine load: blue line - measurement from engine shop tests; red line - measurement taken by the crew; grey line - measurement taken for the sake of the case study.

To ensure the design operating conditions of the studied engine, the inlet cooling water temperature must not be lower than 60 °C. The inlet water temperature measurements made for the research in Fig. 13 show a lower temperature, while the outlet water temperature took correct values in the range of 78–82 °C.

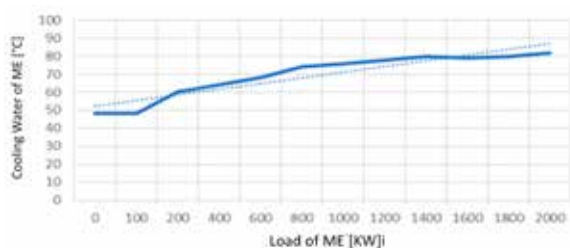
Fig. 14 shows the variation of the engine cooling water temperature measured for the present study, from the value of the heating starting level during engine idling and port exit manoeuvres to the design value of the continuous operating temperature with the engine loaded at its nominal power. The relationship indicates that the water temperature at the beginning of the start-up is too low, reaching the correct value only after 20 min of operation with the engine load of 80% of its nominal power. The dotted line in the figure, reflecting the trend of the temperature change, confirms the correct operation of the automatic engine cooling system.

Fig. 14. Changes in the cooling water temperature as a function of engine power.

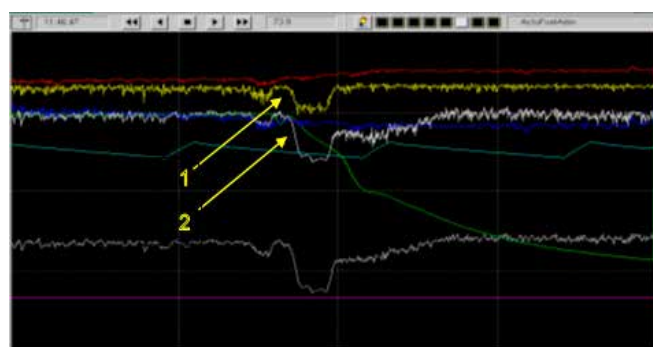
consequence. This caused deterioration of the operating conditions of the barrel/plunger of the injection pumps and, consequently, the organization of the combustible mixture. The underheated engine operated unstably with a temporary reduction in speed and fuel delivery rate. Fig. 15 shows a run of the rotational speed and a representative of the fuel dose recorded during the engine start-up with the help of the Norris type control system.

Fig. 15. Runs of the monitored parameters of the main engine operation during start-up: 1 - engine speed, 2 - fuel dose equivalent (Actual Fuel Admin).

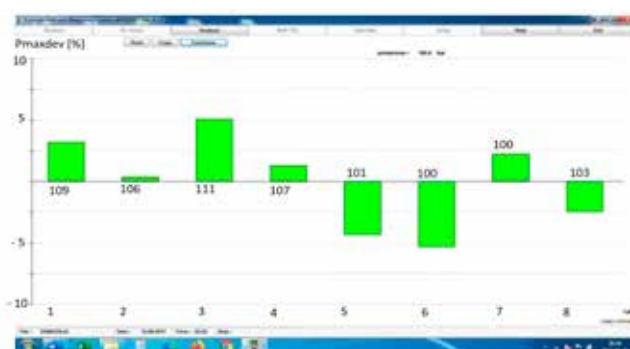
An examination of the run of the start-up and the initial phase of engine operation showed an uneven distribution of loads on individual units. Lack of balancing of unit loads significantly hinders the start-up and the start of stable engine work and, thus, its ability to accept the load. The cylinder imbalance that is occurring, represented by the compression pressure, is shown in Fig. 16, with the distribution of the combustion pressure difference between the units.

Fig. 16. Deviations from the mean value of the combustion pressure at the beginning of the second stage of engine start-up.

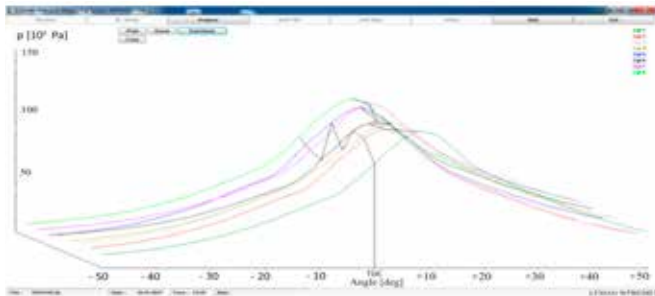
the WPREMET software, enabling the real-time measurement of combustion pressures. Disturbances in the operation of the fuel system of individual injection pumps in the form of combustion pressure runs of the fuel-air mixture are shown in Fig. 17.

Fig. 17. Runs of combustion pressure in the first stage of the main engine operation as a function of the crankshaft rotation angle.

The combustion pressure runs for each cylinder showed significant differences. Identified by means of a diagram (Fig. 17), the hanging-up selected injection pump, disassembled for verification of its technical condition, revealed local traces of scuffing (B) and overheating in the form of a dark purple discoloration of the surface layer, as shown in Fig. 18.

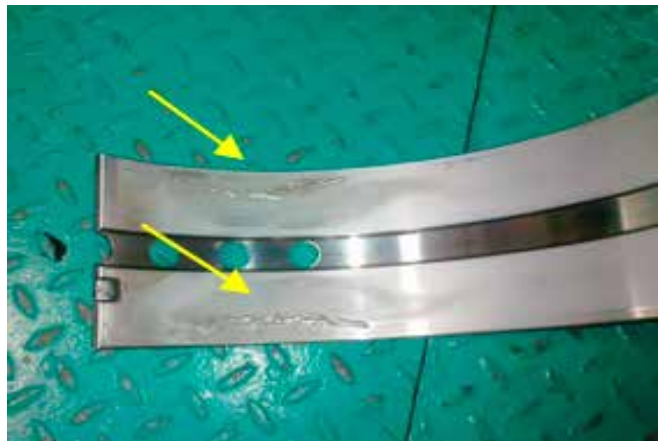
When the oil temperature is lowered, its rheological properties change. The viscosity of the engine lubricating oil increases and the resistance of the crankshaft movement increases. Oil with a higher viscosity does not reach all the motion pairs to the required extent. These conditions make it difficult to create an oil wedge in the hydrodynamic lubrication of the crankshaft bearings at the beginning of a start-up, which in turn leads to bearing pan damage. An

example of such damage to the crankshaft bearing pan of the engine under study is shown in Fig. 19.

Fig. 19. View of the damaged surface layer of the crankshaft bearing pan.

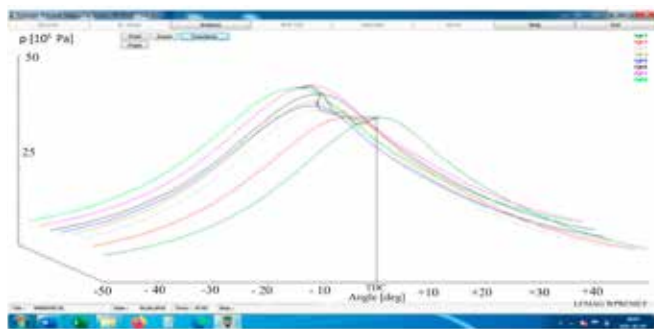
The performed corrective actions balanced the load distribution across the engine units to some extent, as shown by the engine indicator graph in Fig. 20.

Fig. 20. Combustion pressure runs in the ship main power engine as a function of the crankshaft rotation angle, after correction actions, taken at the load of 50% of the nominal engine power.

The recorded runs of the pressure show more balanced loading of individual piston-crank systems. The effectiveness of the performed corrective actions, taking into account the conclusions of the conducted tests as fully as possible, was confirmed by the successful control tests of the engine start-up and its further operation without unscheduled repairs and valve damage.

On the basis of the partial conclusions from the research, corrective actions were carried out during stay in port and verified during start-ups and registration of initial periods of engine work. Cooperation of the engine start-up time controller with the crankshaft speed meter was verified. Temperature controllers of the engine heating water and the state of the non-return valve at the connection of the engine heating and cooling circuits were corrected. Operation of the thermoregulatory valve adjuster in the engine circulating oil purifier system was adjusted.

The automatic setting of the starting fuel dose was adjusted. Settings of the injection pumps (fuel doses) and the moment of starting the fuel injection were corrected. The correction was made on three injection pumps with the use of a fuel dose corrector, included in the equipment of the injection pumps. The correctness of the timing phases of the mutual angle of rotation of the crankshaft and the camshaft was checked using an electronic meter.
