Geophysical imprint of mining-induced rock mass deformation in the area of construction disaster in Bytom (Poland)

Andrzej Kotyrba, Łukasz Kortas*

Central Mining Institute, Plac Gwarków 1, 40-166, Katowice, Poland

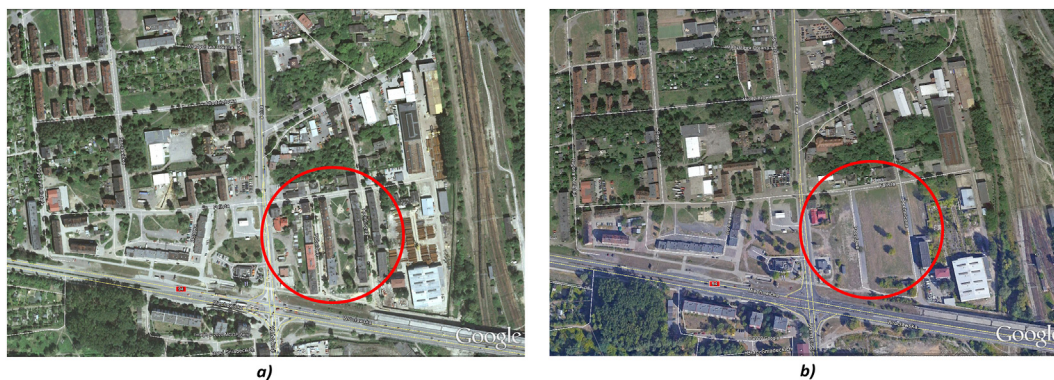
Fig. 2. Satellite images of the study area (in red) before (a) and after (b) the catastrophic event [29].

The effects of coal extraction for the urbanized area of the analyzed part of the Karb district are illustrated by satellite maps from Google Earth resources (Fig. 2). They show the land development of the area before the construction disaster and two years after its occurrence.

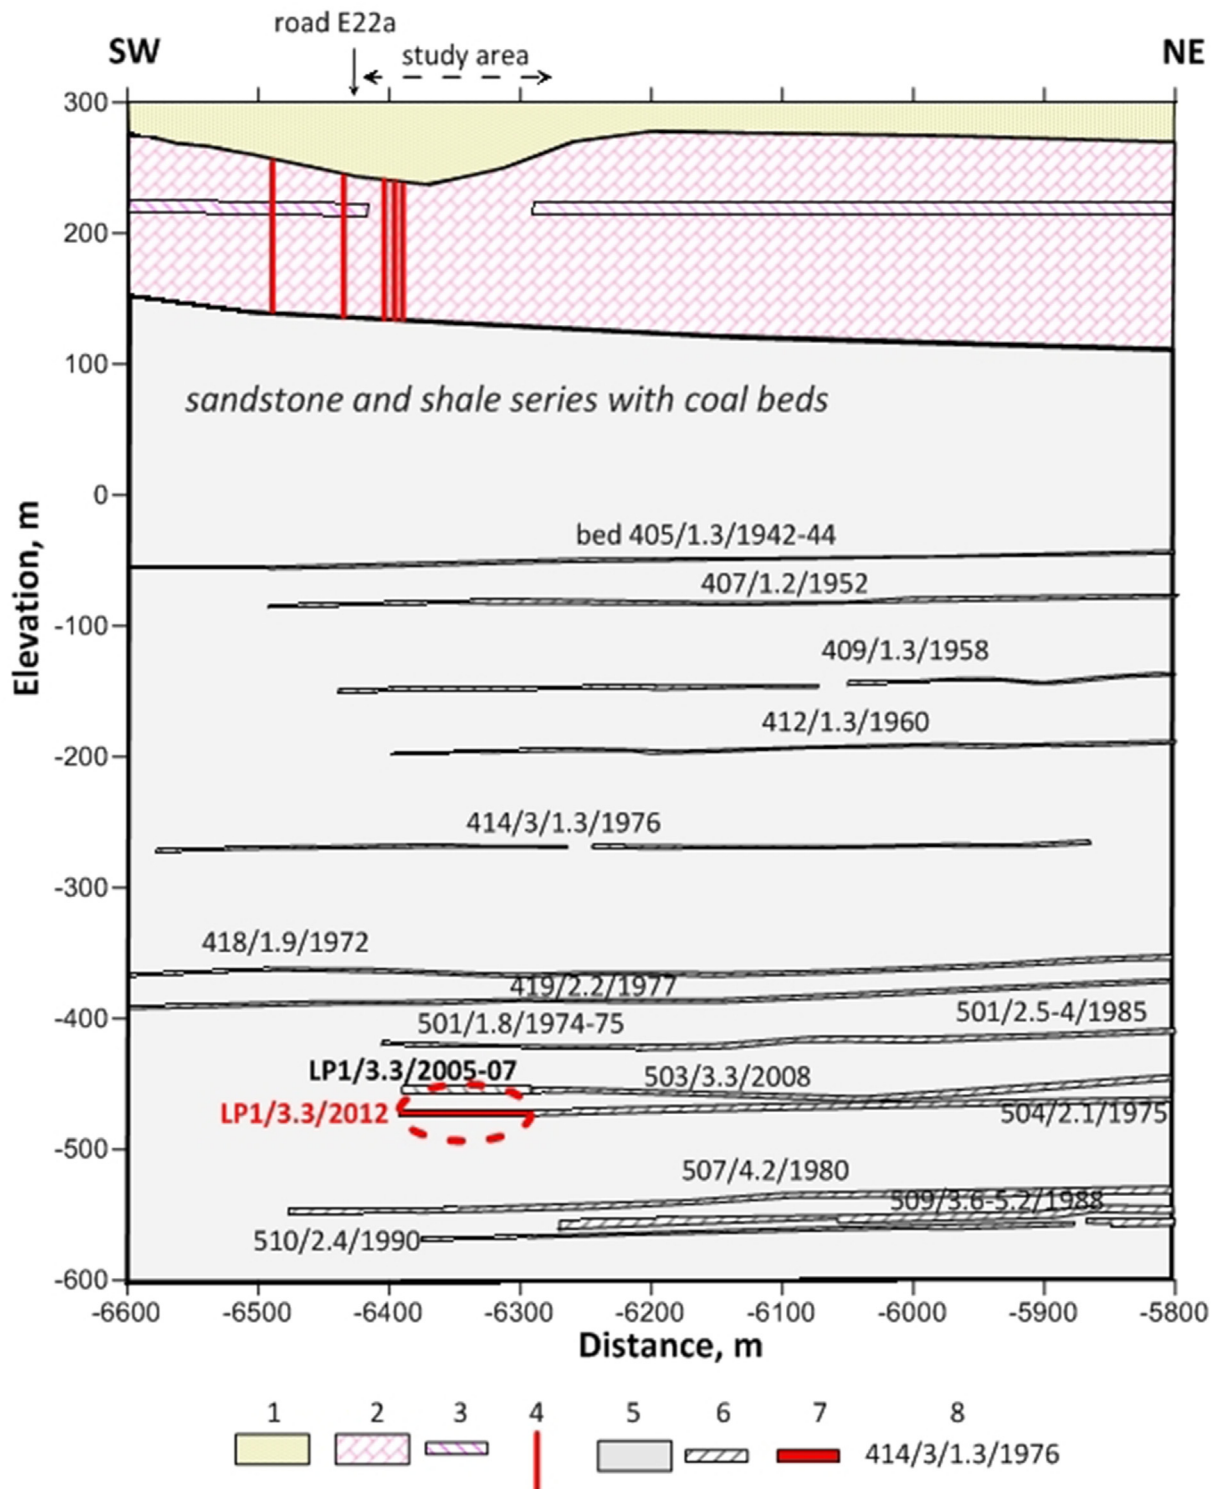
Fig. 5. Geological cross-section of the surveyed area with mining work-outs. 1 – quaternary, 2 – triassic, 3 – abandoned ore gobs, 4 – fissures in Triassic series, 5 – carboniferous series, 6 – abandoned coal gobs, 7 – longwall panel driven before the catastrophe, 8 – coal bed no/thickness of coal extracted in the year of extraction.

The geological structure of the region is illustrated in the German archival structural map from 1941 [28] (Fig. 4). A vertical image of rock mass structure to a depth of about 900 m and its transformation by the exploitation of hard coal and ores in the study area is shown in Fig. 5. The location of the area of geophysical surveys is indicated in both figures.

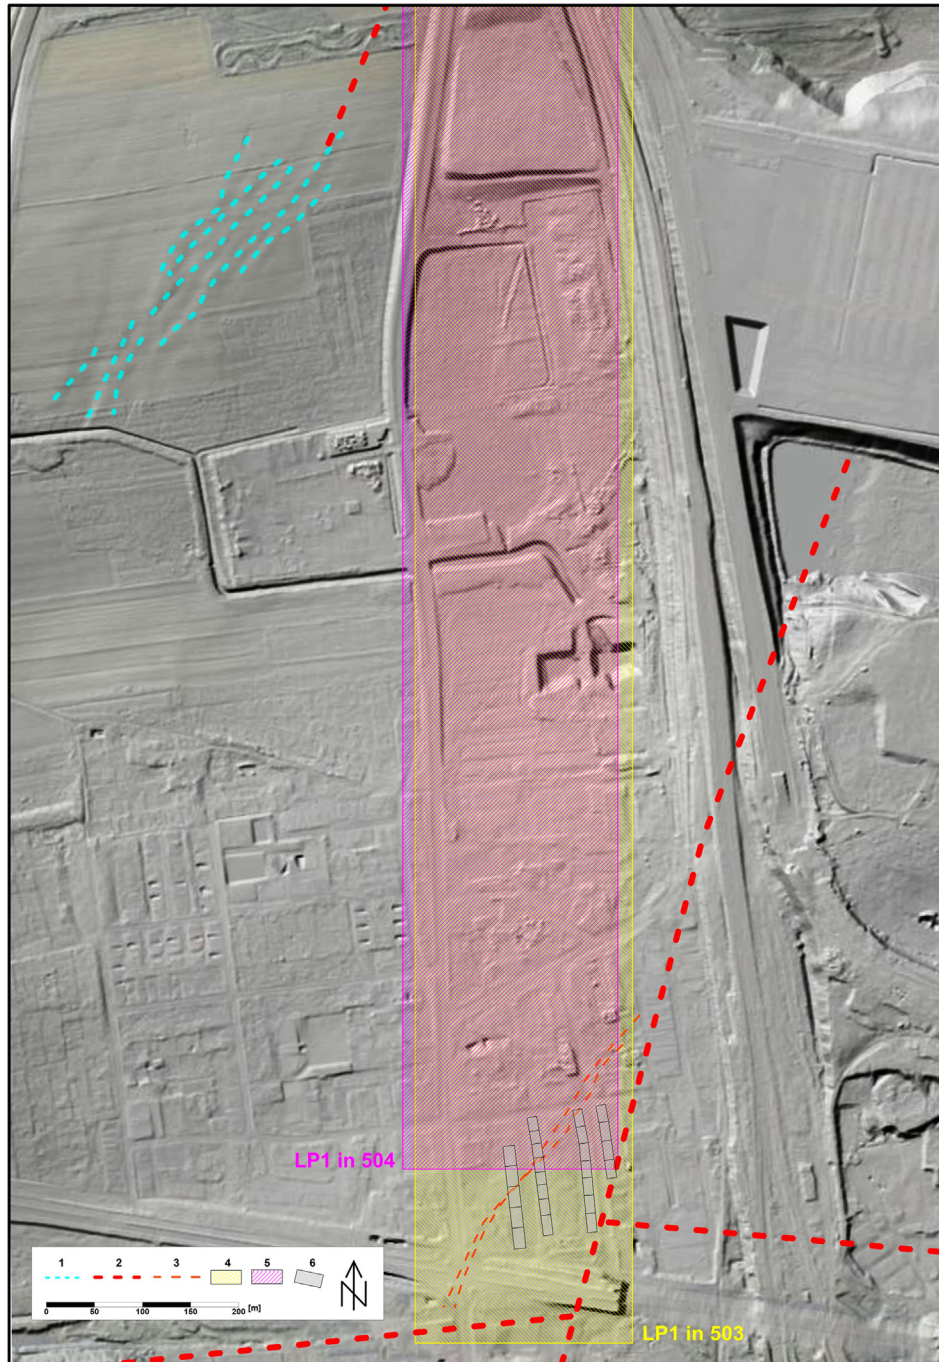
Fig. 6. Lineaments in the region of one of the Triassic fault visible in the hillshade image of the numerical relief model [28] after extraction of coal by the LP1 longwalls in 503 and 504 seams. 1 – lineaments, 2 – tectonic faults in Triassic, 3 – tectonic faults in 503 and 504 coal seams, 4 – panel LP1 in 503 seam, 5 – panel LP1 in 504 seam, 6 – damaged building segments.

the rock mass ceiling. They outcrop in the NW part of the studied area, adjacent to the projection of the edge of the long wall on the surface. These cracks are visible as lineaments in the hillshade image of the numerical relief model (www.geoportal.pl) in a zone about 50–100 m wide (Fig. 6). Presumably, there are discontinuities of tectonic genesis in the Triassic as well as structural disturbances of sedimentary or glaciectonic origin in the Quaternary deposits in this region, visible also in the upper center area of Fig. 4 (marked with cyan arrow).
