Stress measurements at load-bearing components of the shaft steelwork and the mine hoist frame in the Regis Shaft of the Wieliczka Salt Mine

Keywords: measurements, hoisting installation, mine elevator, stress, shaft steelwork, elevator car frame

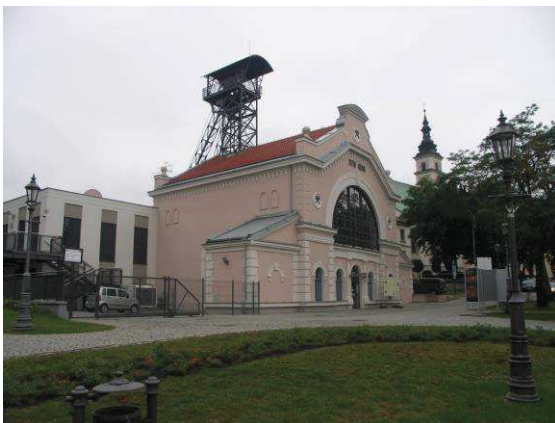
Fig. 1. The top of the Regis Shaft [3]

In order that the shaft top facility should remain as a heritage asset, the conservation officer decreed that the winding tower +24.26 m high, located on the level +21.05 m and housing rope pulleys, should be brick-lined and maintained as a piece of architecture (Fig. 1).

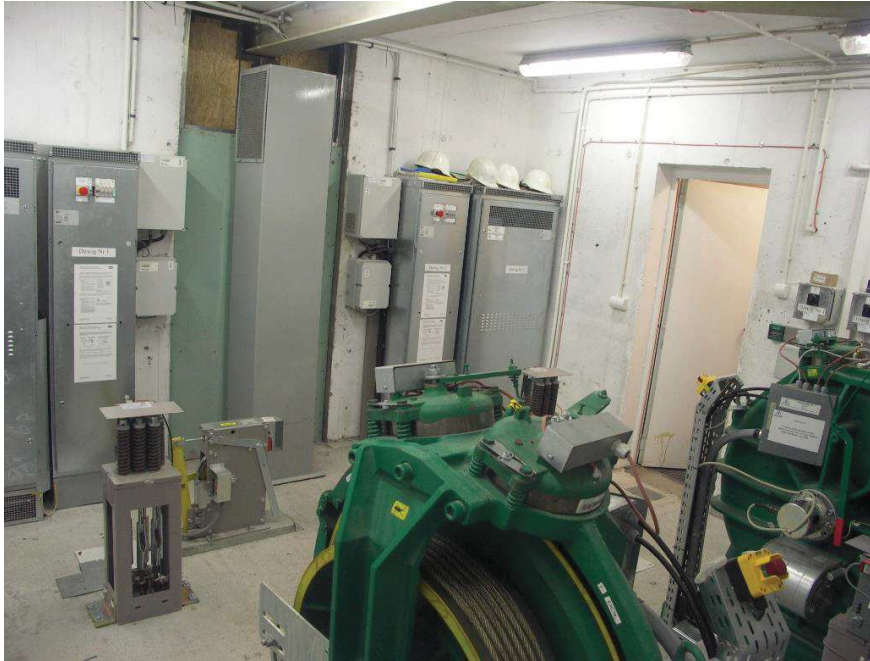
Fig. 3. Machine room with installed gearless winches MX18 with the friction pulleys 690 mm in diameter [3]

A general view of the machine room is shown in Fig. 3 and the hoist shaft with wall-mounted equipment is shown in Fig. 4. Fig. 5 gives a vertical cross-section of the top part of the hoist tower, a view of the machine room and the upper section of the shaft.

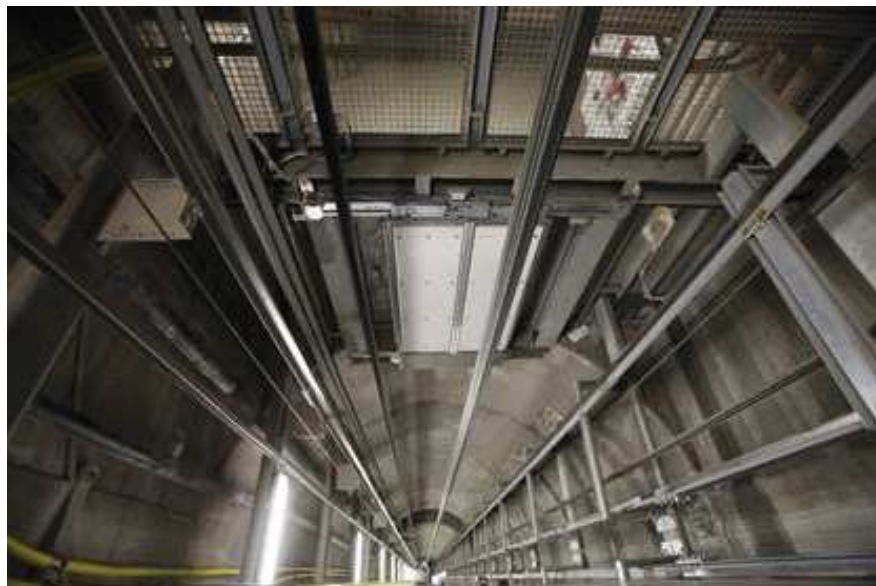
Fig. 4. The shaft with mounted guide bars – general view [1]

The diagram cross-section of the Regis shaft with wall-mounted equipment is shown in Fig. 6. The shaft with installed guide bars and other shaft fittings is shown in Fig. 4.

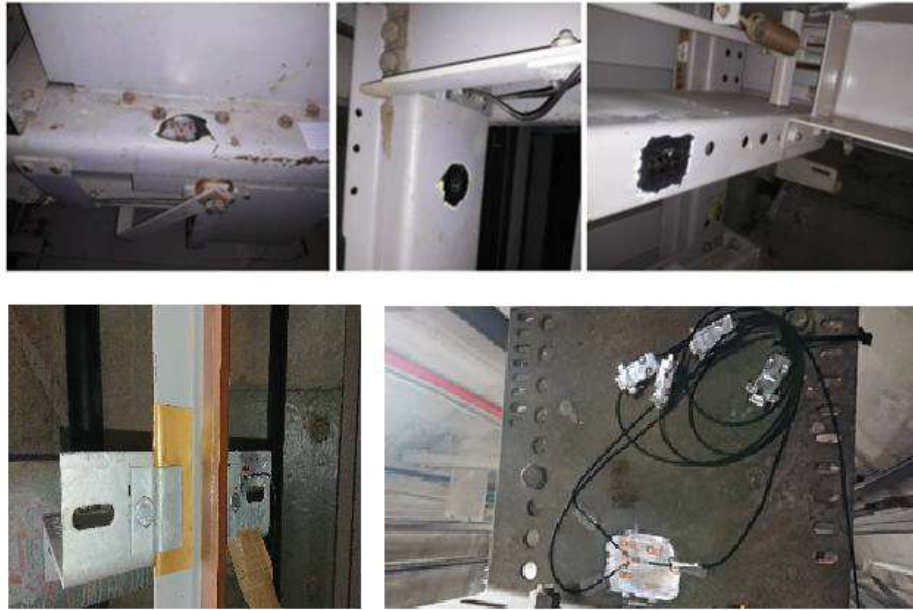
Fig. 11. Strain gauges attached to the selected points on the car frame and east-end supporting beam [3]

Before the strain gauges were attached to the elevator car frame and to the supporting beams, the corrosion–protection coating had to be removed from their surface by polishing with silicon carbide sandpaper, grit range from 100÷400, to achieve as smooth and even surface as possible, free from corrosion pits and mechanical losses. All strain gauges, being attached at selected points, their leads were soldered to the quarter-bridge adapter. A view of strain gauges fixed at selected points on the car frame and supporting beam is shown in Fig. 11.

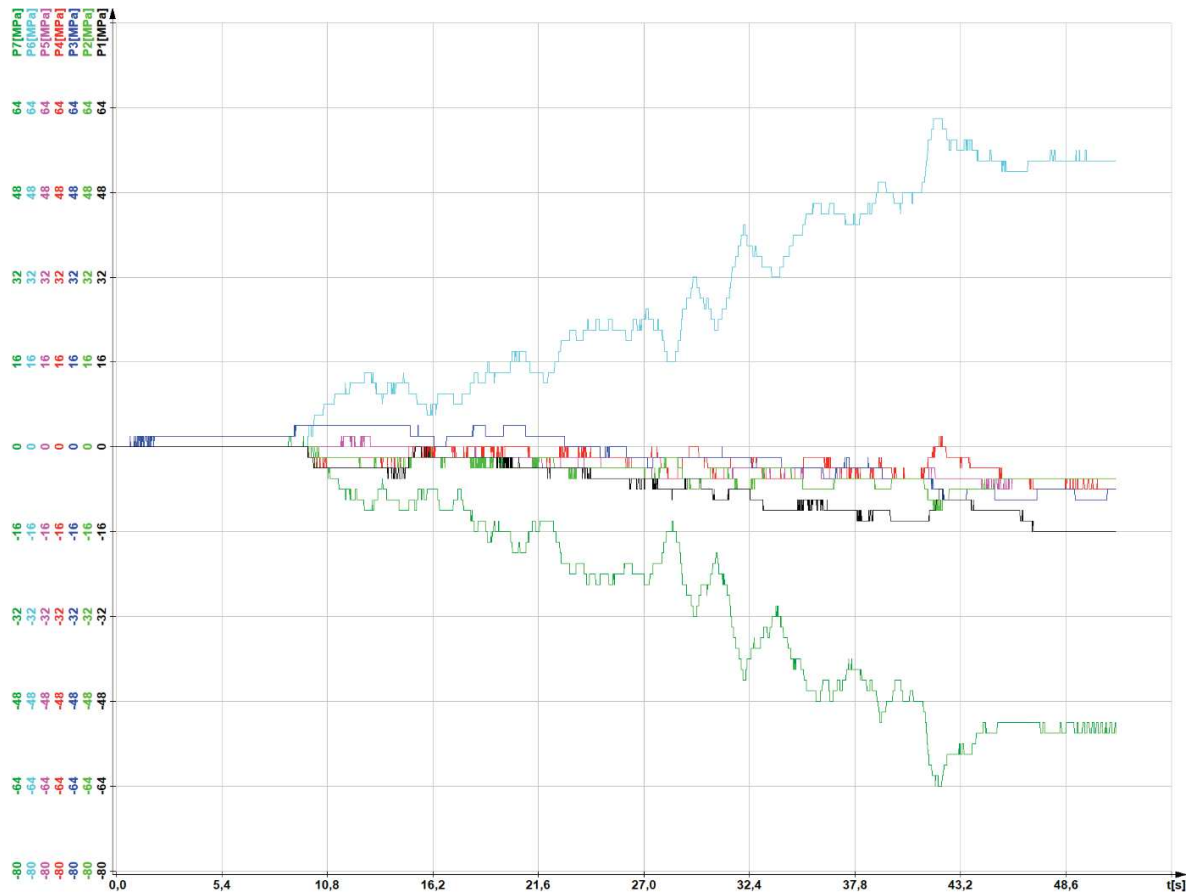
Fig. 12. Downward ride of the elevator car at 4 m/s, with no load [7]

The first series of car frame tests were conducted during the ride at nominal speed. The standard hoisting speed during the normal operation was 4 m/s, with no load carried $Q=0.0$ kg. Fig. 12 plots the stress increase registered by individual strain gauges during the ride from the bank level station 1 down to the level – 135 m.

During the first 9 seconds minor stress changes are registered by strain gauge 3, that is the time when the car doors and station doors are opened and closed. Afterwards, the elevator is started and the car begins to ride downward. Successively, with the metres travelled the stress tends to increase, which is registered by strain gauges P6 and P7. These stress increases result from the changes in loading due to the tail rope self-weight and the floor beam may experience slight bending and torsion. Forces and moments of forces that cause this effect are due to the changes of tail rope weight and tail rope motions. In the period from 43rd and 47th second, the car decelerates before reaching the bottom level station. Between the 47th and 49th second an opening of car doors occurs. The further part of the graph does not need to be considered because it reveals disturbances associated with the servicemen entering the car.
