## RESEARCH PAPERS

### FAILURE AND DEFORMATION OF FULL-SCALE LIGHT FRAME POPLAR AND SPRUCE WALLS UNDER VERTICAL COMPRESSION AND SHEAR LOAD

*Wood frame houses are usually made of softwood species in Europe and North-America. But many countries have a great population of different hardwood species, e.g. poplar. This study investigates the possibility of using poplar, instead of pine for wall frame construction of lightweight houses focusing on the mechanical properties of the panels. Vertical compression tests and cyclic lateral shear tests were done using full scale light frame panels. Results show that the poplar panels have unexpected strength; the compression failure force of poplar panels [316.02 kN] is no more than 6% lower than spruce panels [335.00 kN] and no significant displacement was found at the moment of breaking. Poplar panels show more flexibility and lower deformation values during the lateral shear cyclic and the moment of failure, although the failure force was slightly higher in the case of spruce panels.*

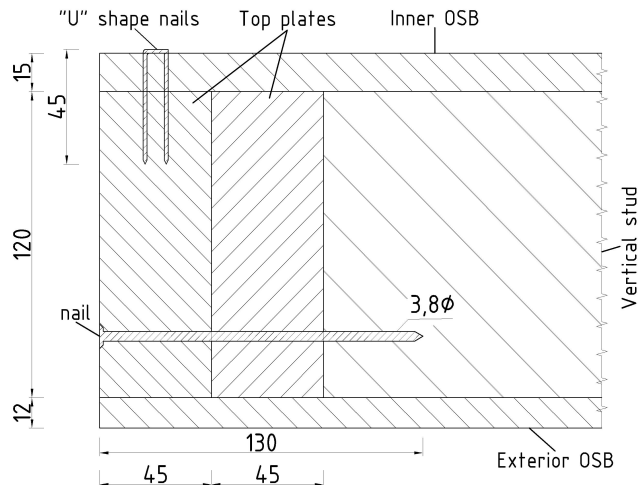
**Fig. 1B.** Schematic drawing of connections

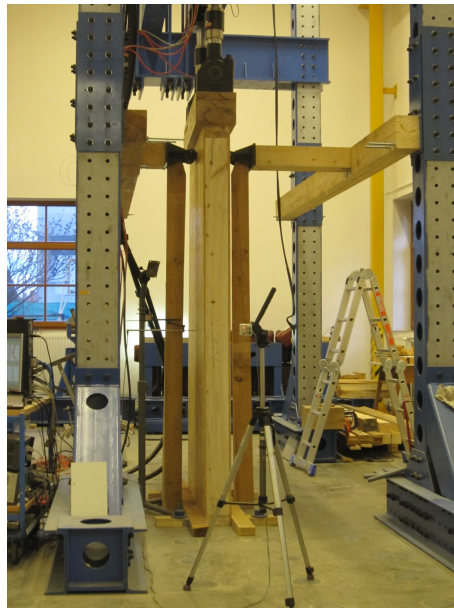
**Fig. 2. Compression test measuring position**

Actuator cylinders can register the applied force as well as the position data. These Hydraulic Power Units are a servo-hydraulic system, with an accuracy of 0.001 mm and 0.01 kN. In the compression test, two 250 kN maximum load capacity actuator cylinders were applied, positioned to the middle of the half width of the panel. The even distribution of the load was ensured through a thick glued laminated oak beam (fig. 2).

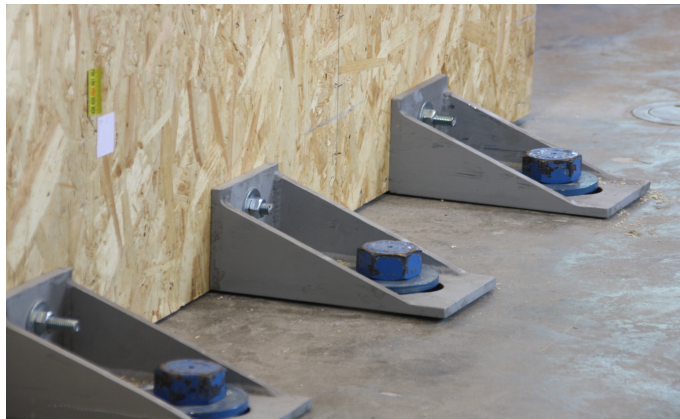
**Fig. 3. Fastening to the strong floor**

With the shear test panels, only the differences (compared to compression test panels) were determined; all other parameters and materials were the same. The panels had three modules of small panel with  $3 \times 1250$  mm. The overall width of the shear test panel was 3750 mm, the thickness and the height and assembling methods were unchanged. The bottom plate of the panels was firmly bolted to the ground (fig. 3) and one of the lower corners was attached to a down bolted support to the structure from sliding due to the compressing force.

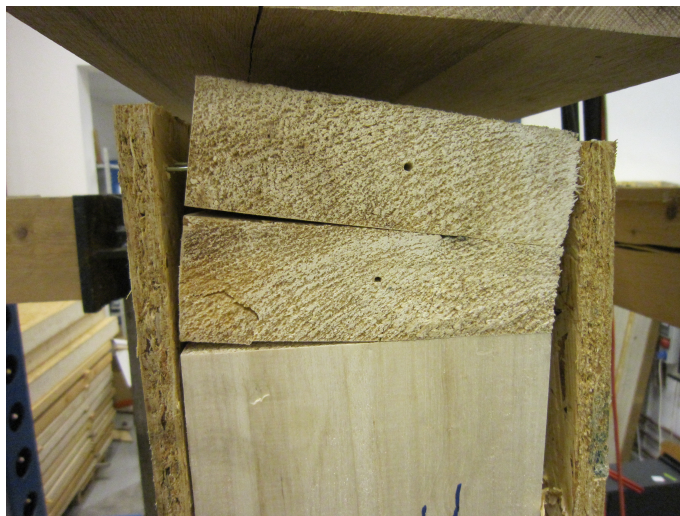
**Fig. 5. Deformation of the upper stud**

be related to a potential assembly error. For instance, the OSBs for P2 very slightly extended over the wood frame; this could have caused the OSB to initially bear the entire burden from compression and so, it broke down rapidly as the compression force was increased. Consequently, the wood frame got a sudden strike. In many cases, the failure starts from the joining point of the vertical and upper studs. In this place the upper studs lay on the butt surface of the vertical stud. This connection area is three times 7200 (120 mm by 60 mm) square mm which is quite a small surface regarding the load of over 300 kN. Because the compression strength of spruce and poplar is higher along the grain than perpendicular to the grain, the upper stud fibres break (fig. 5).

- The break started at the connecting surface of the vertical and upper studs where the upper stud fibres broke in many cases. The compression strength of wood is higher in the direction of the grain than perpendicular to the grain. The compression strength of poplar, perpendicular to the grain, is lower than spruce which can partially explain why the poplar panel had a lower compression strength.

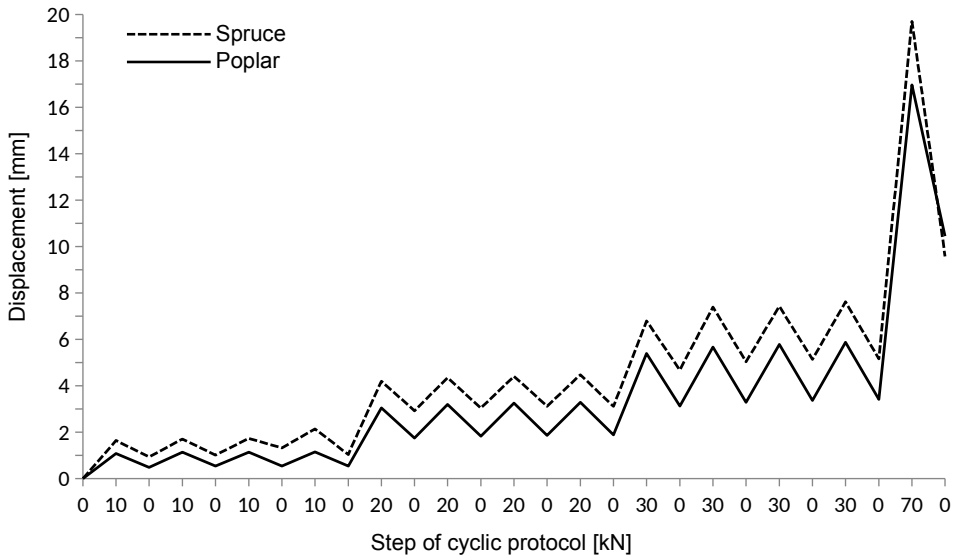
**Fig. 6. Average displacements of spruce and poplar panels**

In the shear test the panels were twisted or shifted without a spectacular break of the frames or OSB boards. The cyclical loads made the panel rather exhausted without a break. Each force in a given cycle was sustained for one minute and then the actuator force decreased to zero. The panels suffer some deformation from the load. Up to a certain point it is elastic and beyond that, deformation is permanent. Figure 6 shows the cumulative average deformation data of the panels. The different values between the peaks at the same load level mean the worn effect of the panels, i.e. the same force caused higher displacement. The graph proves that the spruce panels suffered higher deformations at all load levels and the failure deformation was also higher than poplar panels.

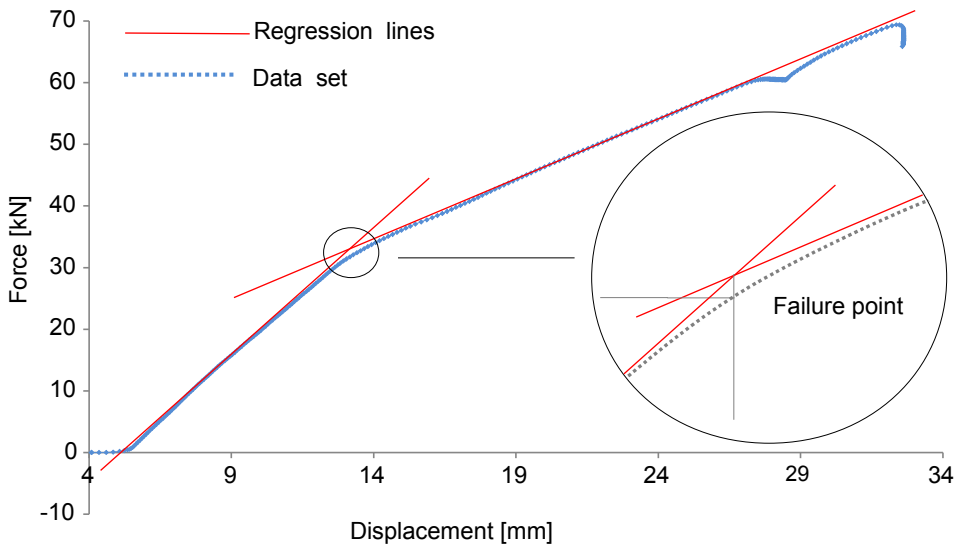
**Fig. 7. Determination of failure point**

To determine the failure force is not as simple as in the compression test. There is no spectacular effect or loud crackling sound. By checking the displacement and force graphs, there is a visible breaking point on the function (fig. 7). The failure level is determined where the angular coefficient becomes milder and after this point, the acting force can cause higher displacement. Practically speaking, this point is the yield point. The curve can be divided into two parts and both parts are linear; the fitting lines have an R square over 0.99. The intersection of these lines was determined as the failure displacement point and the failure force was determined by the function value at the displacement (fig. 7). For comparison, this method offers the simplest most objective way to determine the failure point, according to the primary goal of this study.

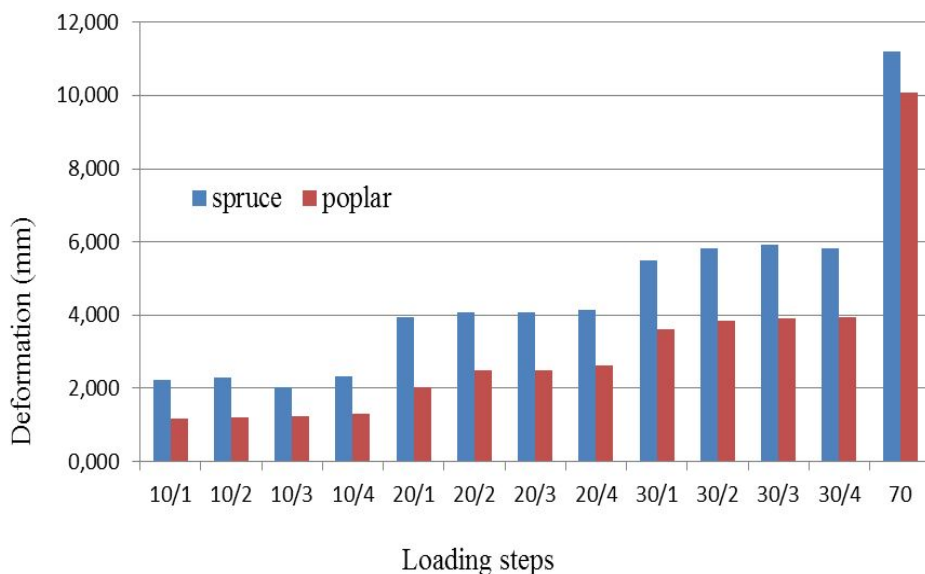
**Fig. 8. Permanent deformations after every load**

After the end of loading, when the actuator was released, the panel sprang back, but it could not reach its original zero point. This difference was measured

as a permanent deformation. Similarly, to the displacement, the permanent deformation of poplar panels was smaller after the 4<sup>th</sup> 30 kN load. The average is 5.160 mm for spruce and 3.410 mm for poplar. The poplar panels reach only 66% of spruce panel deformation, which is remarkable because the failure force is almost the same. Figure 8 shows the permanent deformation averages after every load step. The poplar panels had better stability during the shear test.
