Testing of Railway Pantograph

Abstract

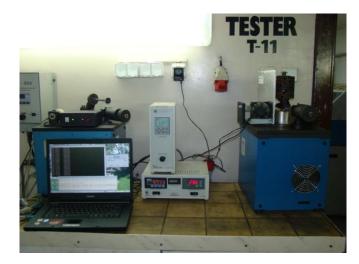
As part of laboratory tests the friction coefficient was measured for the various materials used for the fabrication of pantograph strips when interacting with the material used for the manufacturing of overhead wires. The testing was performed on a T-11 type tribology tester (pic. 1).

Fig. 1. The T-11 tribological test stand

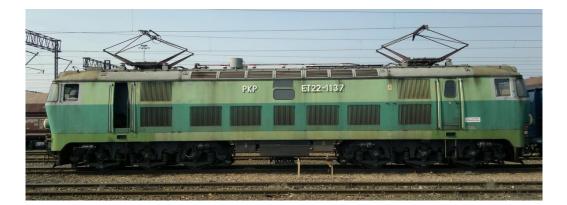
One of the additional tests conducted during the period of operation was the determining of the quality of interaction of the new type collector shoe with carbon strips and the overhead catenary. For that purpose a FAN type collector shoe equipped with pantograph strips made of MY131 [7] carbon material was mounted on the ET22-1137 locomotive (pic. 10). A purpose-built measuring device was devised and installed on the new type collector shoe with carbon pantograph stripes in order to analyse the connectivity of the collector shoe with the overhead catenary when the locomotive is in motion. When installed on the collector shoe, the device enables real-time measurement and recording of the forces occurring between the pantograph strips and the overhead wire of the overhead catenary system (pic. 11).

Fig. 10. The ET22 locomotive before testing with the collector shoe installed
