## Technical Notes

# The Study of the Influence of the Ceiling Structure on Acoustics in Contemporary Churches

Anna SYGULSKA

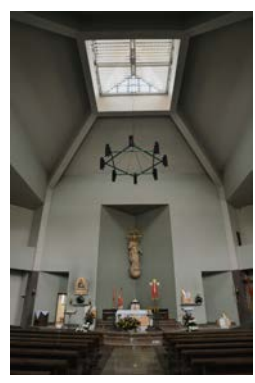
Church of the Sacred Heart of Jesus (HJ) volume 5410 m <sup>3</sup>

Table 1. A comparison of the churches.

**Church of the Sacred Heart of Jesus (HJ)** in Suchy Las near Poznań, with an internal volume equal to 5410 m<sup>3</sup>, was completed in 2000 (Fig. 1a). It is an

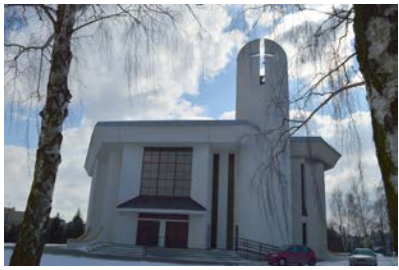
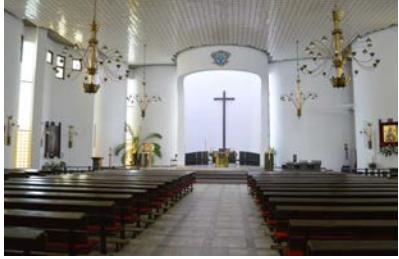
<p>Church of the Blessed Virgin Mary Mother of the Church (VM), volume 6700 m<sup>3</sup></p>

Table 2. A comparison of the investigated churches.

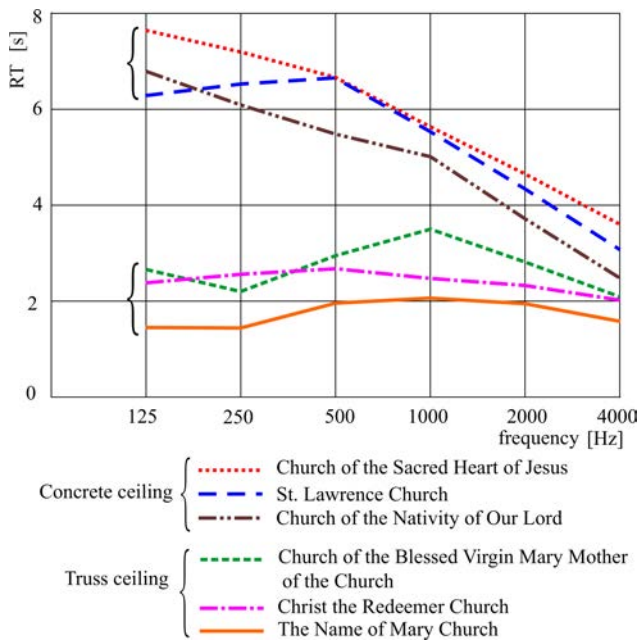
Fig. 3. Reverberation time in the frequency function – comparison of the investigated churches.

where organ music is performed. There is an evident difference between  $T_{30}$  values depending on the type of structure (Fig. 3). For all the churches with a truss type cover,  $T_{30}$  is within the recommended values. In most cases, however, they are very close to the top value. The most favourable values were registered in NM, where  $T_{30} = 1.8$  s, which is a moderate value as the recommended value ranges from 1.3 to 2.8 s. In VM, there is an evident rise of reverberation time for mid-range frequencies ( $T_{30}$  for 500–1000 is 3.2 s), which can be subjectively perceived as excessive reverberance of the interior. In contrast, all the churches with a reinforced concrete ceiling registered reverberation time values which considerably exceeded recommendations. The mean value of  $T_{30}$  in these buildings oscillated between 5.0 and 5.9, while the recommended value should not exceed 2.9 s for the biggest of them. Thus, strong reverberant noise will be a distinctive feature of these interiors. Frequency characteristics of reverberation time for the two groups of churches differ a lot (Fig. 3). In all the churches with a concrete ceiling, reverberation time considerably rises for low frequencies. In the investigated buildings, the mean value of  $T_{30}$  amounts to 6.8 s for frequencies 125–250 Hz. In contrast, in the churches with a truss type ceiling frequency characteristic is almost flat. Churches with reinforced concrete covers are characterized by a considerable drop in reverberation time in relation to the drop in the frequency. Over 1000 Hz, reverberation time rapidly decreases to reach results similar to those in buildings with truss type covers, which is mainly caused by air absorbing sound. The product 4 mV seen in the denominator of the Knudsen formula (1) shows that a big internal volume of an interior will cause greater sound absorption by air.

Values of the investigated parameters are shown in Tables 3–5 and on graphs in Figs 3–5. Table 3 presents results for parameters  $T_{30}$ , EDT, and  $t_S$ . It was assumed that mean values of reverberation time for all the measurement points for individual octave bands cannot vary by more than (JND) which is defined by the Polish standard PN-EN ISO 3382-1 and amounts to 5%. The measured reverberation time  $T_{30}$  confirms a high level of reverberance in Polish contemporary religious buildings. On the basis of (EVEREST, 2009), Table 3 shows recommended values for reverberation time. The bottom value refers to churches where speech prevails; the top value refers to churches

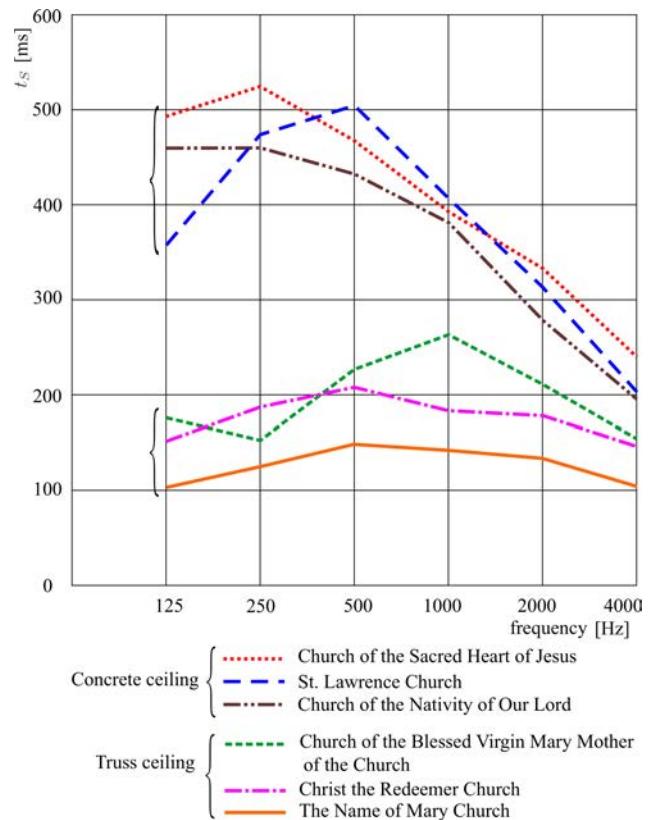
Fig. 5. Center Time  $t_S$  – comparison of the churches.

Values of parameter center time  $t_S$  in all the churches exceed recommended values. It should be highlighted that the parameter is particularly un-

favourable in buildings with a concrete ceiling. The mean value  $t_S$  in the buildings ranges from 367 ms to 408 ms (in HJ), while the extreme recommended value is 120 ms (WRÓBLEWSKA, KULOWSKI, 2007). The values considerably exceed the permissible value for organ music, which is 180 ms.

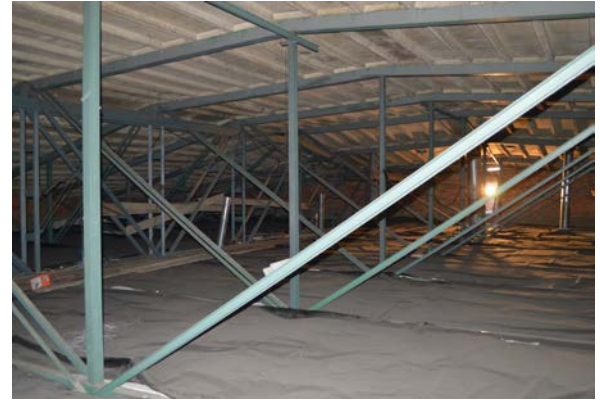
Fig. 10. Inside the ceiling of church VM.

loosely placed on a steel frame lined with polyethylene sheeting. Along with thin aluminum tiles, the polystyrene constitutes a transodent layer. Figure 10 shows a photo of the inside of the ceiling. The foreground features vertical and cross members; reinforced slabs are placed on the top member of the truss, with polyethylene sheeting placed on the bottom member of the truss.

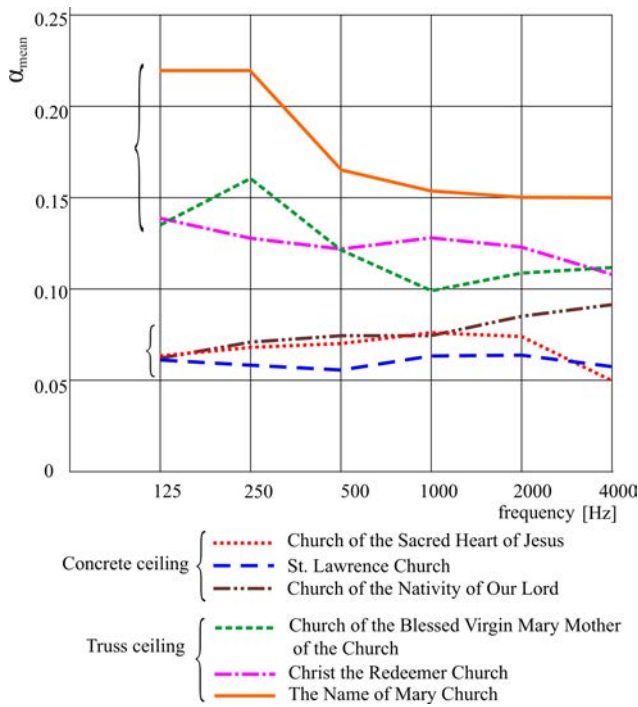
Fig. 11. Mean absorption coefficient  $\alpha_{\text{mean}}$  in the frequency function.

Figure 11 presents the mean absorption coefficient.

It can be seen that in the churches with truss type ceilings, the value of the mean absorption coefficient is about twice as big as in the churches with reinforced covers.

$$\alpha_{\text{mean}} = 1 - \exp\left(-\frac{0.161V}{TS} + \frac{4mV}{S}\right). \quad (3)$$
