The effectiveness of fault detection in common rail injectors examination methods

The article presents the effectiveness tests of fault detection in common rail injectors. 40 injectors with different wear levels were tested. Testing was made on two test benches of a completely different design. Research includes comparison of accuracy, reproducibility and testability to detect specific defects. A device was created for visualization of the fuel injector spraying steam.

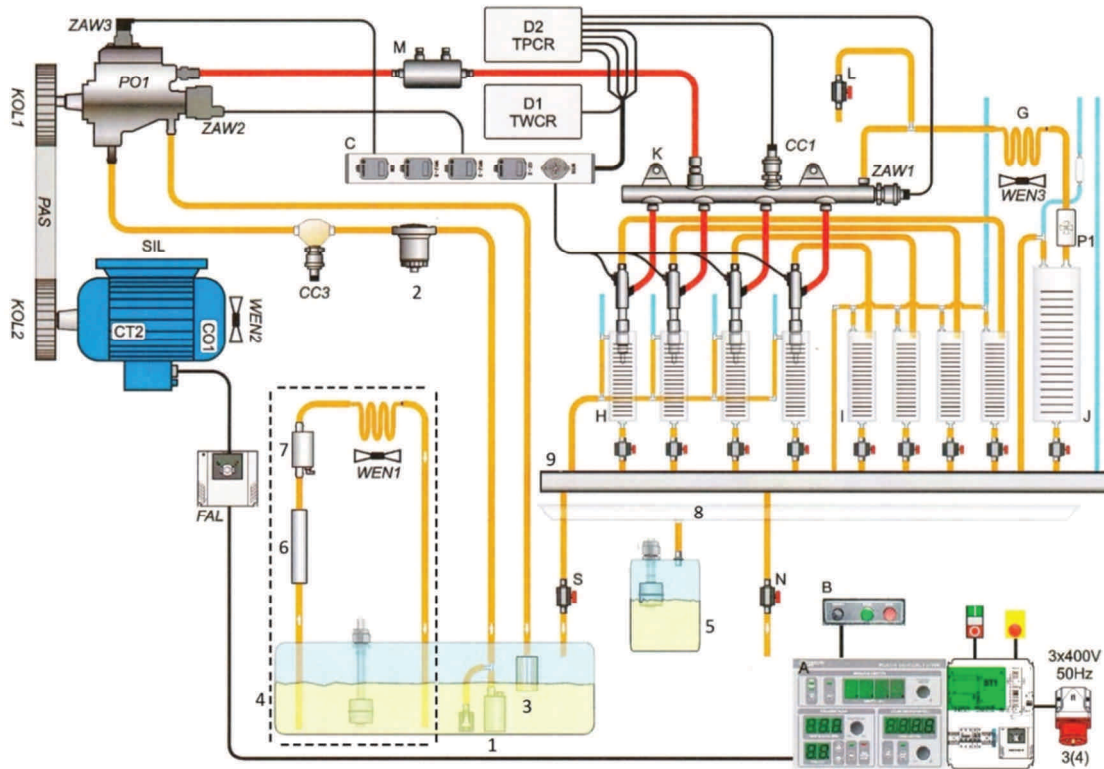
Fig. 3. Scheme of STPiW device

STPiW 3 is designed for testing pumps, injectors, pressure sensors and control valves which occur in common rail systems and systems with distributor pump. Construction of the test bench allows simultaneous testing of four injectors. Figure 3 shows the layout of the device. The fuel system has all the elements that can be found in a system of a car. The electric feed pump (1) supplies calibration fluid through the filter (2) to the high pressure pump (PO1). This is the 3-plunger radial-piston pump Bosch CP1H. It is driven through toothed belt by the induction motor (SIL). The motor is powered by the inverter (FAL) that provides smooth and precise speed control. The pump is controlled by the cut-off valve (ZAW2) and the pressure regulator valve (ZAW3). The rail (K) is equipped with the pressure sensor (CC1) and the pressure control valve (ZAW1). Pressure value in a high pressure system is controlled by the electronic module (D2) which controls all valves on the basis of a sensor reading. Tested injectors connected by flexible cables are placed in

the injected fuel quantity measuring cylinders (H). On the right side, there are cylinders that measure the return quantity (I). All return pipes are connected to the return collector (9) from which the liquid flows into the main tank (4). Injectors control the pulse generator (D1), which is set by the software on the computer connected to the device. In order to maintain accuracy of the tests and comparability of the results, it is necessary to keep the fluid temperature constant. This is done by the system, marked by dotted line, consisting of the heater (6), the electric pump (7) and the cooler with the fan (WEN1).

Quantity measurement begins with the measurement of hydrostatic pressure of the liquid in the measuring cylinders (H). Subsequently, the motor driving the pump is started. When the pump speed is stabilized, the pressure is adjusted to the setpoint. In the next stage, the injectors start injecting the calibration fluid into the measuring cylinders. The standard measuring cycle is set to 1000 injections. At the end of the series of injections, the hydrostatic pressure is measured again. Based on the pressure difference, before and after a test, the software calculates the amount of liquid that has increased during the test. Afterwards the volume is divided by the amount of injections which determines the injected fuel quantity.

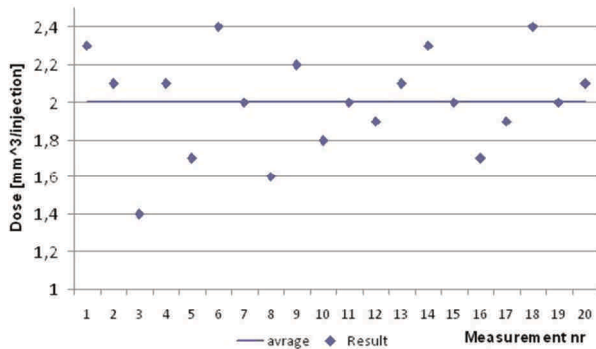
Fig. 4. Outlines of VE test before test modification

The results of 20 measurements that were performed under the conditions shown above, are presented in the Fig. 4.

Standard deviation was relatively high and amounted: $\sigma = 0.266$.

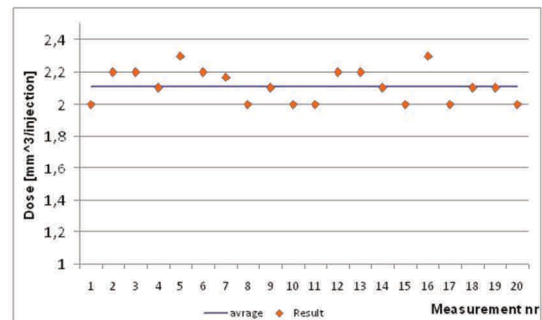
Fig. 5. Outlines of VE test after test modification

measurement. Precision of the test would be better if the number of impulses in time of one test was increased. Such modification would lead to increase of a measured volume. During consecutive examinations the number of impulses was increased to 4000. The distribution of results after the test modification is presented in the Fig. 5.

In that way the standard deviation decreased more than twice to the value $\sigma = 0.103$.

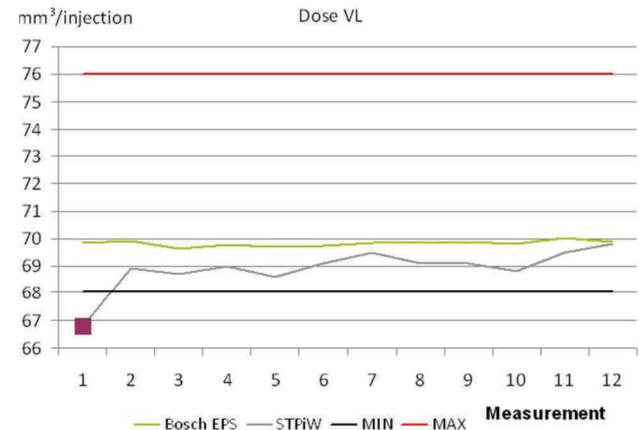
Fig. 6. VL test (actuation time 1300 μs, pressure 130 MPa)

In order to compare the accuracy and reproducibility of the measurements, a series of 12 measurements was carried out on both devices. The solenoid injector with a catalogue number 0 445 110 021 was used to carry out the tests. The following graphs (Figs 6–9) presents the results of the tests. Green lines indicate results obtained on the Bosch EPS and grey lines stand for the STPiW device. The minimum

permissible quantity is marked with a black line, while the red is the maximum. If injector test results are within the range between these lines, the injector retain its correct work parameters.

The first VL result is vitiated by a gross error, which is marked with a red point (Fig. 6). It will not be considered in calculations.

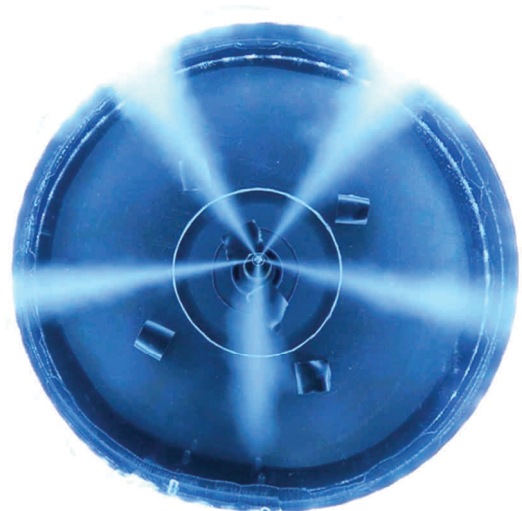
Fig. 20. Fuel spray pattern of a damaged injector

In addition, the spray pattern of the injector number 1 was documented (Fig. 20). The streams formed by the two upper holes are characterized by a larger cone angle than the others. Considering the amount of reflected light from these streams it can be inferred that they contained a higher injected fuel quantity. The spraying from the lower hole is

severely opened from the beginning, while the sprayed droplets have not yet reached the wall of the visualization chamber. This means that spreading speed of the droplets flowing from the lower hole is smaller than those from the remaining holes. The reason for such phenomenon is because the flow through this channel is disturbed by the unevenness of its geometry, which may be due to internal sediments.
