ANALYSIS OF CAUSES OF PELLET MILL MATRIX WEAR BASED ON A SELECTED EXAMPLE

This paper presents selected results of an analysis of damage causes to pellet mill matrix. The tested pellet mill matrix was used for the traditional technological process of pellet production. The tests were carried out since matrix failure times were found out to be too short. In order to assess the causes of matrix damage, tests of chemical composition and hardness of the matrix material were performed as well as observation of microscopic points of wear, analysis in the area of parameters of the process of operation and general conditions of use of the pellet mill. Discrepancies between the chemical composition of the material of the pellet mill and the information contained in the DTR were observed. Attention was paid to a possible influence of heat treatment and operating parameters on its premature damage.

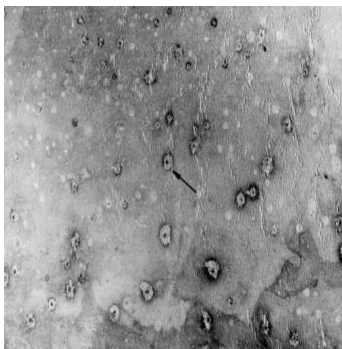
Fig. 7. Pitting corrosion [11]
Rys. 7. Korozja wżerowa [11]

Fig. 6a illustrates small dark spots with dimensions of several to several hundred micrometers. They may be a result of both fine-dispersive liberations and intercrystalline and pitting corrosion. Fig. 7 presents an example view of a metallographic specimen with focal points of pitting corrosion – the photograph was taken from literature [11]. Areas of pitting corrosion appearing on this specimen are very similar to the dark spots observed in fig. 6a.

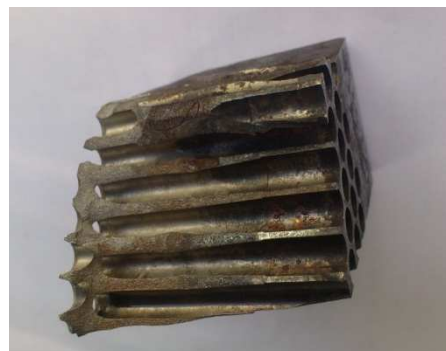
It can be added that the performed macroscopic observations allowed to identify a corroded structure on working surfaces and in breakage points of the matrix (fig. 9).

Fig. 9. Corrosion on working surfaces of the matrix
Rys. 9. Korozja na powierzchniach roboczych matrycy

4. The most probable cause of matrix cracking is an inappropriate process of its heat treatment or inappropriate parameters of this process. Negligence in this area may result in, among others, hardening cracks, or pitting and intercrystalline corrosion, which lead to a complete damage to the material. The aforementioned high sulphur content should also be remembered as it creates compounds that lead to heat cracking.
