## Baltic Sea coastal erosion; a case study from the Jastrzębia Góra region

Grzegorz Uścińowicz\*, Regina Kramarska, Dorota Kaulbarsz, Leszek Jurys,  
Jerzy Frydel, Piotr Przewdziecki, Wojciech Jegliński

Polish Geological Institute-National Research Institute, Marine Geology Branch; Kościarska 5, 80-328 Gdańsk, Poland;  
e-mail: grzegorz.uscinowicz@pgi.gov.pl

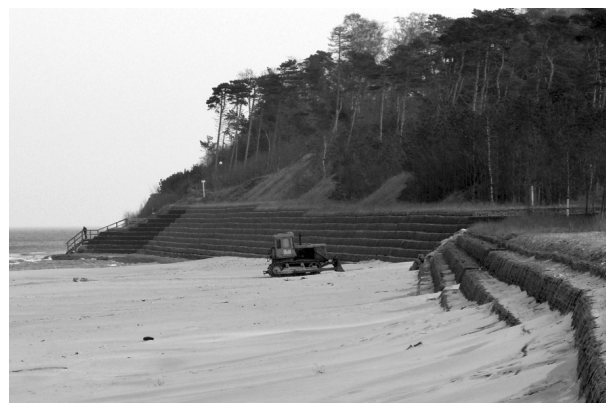
Fig. 4. Coastal protection works – seawall construction and beach nourishment

Recently, the western beach and barrier coast has been protected by seawalls (Fig. 4) over almost their entire length. This protection will put a halt to dune destruction, but not to the erosion of beach and sea floor in the nearshore, shallow areas. Beach erosion could be stopped by artificial beach nourishment and reconstruction and enlargement of the offshore sand bar system. However, it is not expected to stop the process of erosion completely, unless beach nourishment will be repeated periodically.

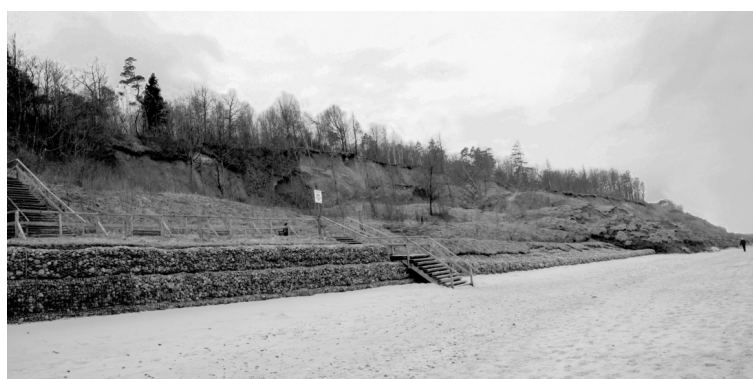
Fig. 7. A view of the landslide in 2011

Landslide (Fig. 7) location in the marginal parts of the plateau (glaciotectonic deformation zone) is one of the reasons for its significant activity. Another reason is undoubtedly the geological structure.

Unfortunately, this is difficult to assess. While the upper part of the landslide (i.e., main scarp) consists of massive tills and sands of different grain size, whereas the lower part of the section is impossible to trace because of its colluvium. It is likely that the lower part of the section comprises rock of a marked changeability (Kamiński et al., 2012; Subotowicz, 1991, 2000). Additionally, the situation is complicated by the irregular flow of groundwater, which contributes to the activation of mass movements. Inflow of groundwater beneath the sea floor affects the stability of the slope (cliff), when the outflow is just a short distance from the shore and takes place within non-cohesive rocks undergoing relaxation (which in turn affects the stability). Such a situation, due to the presence of cohesive Quaternary tills and Neogene clays, is of negligible importance in this case. Much more important is the groundwater flow which occurs locally in discontinuous layers, where the inflow takes place to the wall of the cliff. Monitoring of such waters is very difficult, but their presence is indicated by outflows in the cliff face. This leads to plastic deformation of the colluvium which, in combination with marine erosion, destabilises slopes. In summary, the cliff is being broken down by landslides and seasonal storm surges with wave undercutting responsible for erosion of the colluvium that protects the foot of the slope.
