# TASKS AND PROBLEMS IN THE BUILDINGS DEMOLITION WORKS: A CASE STUDY

*Keywords:* demolition works, the risk, construction project, legal regulations

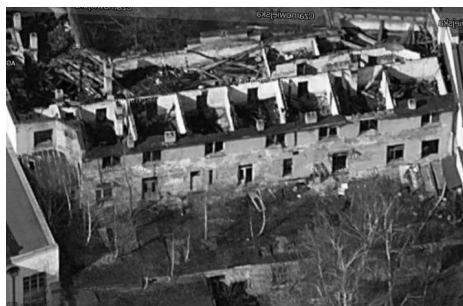
Fig. 3. The top view of the complex of the dry cleaning service "Rainbow" before the demolition, after the fire, around 2012, Source: googlemaps, 06.03.2014]

In the winter of 2011 a fire broke out in the tenement, it was caused by homeless people living there. The fire damaged the building heavily, the roof collapsed, and destroyed the second floor of the building (Fig. 3). During this time the demolition works of individual elements of the laundry-service

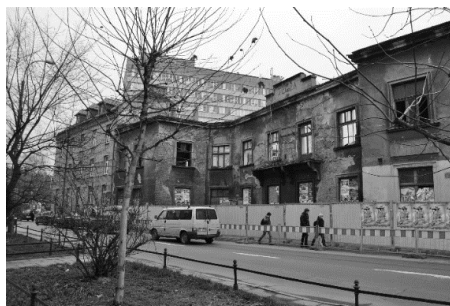
Fig. 4. The view from the Czarnowiejska street on the right wing of the laundry service building "Rainbow", Source: own photo, 06.03.2014

complex had been already conducted by the Investor (AGH University). In June 2013, only the front building remained, visible directly from the Czarnowiejska Street (Fig. 4).

The external walls of the laundry service with a thickness of 45 cm were made of solid brick, combined with lime mortar, anvil-laid thread. Internal walls consisted mostly of wooden boards covered by clay on reed, which was directly applied to the plaster. The floors were made of wooden beam construction or reinforced concrete. Land property was armed in the following networks: water supply, sanitary sewer, storm water and energy network, as well as a central heating network.

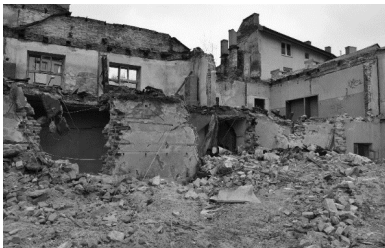
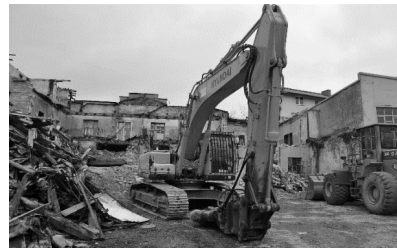
Fig.5. The laundry building "Rainbow" demolition, Source: own photo, 03.2014

Stages of demolition of building	Data
Taking over the site by the demolition company	15.01.2014
Submission of appropriate proposals for demolition works (e.g. permit to exclude sidewalk for the duration of the works, permit to transport heavy equipment, permit to disconnect the media, etc.).	30.01.2014 – 18.02.2014
The construction site area development plan, among others: isolation of the construction site, permanent disconnection of the outdoor-installation powering the facility, marking roads of their run near the active power and water installations, designation of a security zone, preparation of directions and stations for the work of heavy equipment, the designation of a temporary storage place for debris, scrap metal and other materials from the demolition, isolation of the danger zone from the Czarnowiejska Street.	28.02.2014 – 04.03.2014
Demolition works, including: demolition of the outbuildings from the yard, mechanical demolition of the upper floor to the ground level, the demolition of brick walls on the ground floor and the first floor, the demolition of the foundation walls, insulation of heavy foundations and basement foundation walls of the building B7, curing the area, construction leveling layers on the walls of buildings adjacent to the object [Fig.5]	04.03.2014 – 15.04.2014

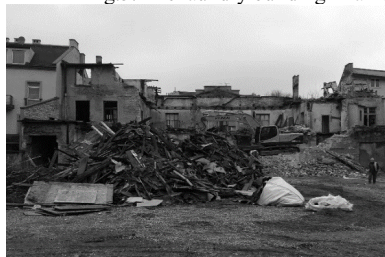
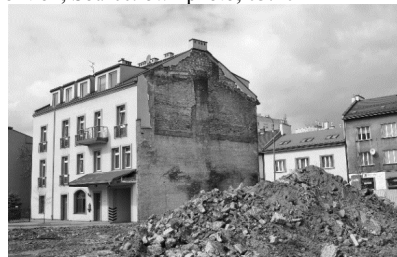
Fig. 6. The segregation of materials from the demolition of the building, Source: own photo, 03 - 04.2014

Segregation of the demolition materials, among others: preliminary debris crushing with steel reinforcement separation, segregation of the demolition materials with cutting into sections to transport, export of the waste materials [Fig. 6]	10.03.2014 – 01.04.2014
Ordinal and finishing works, among others: trimming and leveling the site, hardening the area, (the) execution of the facade on the buildings adjacent to the tenement under the demolition	01.04.2014 – 15.04.2015

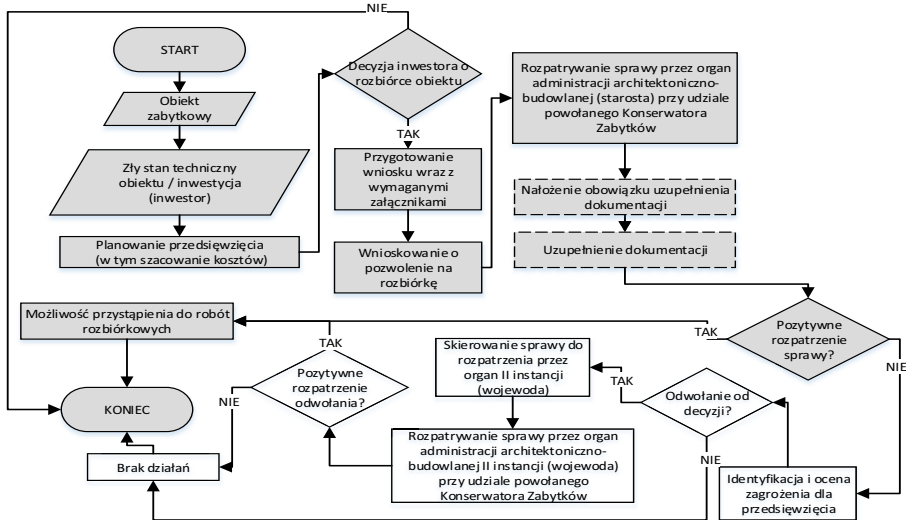
Rys.1. Schemat postępowania poprzedzającego rozpoczęcie robót rozbiórkowych obiektu zabytkowego (linią przerywaną zaznaczono sytuacje, które mogą wystąpić). Źródło: opracowanie własne

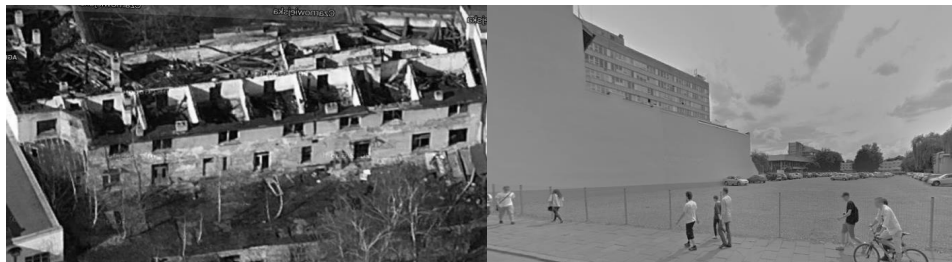
Rys.2. Widok z góry na kompleks pralni chemicznej „Tęcza” przed wyburzeniem, po pożarze, około 2012 [źródło: googlemaps, 06.03.2014] ; Obecnie funkcjonujący parking w miejscu po pralni
