**Research paper****Characteristics of 13th-century mortars  
from the tower at Lublin Castle****Beata Klimek<sup>1</sup>**

The objective of this paper was to characterize the microstructure and mineral composition tests of mortars collected from the walls of thirteenth century from the tower at Lublin Castle.

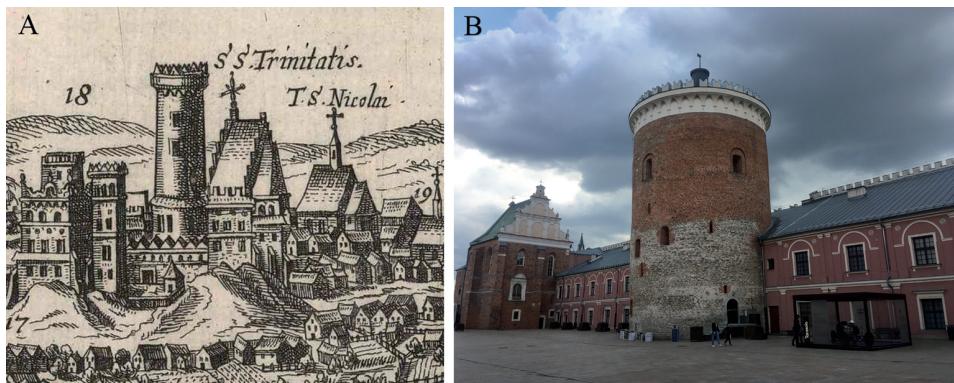
Fig. 1. A) Castle tower in the view of Lublin in *Civitates Orbis Terrarum*, by A. Hogenberg, G. Braun, Cologne 1618, B) Cylindrical tower blended into the south wing of the castle, now the Lublin Museum

The tower on the Castle Hill in Lublin is the only known monument of the late Romanesque period in the historic Lublin province. The tower was erected around the middle of the 13th century in the form of a cylindrical, homogeneous building showing the features of the Late Romanesque style [1, 2], in a typical manner for 13th-century fortresses, i.e. inside the defensive ring, as the main center of the fortification (Fig. 1A).

There are three types of windows: narrow, rectangular windows with a glyph opening inward, rectangular windows with embrasures, and half-circle windows with a narrowing inside the wall. On the top floor, there is a biforium with a preserved square stone column with chamfered corners, passing to a trapezoidal capitol supporting a pair of brick arcades. The entrance to the tower leads through a doorway in the ground floor, from where a spiral staircase inside wall can be used to access the basement or the upper floors of the tower (Fig. 1B).

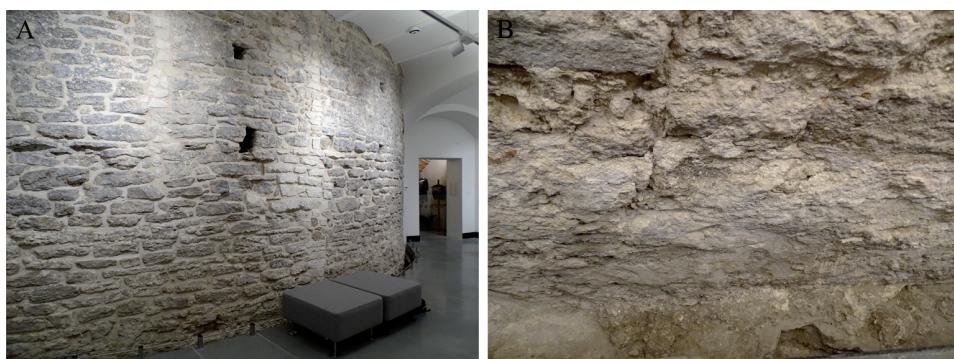
Fig. 2. A) Stone part of the cylindrical tower in the first floor of the south wing of the Lublin Museum building, B) Stone arrangement in the face of the cylindrical tower visible from the first floor of the south wing of the Lublin Museum building

As part of the ongoing research, six representative samples were taken from various locations of the wall, dated to the 13th century by architectural researchers and art historians (Fig. 2).

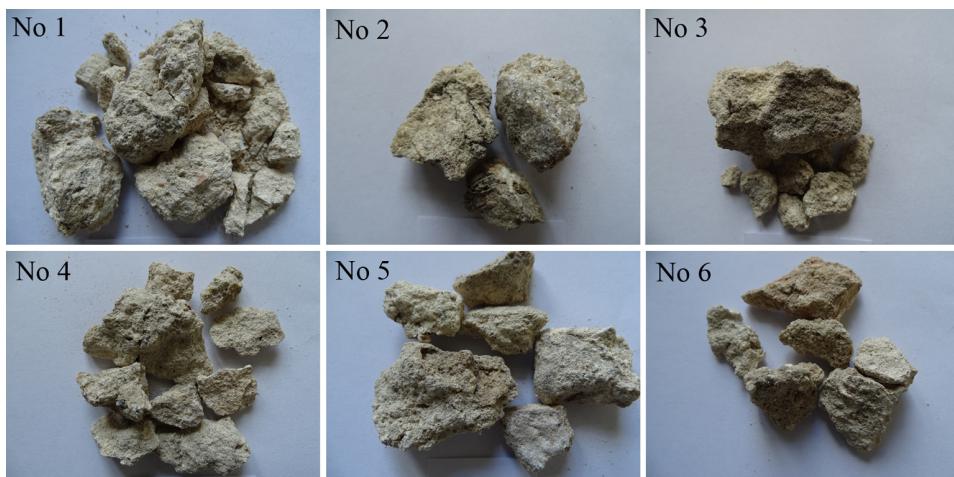
Fig. 3. Mortar samples of the tower inside the first floor of the south wing of the Lublin Museum building

The sampling procedures are carried out with great care under the supervision of conservation personnel, so that the samples taken will satisfy the needs of the planned analytical studies (Fig. 3).

Macroscopic observation of the samples (Fig. 3) showed homogeneous texture and composition. To obtain a complete set of information, the samples were examined using various instrumental methods and techniques. The first step was chemical analysis involving attack with diluted hot hydrochloric acid to determine the amount of residues insoluble in hydrochloric acid [11, 12].

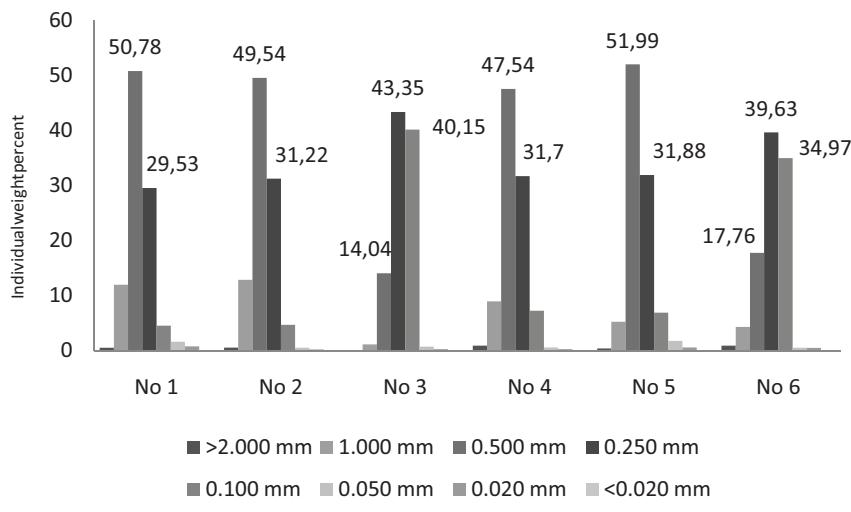
Fig. 4. Grain size distribution of analyzed samples

The mortar samples subjected to grain size analysis show that filler mainly comprises sand fraction (grain size 2–0.05 mm). The grains with a grain size of 0.50–0.25 mm dominate in samples No. 1, No. 2, No. 4, No. 5 and account for about 80% of the weight of the samples. On the other hand, aggregate sizes of 0.25–0.10 mm predominate in samples

No. 3 and No. 6, accounting for 75–83% of their weight. The samples contain no dust fraction (grains less than 0.05 mm) or negligible amounts thereof (Table 1) and (Fig. 4).

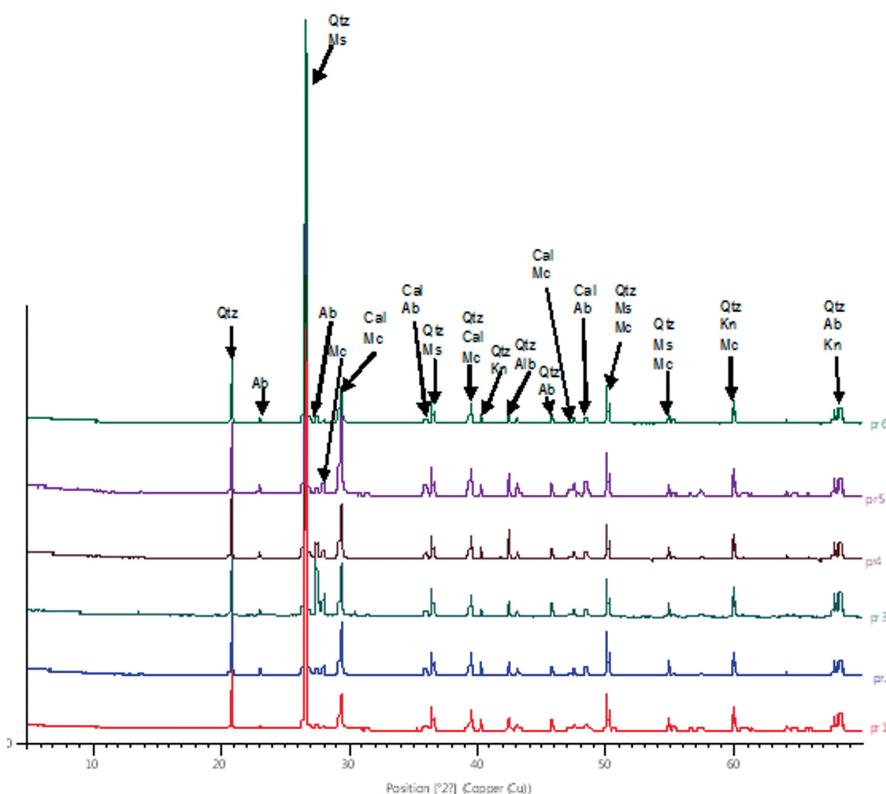
Fig. 5. Representative XRD patterns. Cal: calcite; Qtz: quartz; Mc: microcline; Ab: albite; Kn: kaolinite; Ms: muscovite

The X-ray diffraction technique was used to determine the mineralogical composition of the binder and filler, i.e. mineralogical components or crystalline phases. The X-ray diffraction patterns of the analyzed samples reveal that the mortars are mineralogically homogeneous (Fig. 5). Quartz is the ubiquitous, dominant phase, present in all samples and constitutes the filler grains. Calcite is another important component of the mortars and is a component of the binder. Subordinate components of mortars are minerals of the feldspar and silicate groups. These are mainly represented by microcline, as well as the less common albite, muscovite and clinochlorite. These components, like quartz, constitute the filler grains (Table 2).

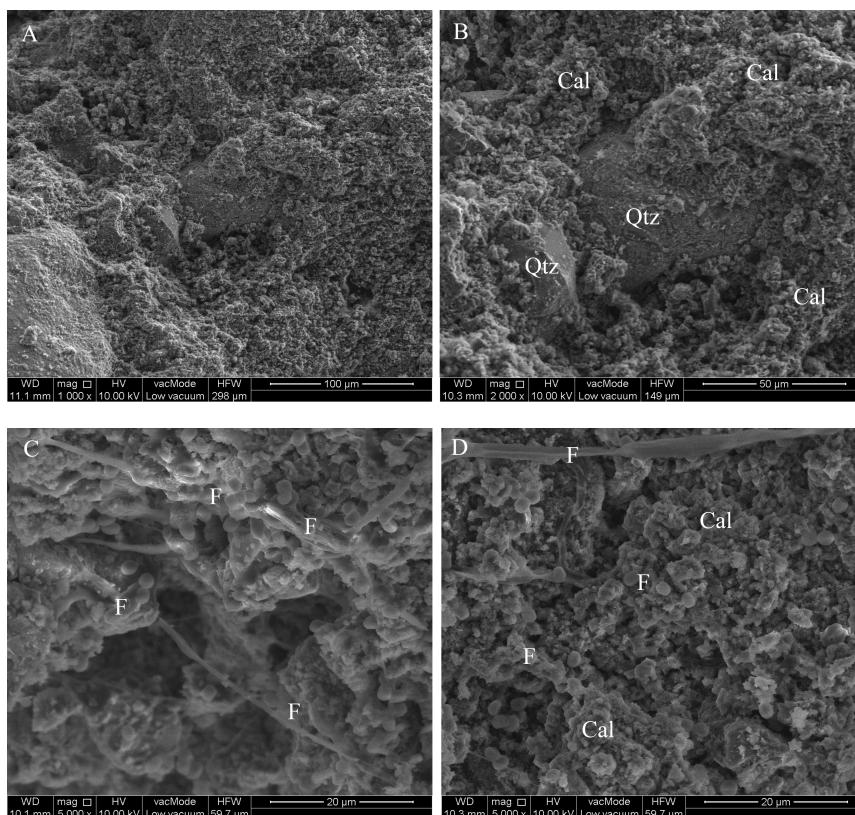
Fig. 6. SEM images of mortar samples. A), B) binder composed of micritic calcite (Cal), with quartz grains (Qtz) in the center. C), D) mortar binder heavily penetrated by fungal colonies (F). Magnification: ×1000, over ×2000, over ×5000

SEM photomicrographs were recorded at magnifications of 1000, 2000, 5000 and are shown below (Fig. 6A–6D).

The tested mortars consist of a binder, which is in the form of microcrystalline calcite (micrite), heavily penetrated by fungal colonies.

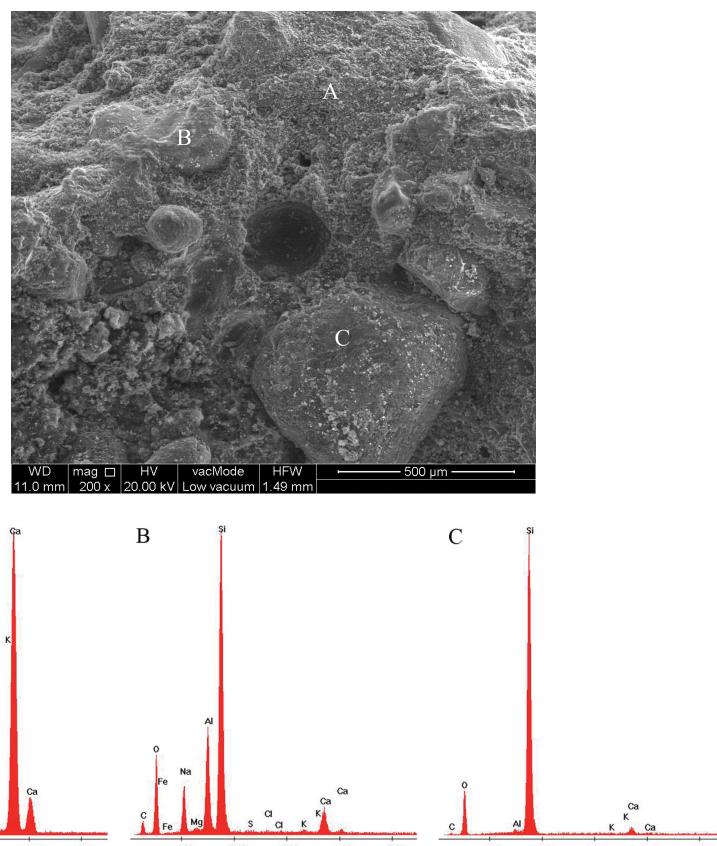
Fig. 7. SEM image of sample NR 2 and EDS spectra taken from points corresponding to: (A) – binder: calcite, (B) – aggregate: aluminosilicate, (C) – aggregate: quartz. Magnification:  $\times 200$

The results of scanning microscope (SEM) observations with an X-ray microanalysis (EDS) attachment show that the mortars tested contain a lime binder with filler. All mortars have a compact microstructure, typical of lime mortar, with aggregates well-embedded in the mass. Using an X-ray attachment, mainly calcite (Fig. 7A), well-bedded quartz (Fig. 7C), and finer grains of aluminosilicates (Fig. 7B) were identified.

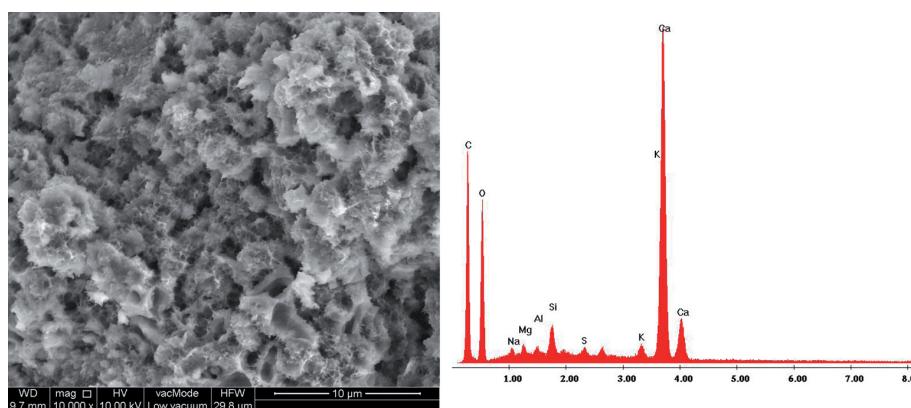
Fig. 8. The mortar binder is made up of micritic calcite. SEM-EDS analysis, magnification: over  $\times 10,000$

As shown by scanning tests, the mortar binder is made up of micrite occurring as isomeric grains of 0.5–1.0 µm in size. They form a kind of crystalline grout. The results of chemical composition tests obtained with a microprobe (EDS) showed that they are accompanied by small amounts of silica ( $\text{SiO}_2$ ), as well as aluminum, sodium, potassium and phosphorus (Fig. 8).
