SŁAWOMIR STRASZAK  
ARTUR WIKTOR

## Sheave axles of mine shaft hoists – difficulties and limitations in assessing their technical condition during in-service tests

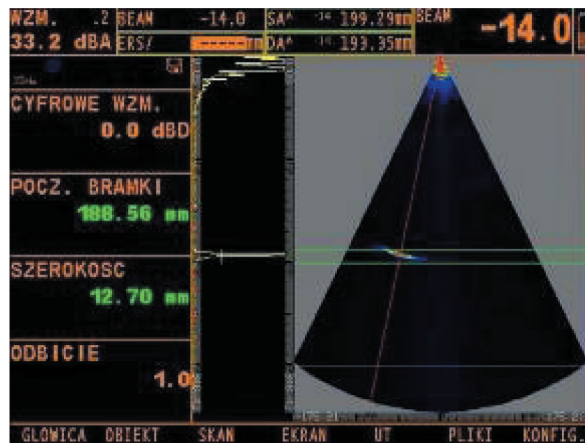
Fig. 6. Phased array imaging of a fatigue crack in the single-groove sheave axle (B2SPA16 16-element 2 MHz probe,  $\pm 30^\circ$  maximum crack indication was obtained for beam insertion angle of  $14^\circ$ )

- increases the effectiveness of the test – allows for detection of in-service fatigue cracks in the initial stage of their formation (scanning in the full range of useful angles, and not only a few as in the case of ordinary ultrasound testing),
- allows to shorten the test time – lesser number of probes used (flaw detector settings),
- facilitates the interpretation of the results (easy change of beam introduction angles – it is possible to determine at what angle the signal from a possible crack is the strongest, presentation of the indication e.g. on S-scan) (Fig. 6).

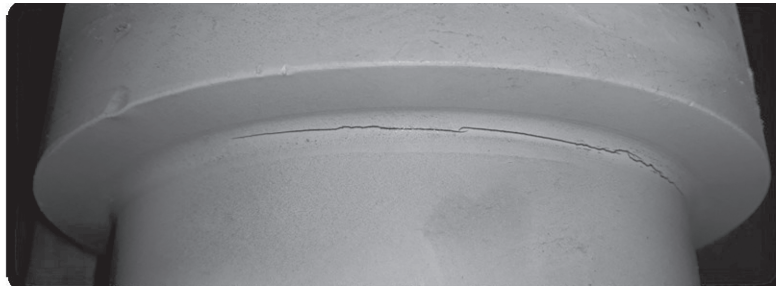
- Fatigue cracks. Usually caused by incorrectly manufactured axles, i.e., too small transition radii between successive offsets, resulting in a notch effect in critical areas of the axles, or too large diameter steps causing excessive stress accumulation in these areas. This is mainly the case for axles in double groove designs (Fig. 6 and 7). Sometimes fatigue cracks are initiated by corrosion pitting, often occurring at the axle-sheave hub contact surface.
- Excessive internal defectivity (i.e., excessive size and severity of defects of metallurgical origin) in critical locations. This mainly concerns the axles of old shaft hoists. These defects do not pose a direct threat to the safe operation of the axles, but under certain circumstances (stress concentration in these areas due to overloading or failure of the hoisting plant) they can cause cracks to appear.

*Fig. 7. Fatigue cracks detected during ultrasonic testing of single groove sheave axle (at second offset) – imaging using the magnetic particle testing (MT) method*

Axles with fatigue cracks should be replaced with new axles as soon as technically feasible, and until their replacement, crack propagation should be monitored by ultrasonic testing over a sufficiently short period of time. Remaining anomalies require immediate remediation of their causes, and axle damage should be controlled during subsequent non-destructive periodic inspections.

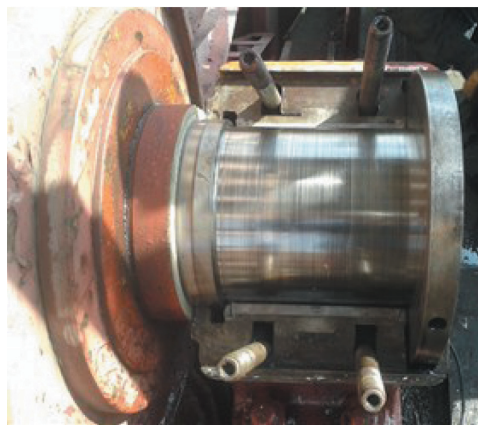
*Fig. 8. Circumferential scratches on the axle journal surface*

- sharp, deep (up to about 2 mm) circumferential indentation caused by excessive wear of the bottom shell, which results in axle settling and rubbing against the bearing housing (Fig. 8),
- circumferential cracks on the sliding surface of the journals caused by contaminants getting into the oil (Fig. 8),
- corrosion spots and scuffs on the sliding surface of the journals caused by improper lubrication,
- mild, shallow, circumferential abrasion caused by the felt seal on the bearing housings,
- loose grease rings.
