Identification and Database Creation of Selected Historic Irrigation Structures in the Czech Republic

Petr Karásek^{1*}, Igor Pelíšek¹, Michal Pochop¹

¹ Research Institute for Soil and Water Conservation, v.v.i., Department of Land Consolidations and Land Use Planning, Lidická 25/27, 602 00 Brno, Czech Republic

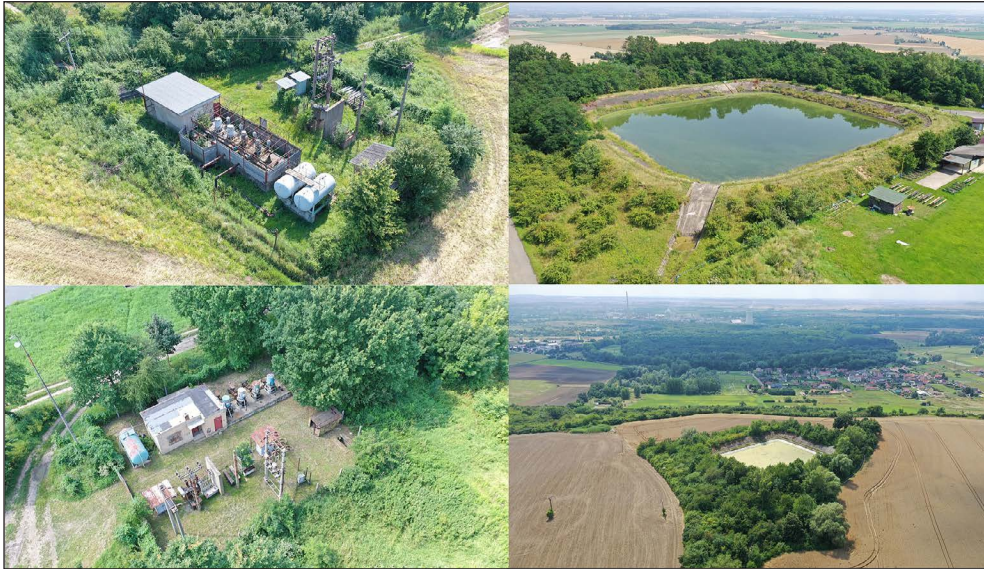
Figure 6. Non-functional and abandoned irrigation water filling stations and water reservoirs (Brandýs nad Labem)

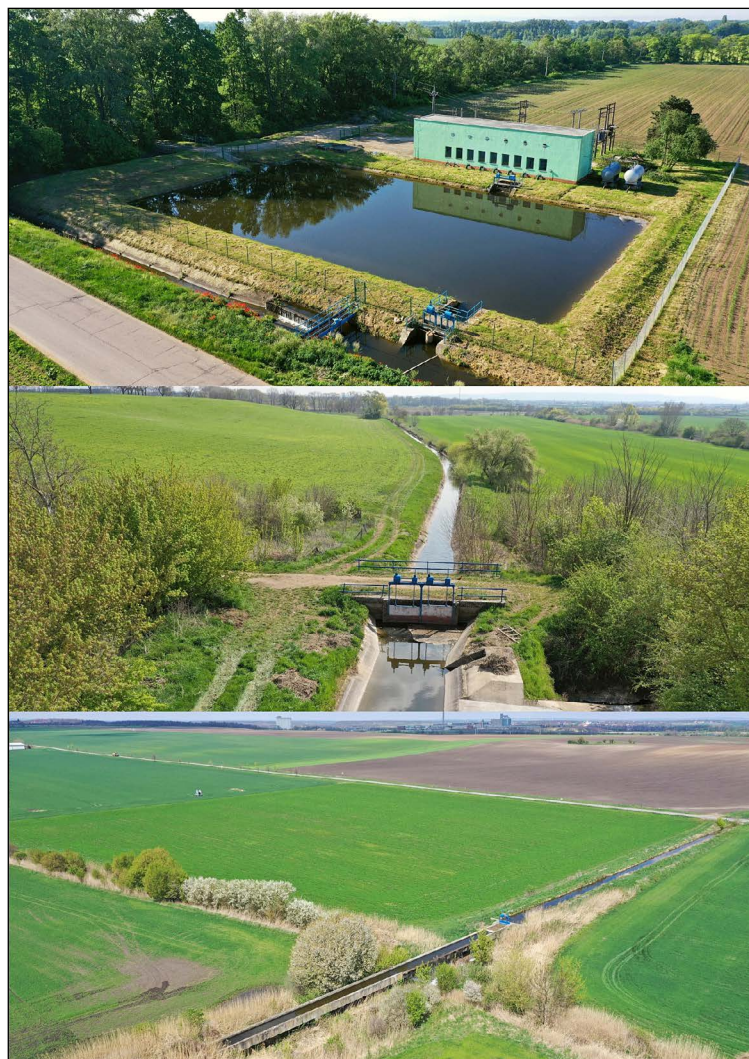
Figure 8. Water reservoir and water filling station (up), regulation device on the irrigation canal Krhovice-Hevlín (middle), historic aqueduct on the Krhovice-Hevlín irrigation canal (down)

This irrigation system consists of the main irrigation canal, which receives water from the river “Dyje” at the weir near Krhovice and transports it to individual irrigation pumping stations, or the water is pumped to other sections of the irrigation system with accumulation water stations (Fig. 8).

The irrigation canal is fed from the Dyje River and the Vranov water dam is an important water reservoir. The irrigation canal Krhovice - Hevlín was built between 1949 and 1954. It is 15 kilometers long and is partly cut into the terrain, partly created by a hopper. The bottom and walls were fortified with concrete slabs. Underpasses were built along the canal route at the crossings with the road network. Reinforced concrete aqueducts were built in several places. The entire main system is equipped with sluice gates at the points necessary to regulate the flow or to shut down selected sections. The system is also provided with lateral spillways to relieve excess flow. The main irrigation canal Krhovice - Hevlín is connected to two feeder canals built in 1966, which strengthen the water distribution. The irrigation area in 1966 was 6 000 ha, and further large sections were built until the 1980s. From a technical and historical point of view,

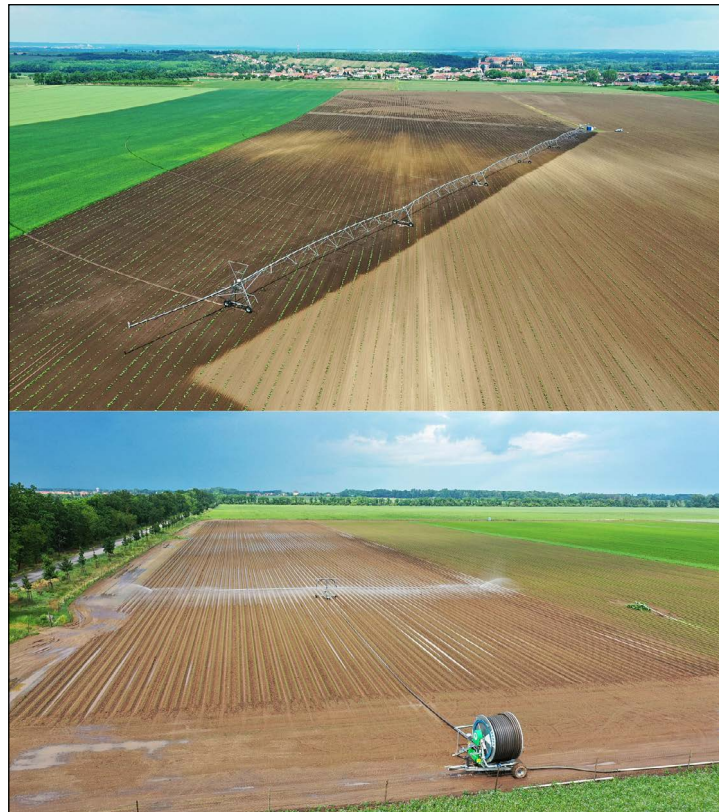
Figure 9. Wide irrigation “pivot” machine (up) and belt sprinkler in the irrigation system Krhovice - Hevlín

the use of a wide range of irrigation technologies (irrigation with belt sprinklers, wide pivot machines, drip irrigation) is important (Fig. 9).
