# Multi-criteria diagnostics of historic buildings with the use of 3D laser scanning (a case study)

Anna SZYMCZAK-GRACZYK<sup>1\*</sup>, Zbigniew WALCZAK<sup>1</sup>, Barbara KSIT<sup>2</sup>, and Zdzisław SZYGUŁA<sup>3</sup>

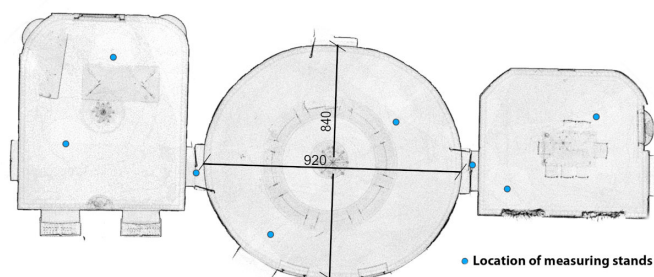
Fig. 3. Location of measuring stands

Focus S70 laser scanner was conducted at 8 measuring stands in the rooms in question (Fig. 3). The manufacturer states that the accuracy of distance measurement is  $\pm 1$  mm, the 3D position accuracy on 25 m is 3.5 mm and the angular resolution is equal to 19 arcsec. The laser wavelength is 1550 nm, and the laser beam divergence is 0.3 mrad.

The average scanning time per 1 measuring stand was about 10 minutes, the scans were made with a resolution of  $10240 \times 4267$  points. The distance between the measurement points on the measured plane was 6.1 mm/10 m with 4-times the quality. Properly prepared individual scans were combined in Faro Scene, creating a coherent point cloud consisting of approximately 157 million points. In the scanning process, reference spheres were used, which in later processing significantly facilitated the process of connecting clouds of points obtained from individual measuring stands.

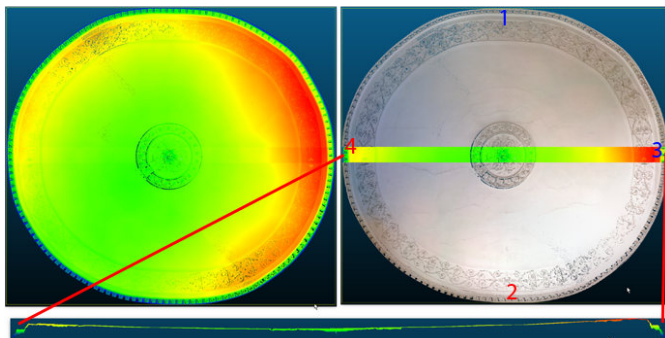
Initially, in Faro Scene, the point cloud was imported to CloudCompare. The cloud was processed to reduce noise and extract only the points that formed the ceiling geometry. Then a horizontal reference plane was introduced. Figure 4 visualizes the map of (normal) distances between the point cloud and the top-down adopted reference plane. As the arrangement of beams of the ceiling supporting structure was unknown, the position of the plane was assumed arbitrarily, and the developed distribution is a visualization of the map of the height of the ceiling face above the assumed comparative level (plane). Additionally, Fig. 5 shows the distribution of distances in the form of a histogram. The mean difference in the position of points (point cloud – reference plane) was 14 cm with a standard deviation of approx. 5 cm. The distribution of changes presented in Fig. 4 indicates that the ceiling is not horizontal, the differences also arose due to the method of finishing the ceiling – bas-relief (Fig. 6). Figure 4 also shows the profile of the ceiling face in cross-section with the greatest changes in its geometry between the entrances to side rooms. The difference between the highest point of the point cloud at the entrance to the room on the right side (Fig. 4 point 3) and the point at the entrance to the room on the left side (point 4) was as much as 12 cm. Similarly, the difference between point 1 and point 2 was 6.6 cm (measurements were made outside the outline of the existing stucco). It should be noted that the lime-cement plaster made on reed does not create a perfectly even surface, therefore, the measurement

Fig. 4. Map of distances from the reference plane and profile of the geometry of the ceiling face

may be at risk of a large error and the location of ceiling beams alone cannot be concluded from it. Nowak et al. conducted similar studies of a historic building planned for reconstruction and adaptation [11], and, based on laser scanning, they estimated the ceiling deflection as 1.39 cm and the deviation of the front wall from the vertical plane by approx. 2 cm.

The large deflections of the ceiling, which were revealed by laser scanning, were not confirmed by calculations. Therefore, it is concluded that they may be caused by structural imperfections created during construction. The flexibility of the floor may be due to poor stabilisation of the wooden floor constructed on joists. Undoubtedly, the structure of the ceiling is also important, primarily the layer of plaster applied on the reed, which

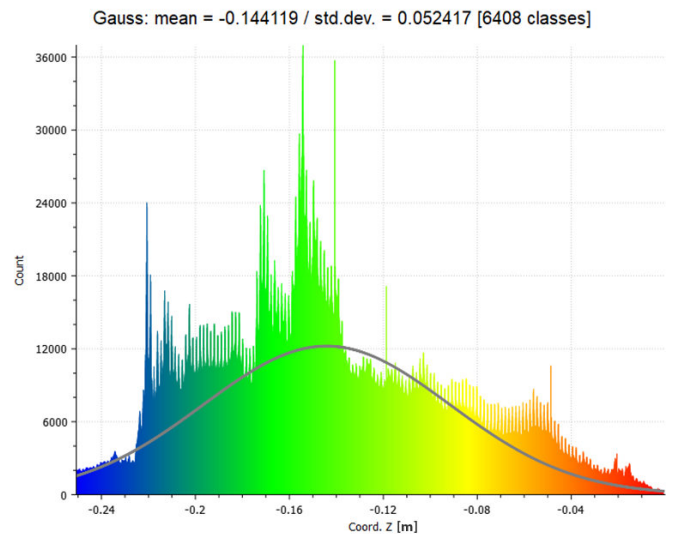
Fig. 5. Histogram of the distance of the ceiling face from the adopted reference plane for the entire point cloud

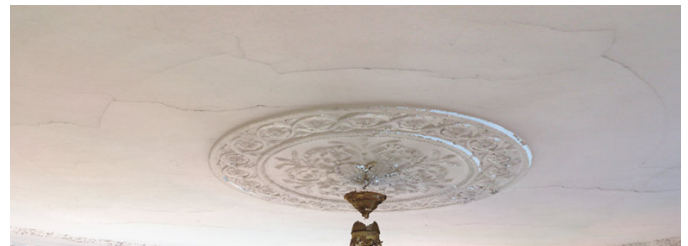
Fig. 6. Stucco on the ceiling (visible cracks in the plaster)

Only one series of measurements was made, therefore it was not possible to determine the deformation of the ceiling during its operation (when changing the ceiling load). It would require the imposition of additional load on the ceiling and re-inventory to obtain such data, for which the conservator's consent was not given.

may be subject to large bending and, consequently, susceptible to scratches and cracks in every direction,

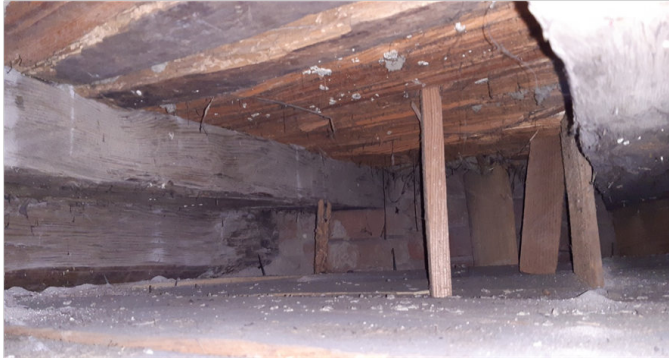
endoscopic inspection camera was inserted, allowing for identifying the location of ceiling beams. It significantly contributed to minimizing the interference in the ceiling structure in this historic building and helped select the location of test holes in the places that did not damage the ceiling structure (Fig. 7).

**Fig. 7.** View of the ceiling cross-section taken with an endoscopic camera

The ceiling layers shown in Fig. 7 have loads with a characteristic value of  $2.355 \text{ kN}\cdot\text{m}^{-2}$ . The span of the ceiling is 8.5 m. The following data is designated for ceiling beams with dimensions of  $24 \times 28$  cm:  $A = 672 \text{ cm}^2$ ,  $W_y = 3136 \text{ cm}^3$ ,  $I_y = 43904 \text{ cm}^4$ .

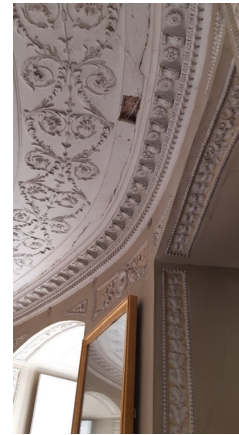
Two  $10 \times 15$  cm test holes were made, the location of which is indicated on the projection (Fig. 8), whereas Fig. 9 shows the location of test holes in the room.

**Fig. 9.** Location of test holes

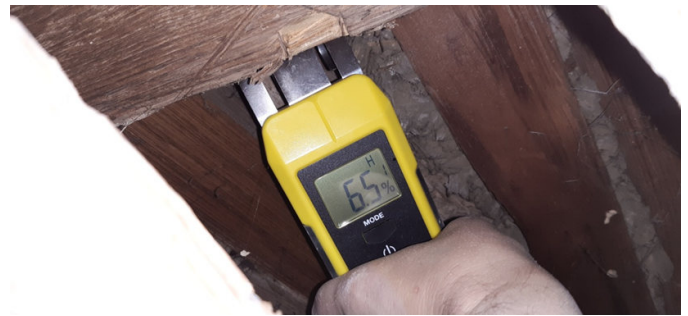
Figure 11 shows exemplary moisture content measurement at measurement point no. 2.

**Fig. 11.** Moisture content measurement of ceiling beams – test hole no. 2

According to the given criteria, the tested ceiling elements in the area near the external wall and in test holes, i.e. the most moisture-prone places, proved to be dry. In situ tests were carried out inside the Palace at maximum temperature  $T = 16.9 - 17.7^\circ\text{C}$  and maximum moisture content 48–52%.

The moisture tests of wood did not confirm any damage to the element, the level of moisture content was 5.8–10.3%, i.e. it did not exceed the value for structures protected against moisture, assuming class 1 use of the structure.

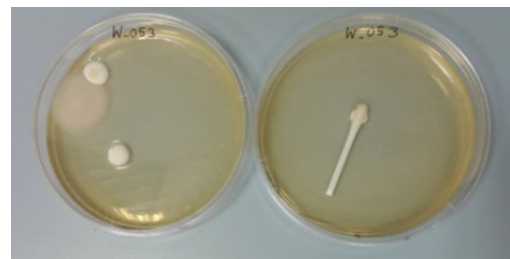
During the examination of the occurrence of condensation on the surface of the ceiling inside the rooms, no "dew point" was found. Also, no symptoms of wood decomposition were observed on the samples submitted for testing as well as no living structures, i.e. domestic fungi belonging to basidiomycetes (*Basidiomycota*) with strong wood decomposition capacity were found (Fig. 12).

**Fig. 12.** Petri dish after incubation (inoculation and the truncated tip from swabs for sample no. 1)

Given mould fungi, it is assumed that the presence of fungal structures (CFU) in the tested material of up to 20% does not indicate the existence of favourable conditions for their growth. Such a level indicates natural contamination by fungal structures present in the immediate vicinity of the sampling site, i.e. in the air.

The number of units forming the colonies of mould fungi in the collected samples was low. In the tested samples, no fungi were found that could pose a threat to structural elements in terms of biological corrosion,
