Physical Elements of Heritage Buildings: Study of the Kadariah Palace in Pontianak City, West Kalimantan

Cytowanie / Citation: Zain Z. Norita N. Andi A. Physical Elements of Heritage Buildings: Study of the Kadariah Palace in Pontianak City, West Kalimantan. *Wiadomości Konserwatorskie – Journal of Heritage Conservation* 2022, 72:89–100

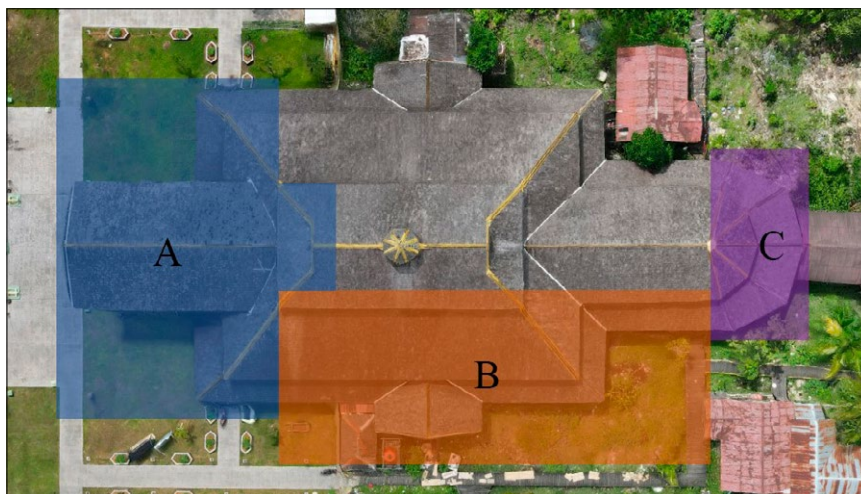
Fig. 1. Zoning of the Kadariah Palace for research analysis; by N. Norita.
Rys. 1. Podział pałacu Kadariah na strefy do analizy badawczej; opr. N. Norita.

Physical elements such as structural elements, non-structural elements, and decorative ornaments [Nor and Isa 2015] are the components of the Kadariah Palace building. These elements will be described in three parts of the building, namely the front side (A), the left side (B), and the back side (C) (see Fig. 1.).

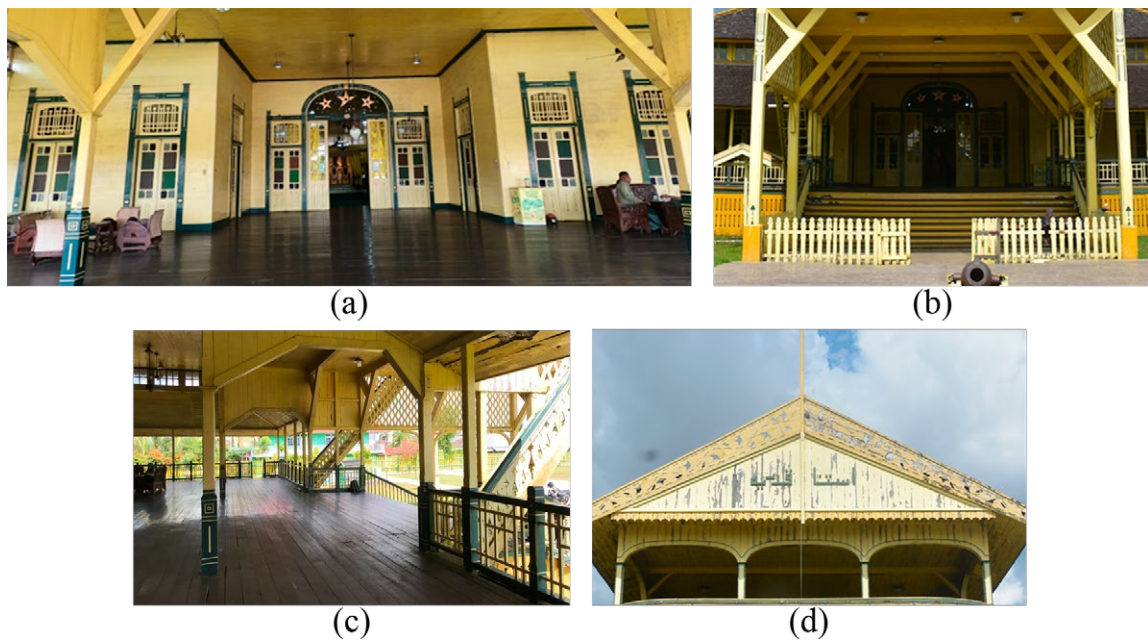
Non-structural elements complement structural elements such as doors, windows, roofs, walls, stairs, and screen spread that complete the palace building [Nor and Isa 2015]. Based on observations, in section A, a number of visible doors on the front of the first-floor building can be accessed directly through the front porch; there are eight small double doors and one large double main door (Fig. 4a). There is one main stair as access from the palace courtyard to the building (Fig. 4b), and there are two stairs as access to the second floor (Fig. 4c). The house screen cliff is also seen to complement the front side of the palace building, and made of belian wood (Fig. 4d).

Fig. 4. The condition of non-structural elements of the Kadariah Palace; photo by N. Norita 2021.
 Rys. 4. Stan elementów niekonstrukcyjnych w obrębie pałacu Kadariah; fot. N. Norita 2021.

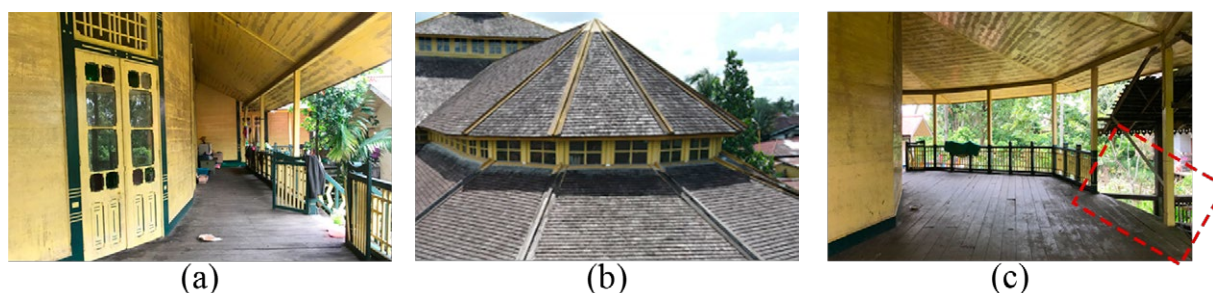
On the rear side of the building in section C, there are two small double doors (Fig. 6a) and some windows which also are found enclosed on the second floor (Fig. 6b), with one stair as circulation access from the back yard of the building (Fig. 6c).

Fig. 6. Situation in the rear section of the Kadariah Palace; photo by N. Norita 2021.
Rys. 6. Sytuacja w tylnej części pałacu Kadariah; fot. N. Norita 2021.

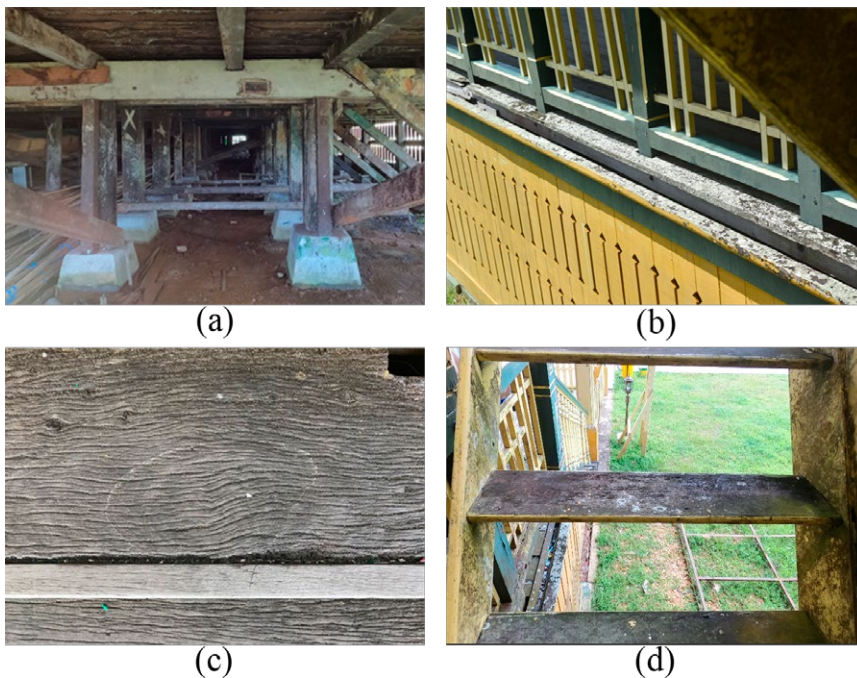
Biological damage found during field observations was due to fungal factors that were visually apparent. No damage caused by insects was observed with the naked eye. The type of fungus found in the Kadariah Palace building is a white-rot fungus. This fungus affects the concentration of wood lignin, which further fades the wood's original color [Pournou 2020]. The growth of the fungi that cause decay dramatically affects the

structure and stability of the building's strength [Zain and Fajar 2014]. Based on the results of observations and literature studies, the element that has a white layer on top indicates that the component is attacked by white-rot with the effect of bright stains left behind [Shang et al. 2013]. Wood materials of past buildings are usually attacked by wood rot or fungi, resulting in a durability decrease of building materials and structures [Alfieri et al. 2016]. However, besides presenting in the form of stains or spots, white-rot fungi can also be seen in the form of white fibers (Fig. 8c). This type of fungus is quick to attack outdoor construction parts [Irbe et al. 2012], such as foundation elements, floors, and stairs. White spots are visible on the wood surfaces that appear to be in good condition, or parts of the wood that have cracked without changing the external dimensions. In other words, this fungus does not cause cracks on the outer surface of the wood, but only changes the surface color due to the degradation of wood lignin [Riggio et al. 2015].

Fig. 8. Biological impact on the wooden surface of structural elements of the Kadariah Palace; by N. Norita 2021.
Rys. 8. Biologiczny wpływ na drewnianą powierzchnię elementów konstrukcyjnych pałacu Kadariah; fot. N. Norita 2021.

In order to effectively stop the assault of dry wood termites in West Kalimantan, liquid chemical protection is frequently utilized as a supplement to structural and hygienic measures [Indriyani et al. 2008; Indriyani et al. 2017]. Future termite control solutions may benefit from using bio-based ingredients to combat subterranean termites made from the crude ethanol extract of *S. Aromaticum* and *M. Leucadendra* [Indriyani et al.

2016]. To reduce or counteract the effects of weathering brought on by organisms or the environment, the treatment of adding a polychromatic coating to a wooden structure could be applied to wood carvings used as ornamentation on historical West Kalimantan structures [Zain and Putro 2021]. The purpose of this effort is to maintain the value of historical buildings according to the need to preserve and present their aesthetic intentions [Nitto et al. 2016; Tomaszek 2016; Palanti et al. 2014].

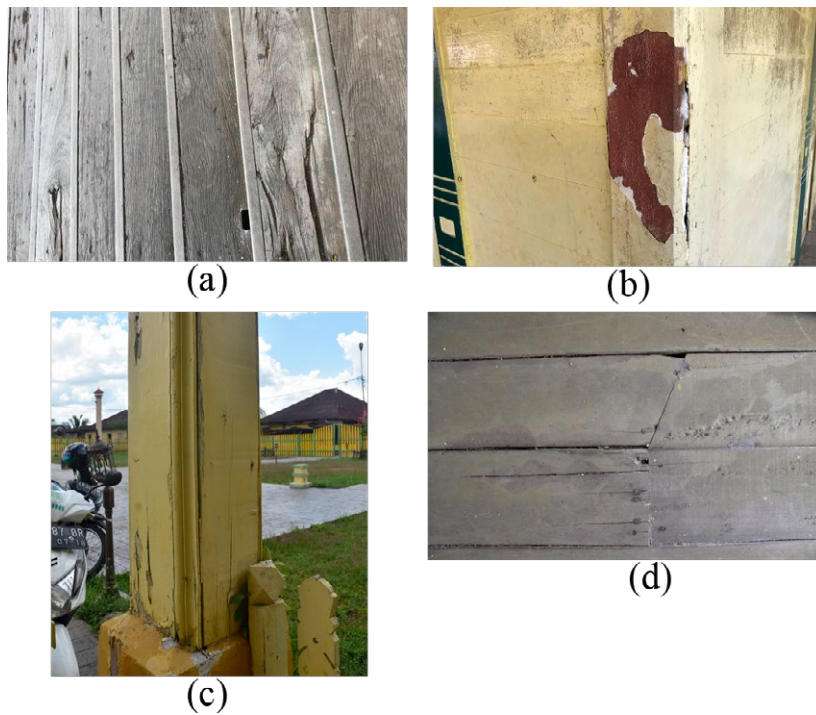
Damage due to mechanical factors was found at several points on the walls, columns, and floors of the Kadariah Palace building. Generally, mechanical degradation is caused by wind, sand, dust, cracks, fractures, abrasion, erosion, and compression [Nilsson and Rowell 2012]. One of the causes of mechanical damage to

the Kadariah Palace is sand. Sand carried by the wind will erode the outer surface of the wood that is not coated with paint [Zabel and Morrell 2020]. Excessive loads applied to the elements are also the cause of mechanical damage so that the wood surface will experience fragmentation or erosion. Cracks are visible in the

wood due to sustained loads, causing a decrease in the vertical load-bearing capacity of timber affected by the reduced cross-sectional area [Dai et al. 2020].

Fig. 10. Effect of mechanical factors on physical elements of Kadariah Palace; photo by N. Norita 2021
 Rys. 10. Wpływ czynników mechanicznych na fizyczne elementy pałacu Kadariah; fot. N. Norita 2021
