Corroded steel support friction joint load capacity studies as found in Piast-Ziemowit coal mine

Key words: *corrosion, heading support, friction joints, load capacity study*

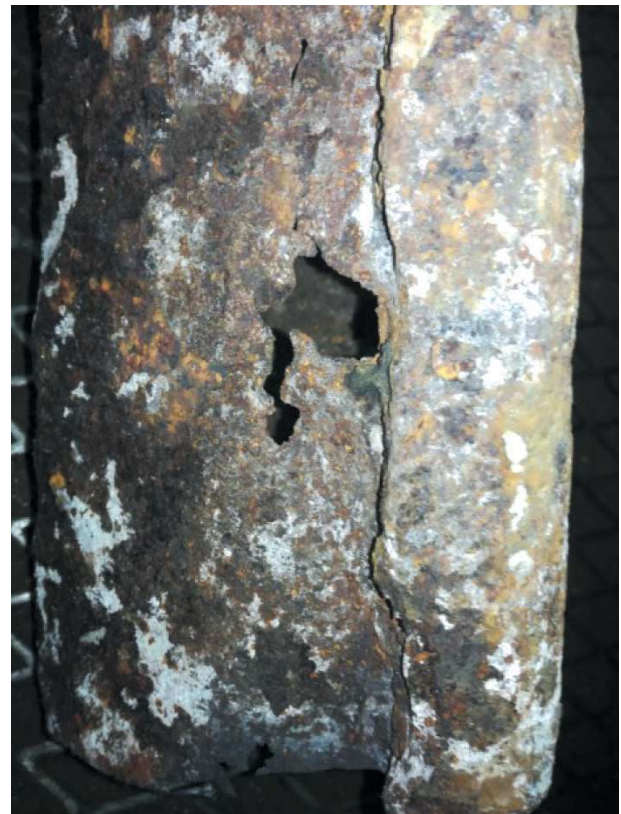
Fig. 2. Section perforation in flange area

The joint ends in contact with the tensile testing machine parallel loading plates were cut in such a way so they would adhere to the machine plates. Due to the fact that section perforations were found in the joint (Fig. 2), its ends were additionally reinforced with a V29 section segment and a single shackle. This was done to prevent the occurrence of V29 section deformations in the joint (which would block its yield) and, thus, disrupt the joint course of operation. A view of the joints prepared for testing is presented in Figures 3 and 4.

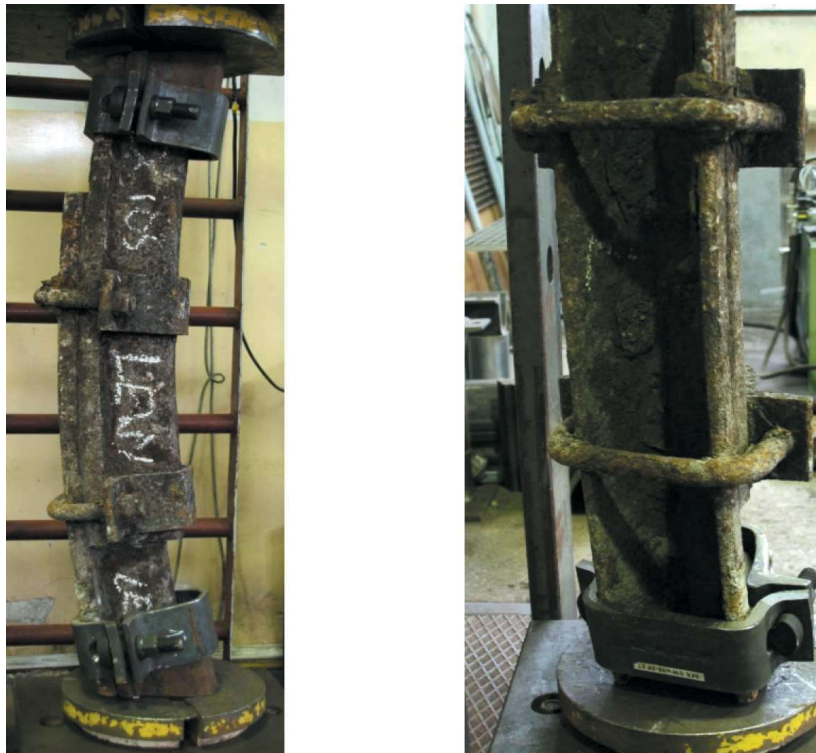
Fig. 3. Friction joint 1 prepared for testing and shackle technical condition

Geometric measurements of the K29 bow shackles in friction joint 1 showed that the M27 bow bolts exhibited slight corrosion resulting in bow diameter reduction within a range of 25–26 mm (both in the lower and upper shackles). The joint overlap of $z = 560$ mm did not change (neither before nor after testing).

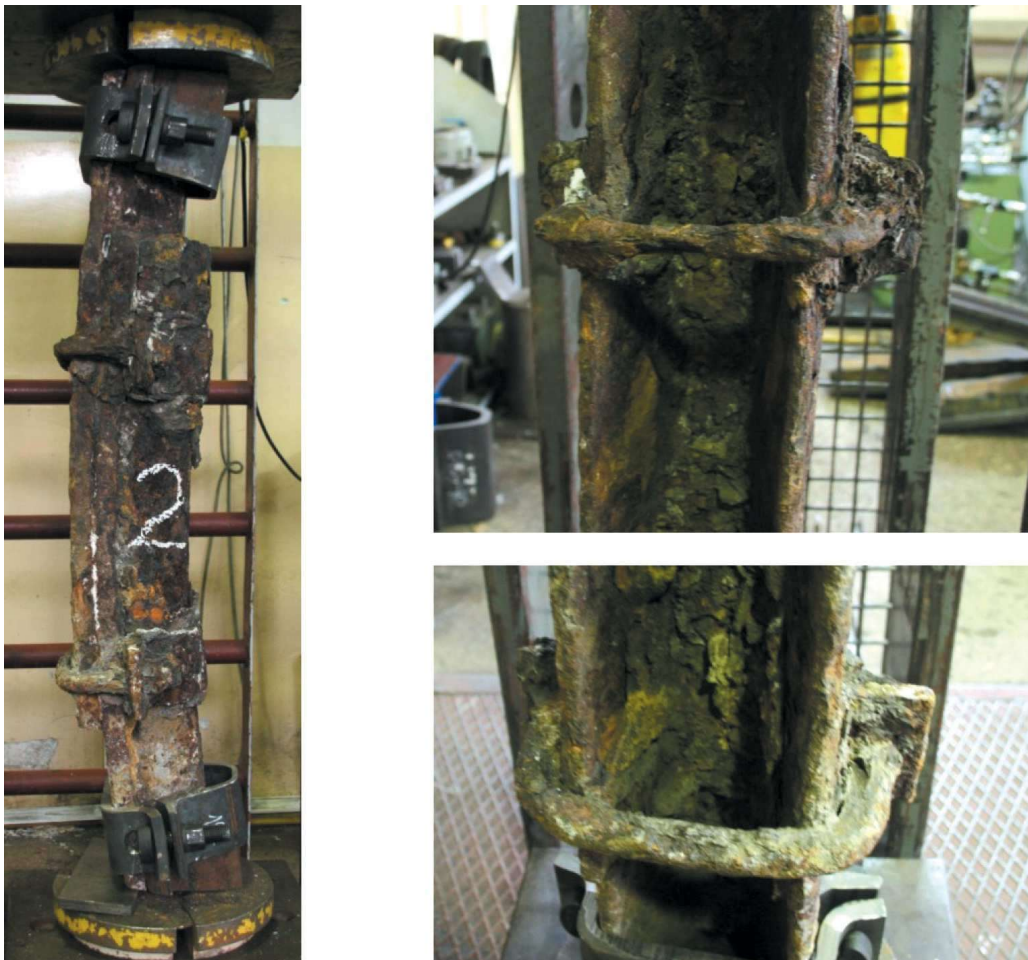
Fig. 4. Friction joint 2 prepared for testing and shackle technical condition

Geometric measurements of the K29 bow shackles in friction joint 2 showed that the M27 bow bolts exhibited significant corrosion resulting in bow diameter reduction within the ranges of 7–20 mm in the upper shackle and 18–23 mm in the lower shackle.
