Problem of Clogging in Drainage Systems in the Examples of the Żur and Podgaje Dams

Witold Sterpejkowicz-Wersocki

Gdańsk University of Technology, Faculty of Civil and Environmental Engineering,
ul. G. Narutowicza 11/12, 80-233 Gdańsk, Poland, e-mail: wste@pg.gda.pl

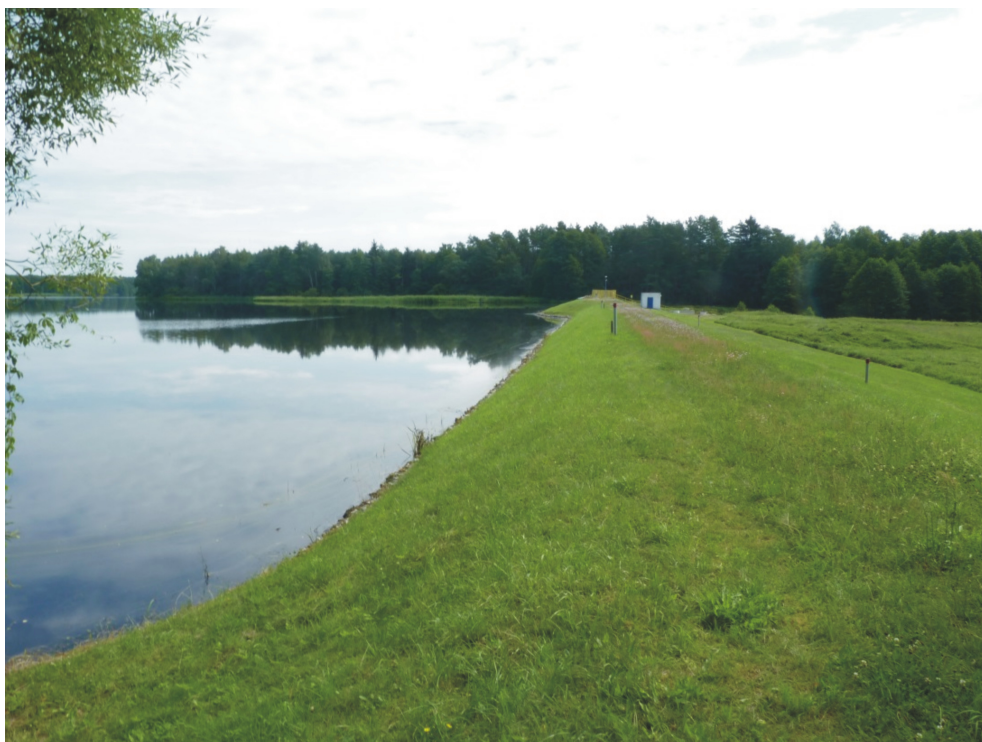
The hydropower plant Podgaje is located in the northern part of the Wielkopolska region, approximately 10 km from the city of Jastrowie. It was launched in 1929 as the first hydropower plant in the cascade of the Gwda river. As a result of damming the river Gwda by the earth dam (Fig. 2) with a length of 520 m, a reservoir was created, which covers an area of 116 hectares and has a capacity of 3.87 million m³, from which water is supplied to the power plant by a diversion channel with a length of about 900 m.

Fig. 2. General view of the Podgaje earth dam
