Pil'a, J., Ojciec, M., Balcerzak, T. Investigation into the production flaws in thin solid carbon laminates by using the ultrasonic phased array method. *Scientific Journal of Silesian University of Technology. Series Transport*. 2018, **101**, 141-148. ISSN: 0209-3324. DOI: <https://doi.org/10.20858/sjsutst.2018.101.13>.

## INVESTIGATION INTO THE PRODUCTION FLAWS IN THIN SOLID CARBON LAMINATES BY USING THE ULTRASONIC PHASED ARRAY METHOD

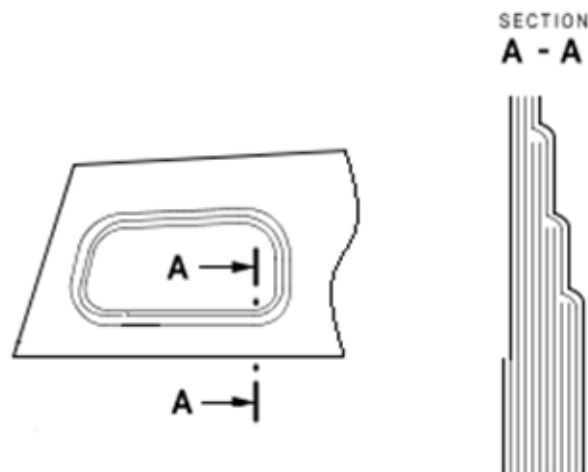
Fig. 1. Drawing of the aileron segment with a sectional view of carbon layers

During the redelivery process of an Airbus A319, one of the technical representatives indicates his suspicion that two delaminated spots are present on the outboard edge of an aileron. To prove that these are not delaminated areas but production flaws, it is decided to probe them by using a tap test, conventional ultrasonic measurement and the phased array method. These methods are selected because they are approved by Airbus and the preferred methods for testing composite structures in NDT manuals. In the thickest area, the inspected component is made of 16 layers of epoxy prepreg carbon fabric (5H satin weave). This type of prepreg contains 45% epoxy resin and, during manufacture, is cured at 180°C. This material meets the requirements given in the BAER 3068 specification. Figure 1 depicts the section of the aileron that was inspected. The closer to the centre, the fewer the cloth layers present, thus the element thickness is reduced.

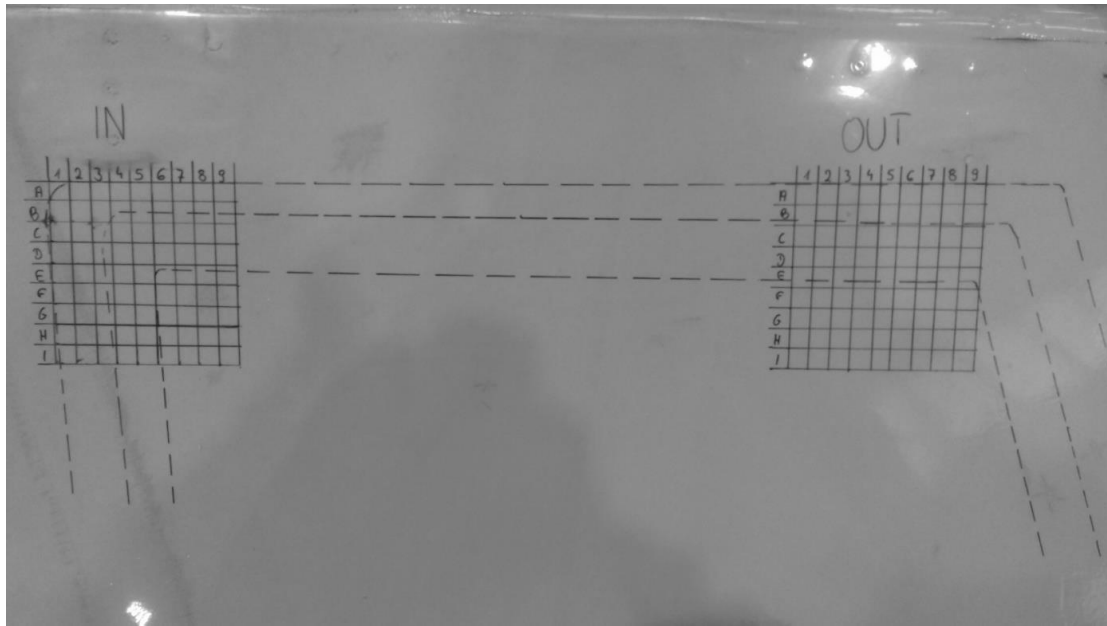
Fig. 2. Aileron segment with the drawn thickness change layout and a grid over the suspected area

In order to perform the examination, a plies layout is drawn on the aileron, along with 10x10 [mm] grid mapping over the areas where the production flaw is suspected. The first phase of this investigation is done by the tap test method [10] using a certified Airbus tap test tool. It is possible to notice a slight change in sound during the test; however, it is not typical and, as a result, it is insufficient proof to come to a conclusion. As such, further testing is required.

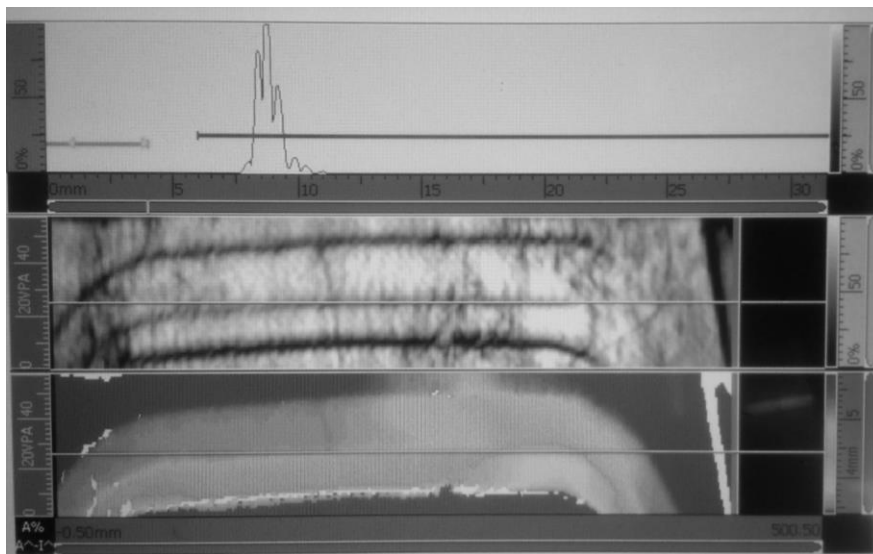
Figures 3 and 4 are screenshots taken directly from the Olympus scanner. Based on these figures, as well as Table 1, it can be easily determined that no damage is present at the inboard corner of the suspected area. There is no visible change in material thickness, which would indicate delamination or other damage both on the UT measurement and PAUT scans. In terms of the outboard edge, it can be seen that there is an irregularity (slightly brighter colour on the C-scan image in Figure 3). This irregularity has also been detected by traditional

Fig. 3. A-C-C-scan views of the inspected sample

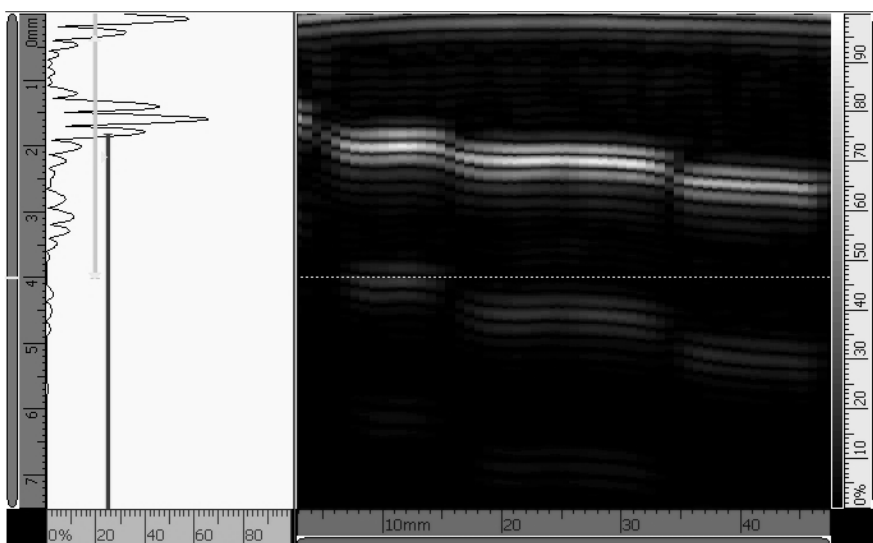
UT measurement (cells E3-E6, F3-F5 and G3-G5, as seen in Table 1). It can be noticed that thickness values within these cells are around 0.05-0.12 [mm] lower than in the surrounding area. For further investigation purposes, it is necessary to refer to the A-S-scan image (Figure 4). In this picture, one can see that the composite layers are intact, as a good back wall echo has been received on the entire scan length. In turn, it is possible to confirm that no structural damage is present on the examined segment of the aileron. The final question that needs to be answered concerns why there is a change in thickness indicated on the outboard corner. In the middle C-scan image, as seen in Figure 3, one can notice a white area in the spot where we have observed a thickness change. This means that there was a lower dampening of ultrasonic signal, probably caused by a larger amount of resin. This accumulation of resin might have occurred during the manufacture of the aileron as it was made of epoxy prepreg material. Thus, it can be called a production flaw.

Fig. 4. A-S-scan images of the examined part of the aileron
