## **TECHNICAL CONDITION ASSESSMENT OF HISTORICAL BUILDINGS – FLOWCHART DEVELOPMENT**

The article presents a methodology of technical condition assessment of masonry and timber structures of historical buildings, demonstrated on the example of palace complex at Gorzanów. Based on a comprehensive diagnostic study prepared by the authors, both on location and in the laboratory, a flowchart was developed to illustrate technical condition assessment procedures for historical buildings as well as for determining existing damage. The flowchart presented here may be found helpful by those providing expert opinions while designing their research and determining damage causes and investors who undertake such a difficult task as an adaptation of historical buildings to modern functional requirements.

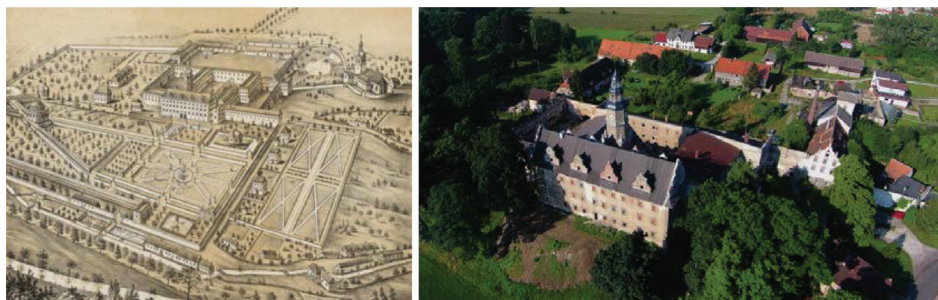
**Figure 1.** Panoramic view of the palace complex in Gorzanów from 1738 (left) and 2014 (right)

palace was modernised and partly rebuild in the baroque style. The palace and park complex in question represent the *entre cour et jardin* type (fig. 1).

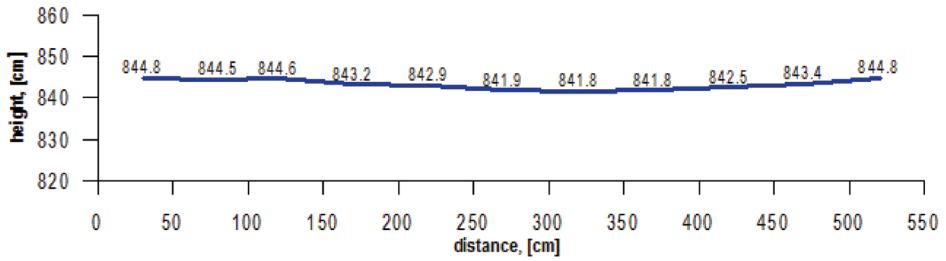
**Figure 2.** Bending example in the middle of a beam's span

Measurements of bending in wooden ceiling beams were performed in rooms in which the whole ceilings were preserved or large portions of ceilings were intact. The bending measurements performed along with the macroscopic assessment allowed the character of beam work and degradation points to be determined. Based on these measurements, two specific types of movements were distinguished – bending in the middle of the beam's span resulting from its own weight and that of static load, which is natural for such a construction system, and lowering in supported areas (e.g. fixtures of ceiling beams) which may result from degradation of wooden elements and the significant tilt of walls from vertical position. Exemplary bending measurements are shown in fig. 2 and 3. Distance between a measurement point and a beam (ceiling) is marked on the Y-axis, while distance between subsequent measurement points is marked on the X-axis.

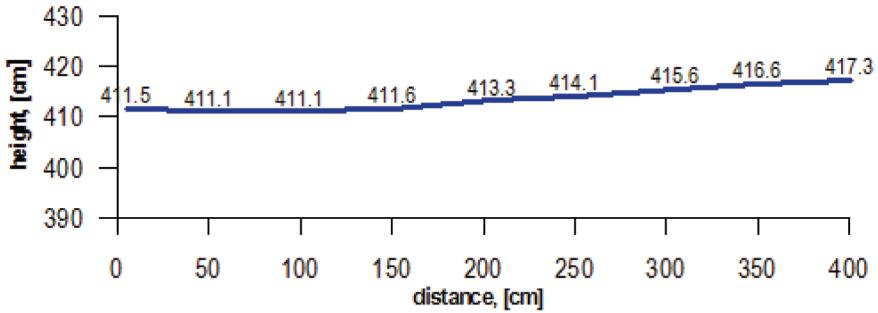
**Figure 3.** Lowering example in supported area

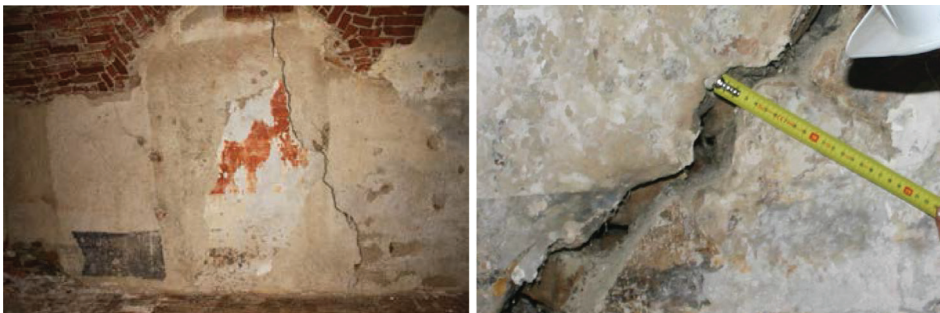
**Figure 4.** A view of exemplary cracks recorded during inventory

Cracks in walls and ceilings are the kind of damage common in historical buildings and also occur in the Gorzanów palace (fig. 4). It should be emphasized that the correct technical identification of the cracks real scope constitutes the basis for the diagnostic assessment that is the causes of cracks, their negative impact and repair possibilities (Masłowski 2000, Oliveira 2006). All cracks were marked on the plans and the elevations developed during the inventory. An analysis of position of wall cracks and monitoring their size allowed for the causes

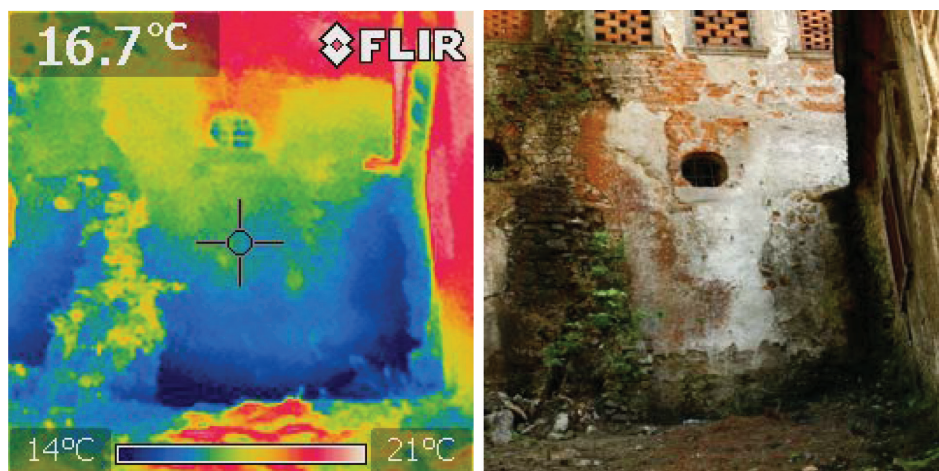
**Figure 5.** Northern elevation of Gorzanów palace

Another important issue identified in the Gorzanów palace related to the considerable dampness in walls and ceilings. In practice, there are several methods which allow a dampness profile of a building, including indirect methods which consist in measuring another physical constant and calculating humidity values based on this constant to be determined. Humidity measurements of construction elements were executed with hygrometers whose operation is based on dielectric constant measurements. During examination, the humidity level in walls and ceilings was also determined. The largest dampness level in ceilings was observed in areas which are no longer protected against atmospheric conditions, while the walls were considerably damp at the foundation level. A visible decrease in the dampness level was also observed with increasing altitudes. Thermographic tests may also serve as an indirect method for determining dampness levels (identifying places of increased humidity). Tests executed at the Gorzanów palace complex identified leakage spots in roof drainage system as well as capillary absorption of groundwater (fig. 5). A change in humidity level along with a change in temperature was clearly visible in places where down-pipes were damaged. The lowest temperature was noted in areas of rainwater

impact. Low temperature areas spread from the damage point in a down pipe towards the ground and enlarged its span, which demonstrates water filtration within construction material. Absorbed water caused considerable erosion of the wall's surface which led to the development of vegetation in ground-adjacent part of construction. Apart from temperature changes resulting from direct impact of rainwater ingress, an increase in temperature along with an increase in altitude was also noted in the same area, which confirms that the dampness resulted also from capillary absorption.

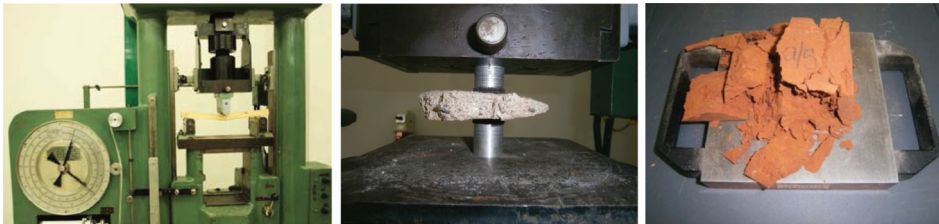
In the case of the discussed building, due to a construction catastrophe which led to a roof collapse in the eastern wing, demolition of parts of ceilings and wall was necessary. This allowed for the collection of a sufficient amount of samples for laboratory testing. Physical and mechanical parameters of masonry and wooden constructions were determined via destructive tests. In the case of masonry constructions, density, humidity and compressive strength were determined for brick and stone elements in natural state and in solid mass state, as well as the compressive strength for the mortar. For wooden constructions, density, humidity, compressive strength along and cross fibres, flexural strength along fibres, and Young modulus along fibres were determined. Methods for testing the mechanical properties (strength) of construction elements are described in detail in Polish and European standards. Figure 6 shows, from left to right: bending test of standard wood sample, „punch test” compression and a brick sample destroyed in a compression test.

**Figure 6.** Laboratory samples collected from examined construction elements under testing

Strength parameters obtained in these tests allowed material classes for individual elements to be determined. Due to the numerous historical layers, tests were performed in several groups according to original location of samples in the structure.

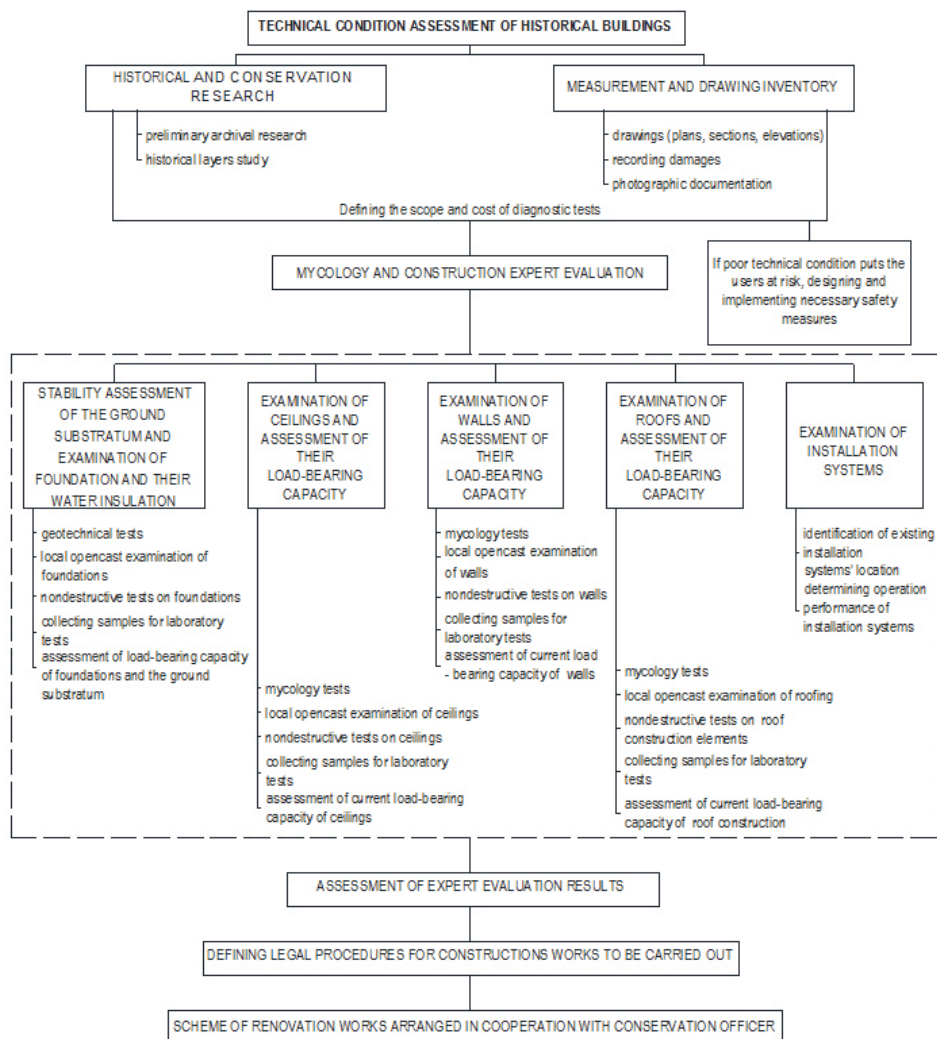
**Figure 7.** Flowchart of technical assessment procedures for historical objects

Based on tests and examination executed at the Gorzanów palace complex, observations of restoration works carried out there and literary resources, the following flowchart of technical assessment procedures for historical objects and determining damage causes was developed (fig. 7). In the future, the scheme presented here may help, among others, experts in conducting evaluation of technical condition.

An analysis of the flowchart (fig. 7) justifies the conclusion that a technical condition assessment of a building is a complex, interdisciplinary task requiring the involvement of a whole group of experts. Therefore, those who attempt to save or modernize historical buildings, especially severely damaged ones, may follow the tips presented below, which will facilitate considerably in implementing the correct order of activities.
