Troubleshooting Maintenance of Concentrated Photovoltaic System – A Case Study

Concentrated photovoltaic (CPV) is a photovoltaic technology that generates electricity from sunlight. Contrary to conventional photovoltaic systems, it uses lenses to focus the sunlight onto small, but highly efficient, multi-junction solar cells. Two modules of CPV with a capacity of 6.4 kW (3.2 kW for each) were imported from Azur-Space Solar Power GMBH (Germany) and installed in Middle East University, Jordan, for testing purposes as a pilot project for this niche technology. It is worth mentioning that the installation of the units had been carried out by the faculty members. A range of technical obstacles were encountered in the process due to unclear instructions/steps from the manufacturer. A series of maintenance techniques and corrective measures were implemented in the system after one year of installation since the power output was unsatisfactory. Accordingly, the units were dismantled, and various procedures were conducted in order to ensure that the conditions of the system were on optimum level. In this paper, technical reviews and preventive setup were explained and presented.

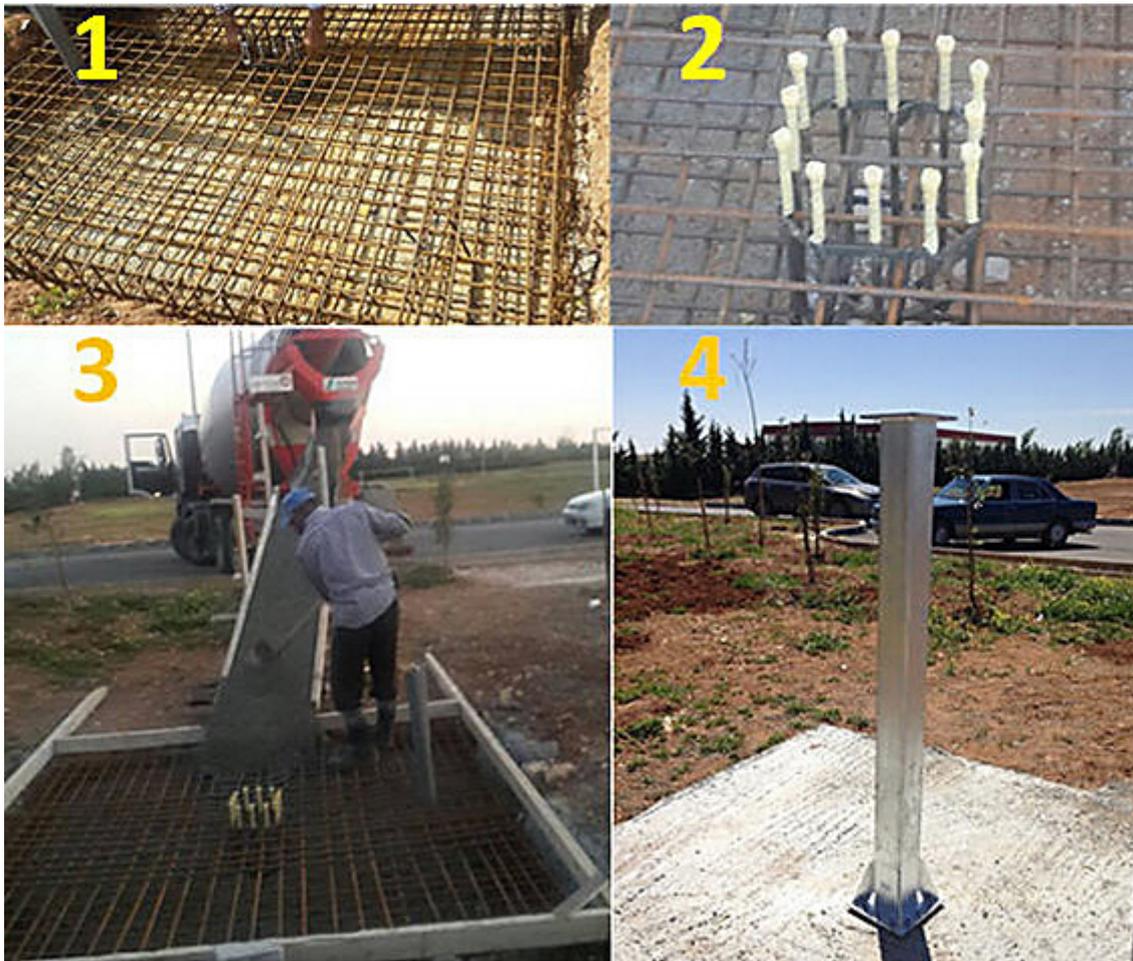
Figure 3. Steps of building concrete foundation process

It is worth mentioning that the installation of the two units has been implemented by the faculty members despite the presence of many technical obstacles during setup due to unclear guidelines and instructions provided in the manual. The installation commenced by picking a shade-free site, for instance, with no buildings or trees around. Then, digging was started and the footings were sealed to protect them from moisture. Finally, concrete foundation with dimension (W: 2.5m × L: 2.5m × D: 0.9m) was laid to support the weight of the CPV structure. In order to fit the poles with their holes onto the anchor rods, they had to be mounted on the foundation properly. The sequence of processes is depicted in Figure 3.

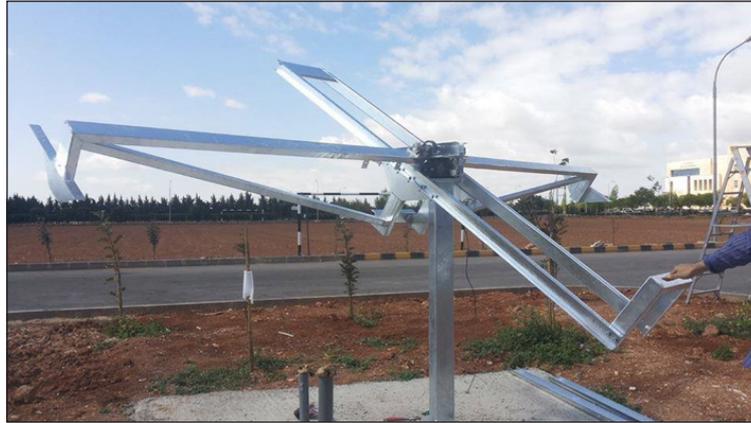
On the other hand, steel structure frames and beams were assembled together. The tracking motor was mounted on the top of the structure. These components are responsible for holding the movable panels of CPV as shown in Figure 4. The final appearance of the CPV system is illustrated

Figure 4. Steel structure of CPV

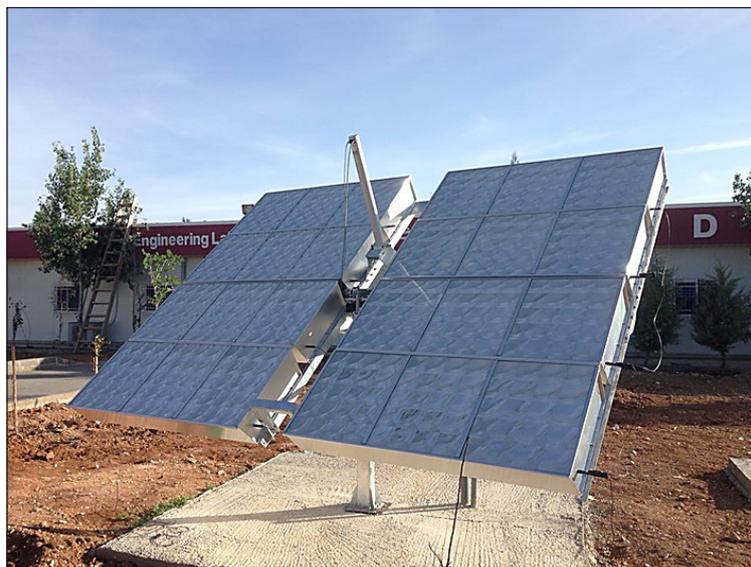
in Figure 5. It should be noted that two units were installed on the site, each including 8 panels with 400 Wp for every panel. A single panel comprises 60 photovoltaic cells. Thus, one unit consists of 480 cells that generate 3.2 kWp.

Figure 5. One of the CPV units installed in the site

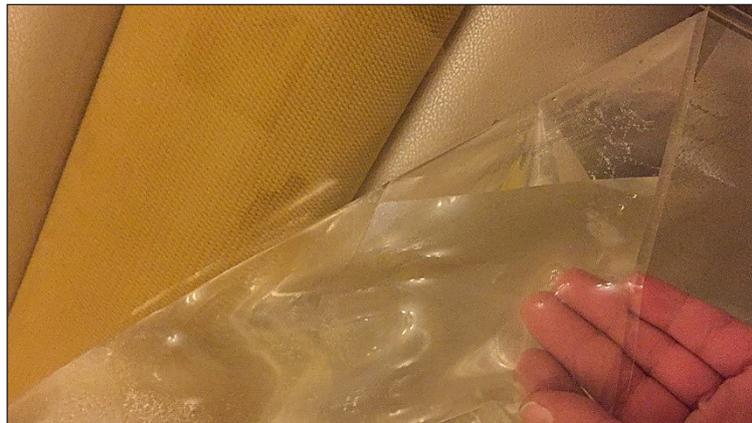
that glass is very fragile and might break spontaneously. In fact, this process took a lot of time and had to be performed carefully, due to the fact that the Fresnel layer is made from thin transparent thermoplastic rubber. Figure 8 shows part of the Fresnel layer used in the CPV modules. Multiple layers of rubber and silicon were used to re-seal the panels in a better way to avoid the issue of water leakage inside the panels recurring under rainy conditions.

Figure 8. Fresnel layer made from transparent thermoplastic rubber

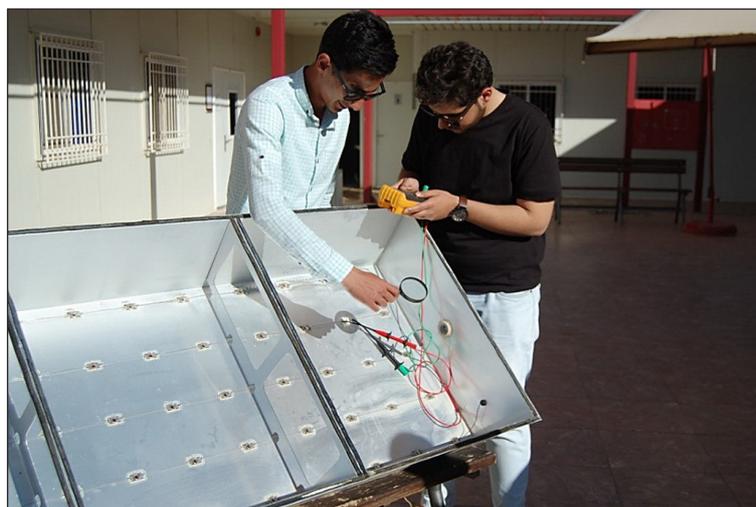
Figure 12. Testing and validating results of Photovoltaic cells after cleaning

- Cleaning every cell from dust and fixing the external wiring connection. Figure 11 shows a cleaned cell.
- Replacing the damaged photovoltaic cell with a new one imported from the manufacturer.
- Testing and validating each cell separately in order to guarantee that the output voltage is 3.2 V, as designed by the manufacturer.

Figure 12 illustrates how the testing procedure is being carried out on the photovoltaic cells. This procedure was repeated for the installed two units, eight panels for each. In other words, the process was conducted on 960 photovoltaic cells.

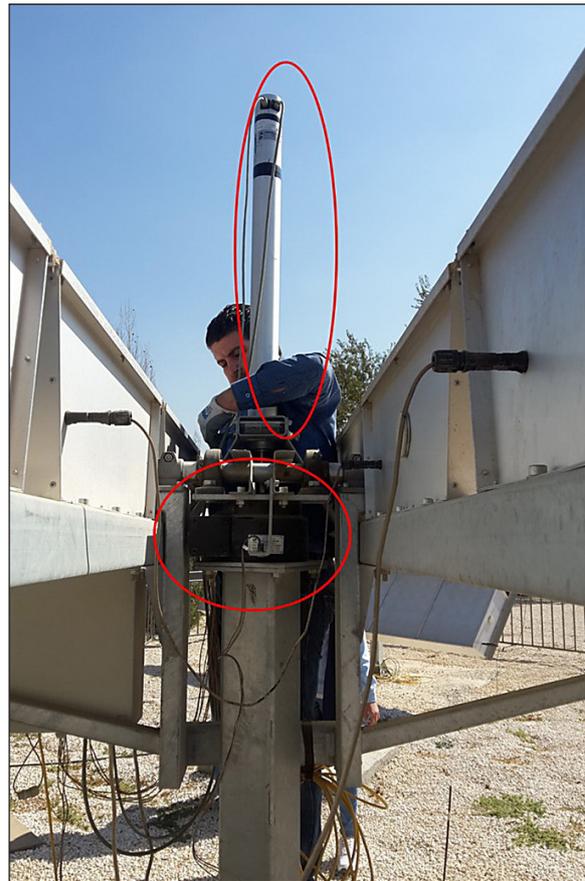
The CPV system contains two motors to follow the Sun, the first being the linear actuator motor, which is a machine responsible for realizing the vertical component of movement necessary in tracking the Sun. The actuator operates by transforming the rotational movement into a linear one. This actuator is shown in Figure 13. The second is the circular motion motor, which is a machine responsible for rotating the entire system. This mechanism could involve the use of a gearbox as is the case in the CPV system installed at MEU.

However, to prevent costly repairs or downtime, continuous maintenance is required to preclude problems before they occur. Unfortunately, both motors of the CPV system at MEU broke down. This breakdown was not due to lack of maintenance but had more to do with manufacturing problems.

Figure 13. Both motors for CPV system

Moreover, as the CPV system has problem with both motors, the first step was to identify the issues by using the auditory or tactile test, then special diagnostic tools were utilized to understand where the required repair was needed to solve these problems.

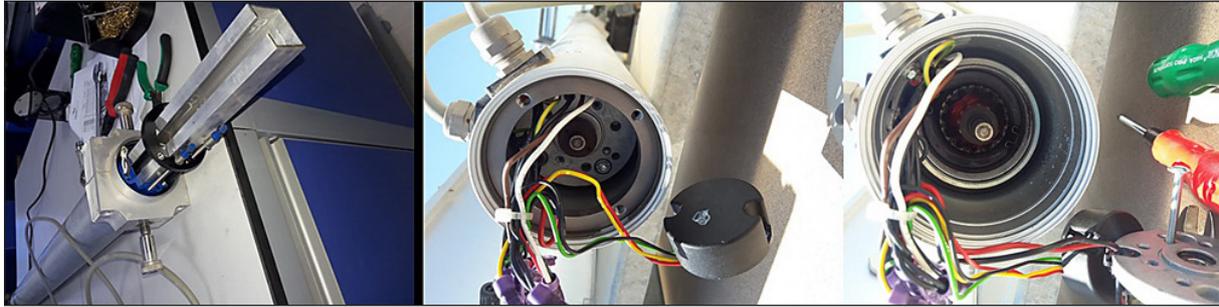
The linear actuator motor was dismantled after being found not to function properly. On inspection, it was found that the motor itself was running but failing to move linearly. All the

constituting elements were then disassembled as shown in Figure 14. Multiple tools were required to take out the gearbox, including a stud (80 cm) to remove the inner bolts; after the cover was removed and all limit switches were dismantled from the linear housing, the electrical motor was separated from the gearbox. A visual inspection was performed for the gear teeth inside the linear actuator gearbox. The gear teeth were found to be broken as shown in Figure 15.

Figure 14. The linear actuator motor after dismantled

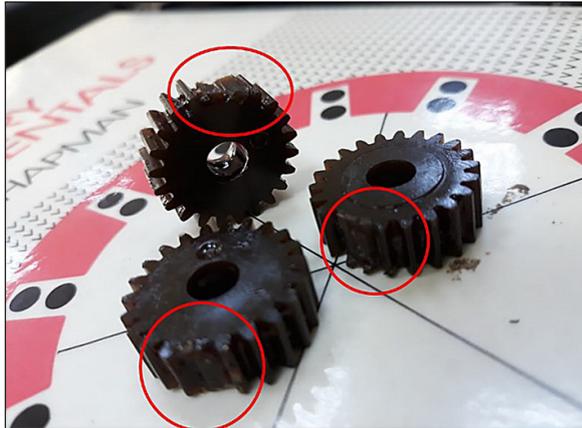
Figure 15. Linear actuator motor Gear-box

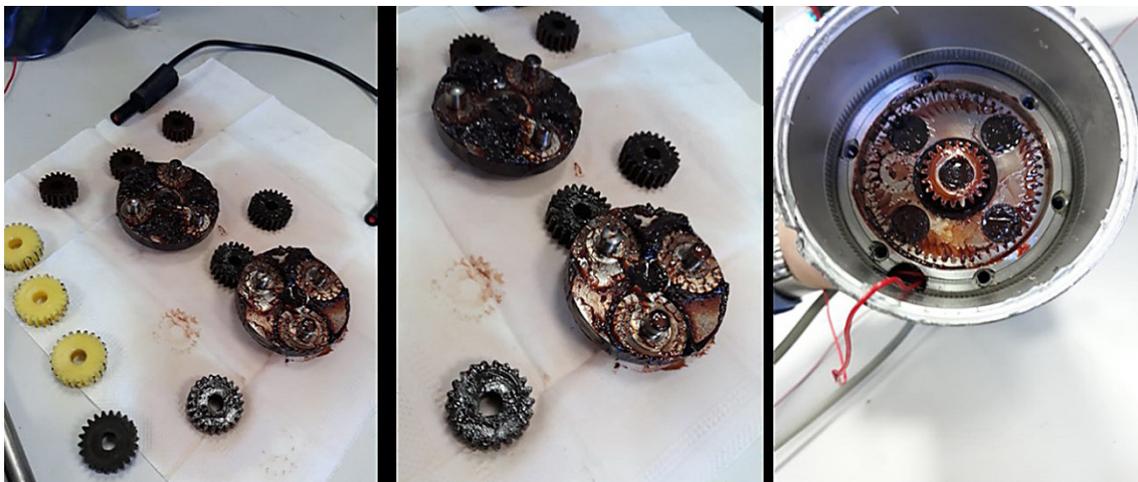
After dismantling the gearbox (containing three layers of gears), one layer was found to include interfaces between the metal and plastic gears. The breakage occurred precisely at these coupled gears. Figure 16 shows an image of the gears in question. An inspection was carried out for gear-fatigue such as cracking or flaking, as well as cracks on the teeth. In one the layers, all of the plastic gears were broken. In order to solve this problem, a lathing machine was to lathe alternative gears using Teflon which were subsequently installed in the gearbox as shown in Figure 16. The new gear-box is marked in yellow. The entire assembly was put together again with all layers greased. A test was then carried out to double check that everything was running smoothly. This

Figure 16. Linear actuator motor Gear-box before and after lathing

was followed by an inspection for the motor bearing (the front and the rear) by using the auditory or tactile test for determining fatigue on the ball bearing such as loose, cracking or flaking. Then a test was carried out on the gearbox with the motor attached. This showed a perfect homogeneity between the motor and the gearbox.

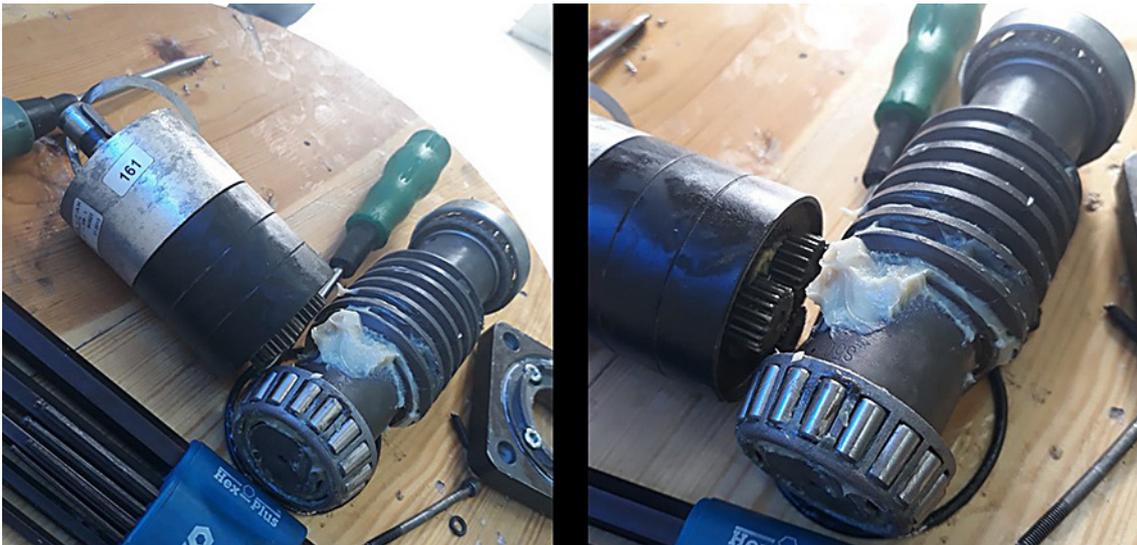
For the circular motion motor, an inspection was done using the auditory or tactile test as

Figure 17. The circular motion motor Gear-box

discussed previously. The problem turned out to be in the attachment between the motor and the gearbox, and was solved by replacing the four coupling bolts, as the old ones were bent. The same test was performed for this motor (as the previous test). This showed that it was now working perfectly. Details are given in Figure 17.
