## HOW TO BRING A BUILDING BACK FROM RUINS

This paper is about the renovation of the baroque palace in Żagań. The journey starts at what was once a Medieval castle and finishes in the XIX century at the villa of Żagań Princes. Now the building is a XIX century villa maintained in a baroque style. The castle was built in the Middle Ages by Silesian Piasts and rebuilt three times, first by prince Wallenstein, then by prince Lobkovic, and finally, in the XVIII century, by princess Talleyrand. It remained the property of a French citizen until the 1960s, with its condition slowly decaying. In 1965, it was almost totally destroyed. Then the first renovation and revitalization works were initiated, lasting almost twenty years. The second renovation took place in the years 2007-2013, co-funded by the European Union. However, as a result of some cost cutting, the palace now requires a further, third approach to renovation.

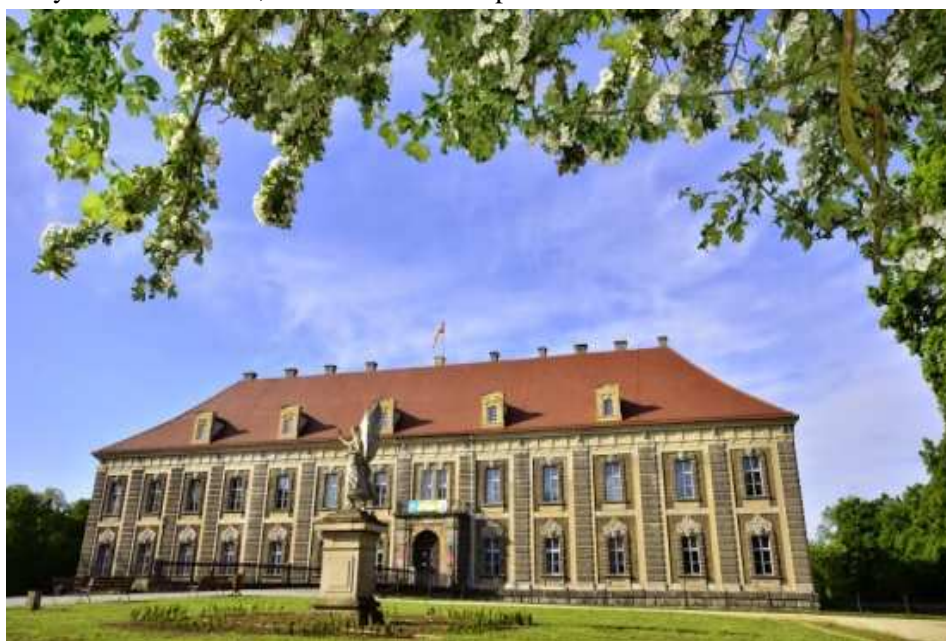
Fig. 1. View of palace from the north (fot. J. Mazur)

The Palace in Żagań is a building that is maintained in the baroque climate. It is currently a XIX-century old estate of Żagań Dukes (Fig. 1). The history of the building is very interesting. Over the hundreds of years of its existence, it underwent three main reconstructions and two renovations. It will soon probably be subjected to yet another, third renovation.

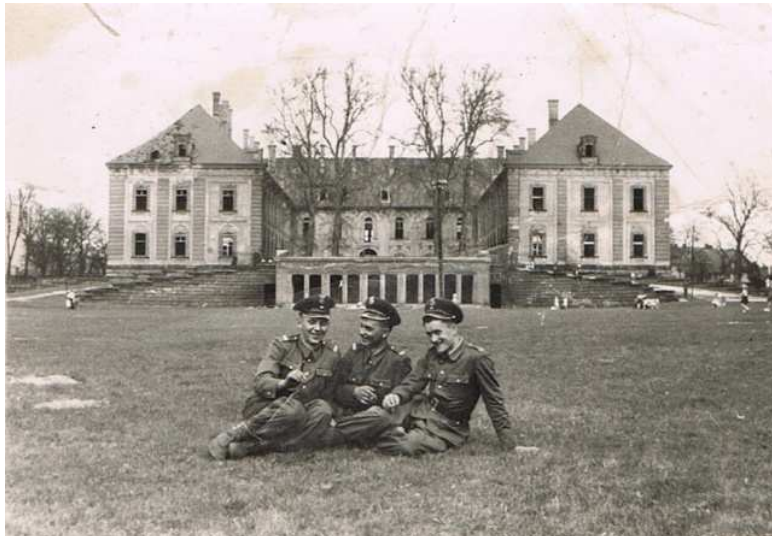
Fig. 3. South elevation of the Palace in Żagań (fot. M. Świątek)

The palace survived the period of the Second World War in relatively good condition, as the Duchy of Żagań continued to belong to France this entire time (Fig. 3).

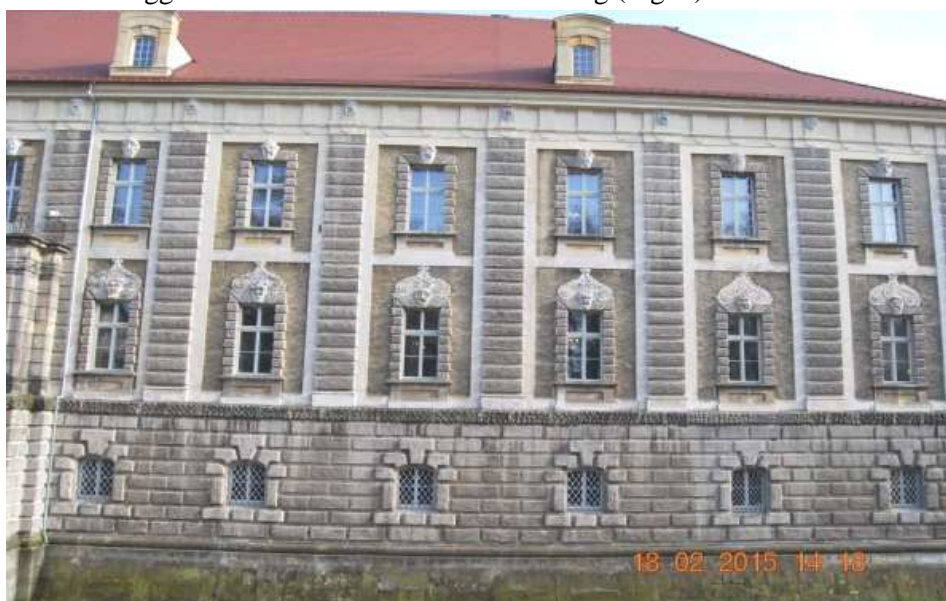
The elevation of the building is in a simple vertical form. It was based on vertical, rusticated selvedges and a pattern of window openings in rusticated frames; their horizontal counterweights are the cornices. The crowning of the decorations are the ornamental reliefs of faces composed into the keystones of the windows and the ornamentation of the crowning cornice. All of these elements suggest the fortress nature of the building (Fig. 4).

Fig. 4. Characteristic elements of the palace façade (fot. W. Sokołowski)

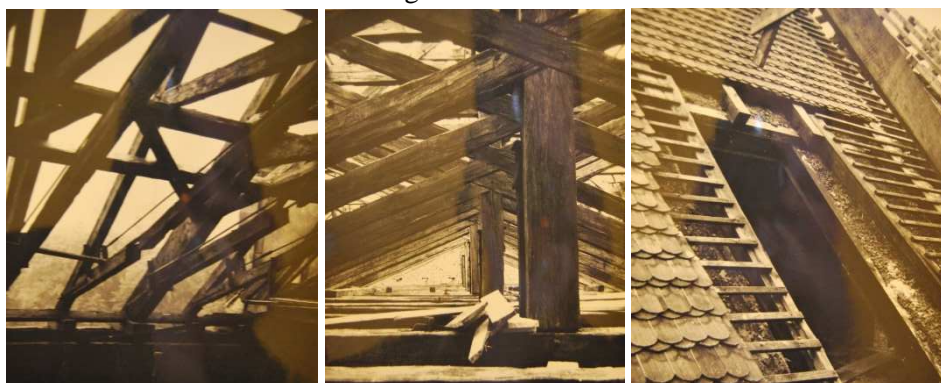
Fig. 5-7. Photographs of the palace roof taken in 1972 (fot. M. Świątek)

During what was almost 20 years, the roof of the palace, which had undergone nearly complete destruction, with the still remaining fragments covered with sheet metal, was replaced (Fig. 5-7). The sheet metal covering was replaced with plain-type ceramic pantiles which lasted until 2007. A new facade was created and the walled-up windows opened up and equipped with new frames and panes. The individual rooms were renovated and adapted to serving as a cultural facility, and a cinema was opened in the palace. Some of the materials used for the decor of the halls were derived from other undertakings of such kind. For example, the materials used to finish the walls of the Crimson Room or the Kurzeme Room were ordered by way of renovating the Wawel castle.

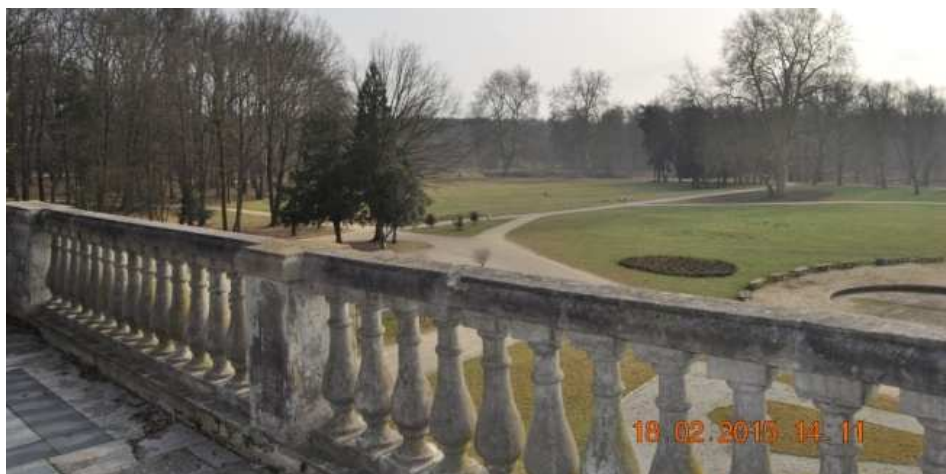
Fig. 8. View of the park following renovation (fot. W. Sokołowski)

The project was co-financed from European Union funds. The revitalization works made use of the above-mentioned design, prepared when Adam Stawczyk was the director. The park was returned to its prior state from the XVI century. Self-sown trees and shrubs were cut down, the old layout of paths returned, and new plantings carried out (Fig. 8).

The park design did not account for lighting, which poses a significant hindrance to its use. Curbs were also not made along the paths of compacted sand, resulting in their erosion and degradation. What is more, the following year, drainage of the paths was carried out improperly by digging up ditches, which damaged the structures of the compacted soil, leading to further degradation of the paths due to the constitutive materials being washed out.

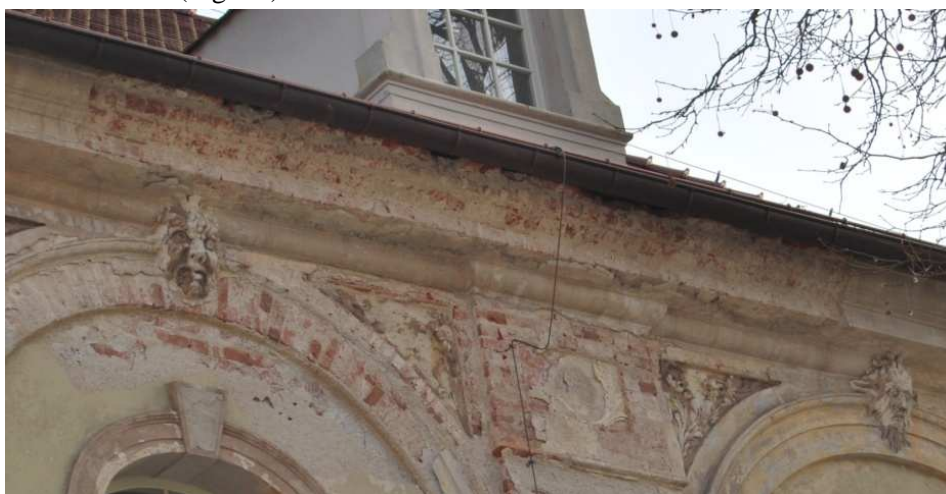
What is more, in the area of the courtyard, the system for draining water from the roof was implemented incorrectly, resulting in water damage to the newly redone facade (Fig. 10).

Fig. 10. Deteriorating east façade (fot. W. Sokołowski)

The many-year renovations carried out on the palace in Żagań have led to its heyday, saving it from the ruins that it had been 1965. However, some of the works were carried out incorrectly (roof drainage system), while failure to complete others (repair chimneys), has led to further deterioration. As a matter of fact, the title of the article ought to read "How to bring a building back from ruins and, once again, attempt to bring it to ruins". Not stopping the progressing deterioration of the facade by redesigning and repairing the system of roof drainage and failure to redo the chimneys can lead to such a situation very quickly. Another important element of the renovation works on this palace is installing a lighting system within the palace-park complex (preferably solar-powered), as well as assessing the effectiveness of the park drainage system and, if possible, bringing the fountains back into use.

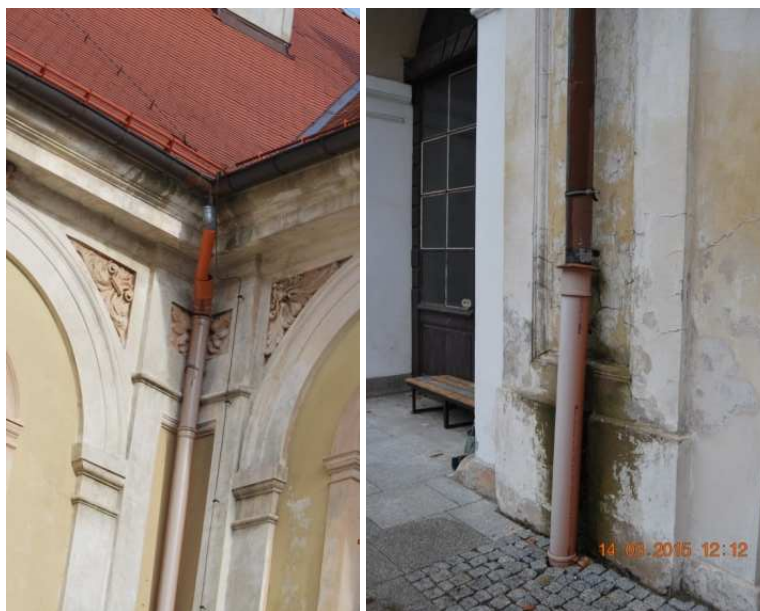
The rainwater pipes were spaced out incorrectly ( $>20$  m), with improper selection of their diameters, which, according to calculations based on the surface of the catchment area, should be between 150-180 mm (Fig. 11). Moreover, the connections of the downspouts with the gutters, as well as their connections to the rainwater drainage system, leave much to be desired (Fig. 12 and 13).

Fig. 12, 13. Existing connections of the downspouts on the east façade  
(fot. W. Sokołowski)
