Assessment of sinkhole hazard in the post-mining area using the ERT method and numerical modeling

Abstract

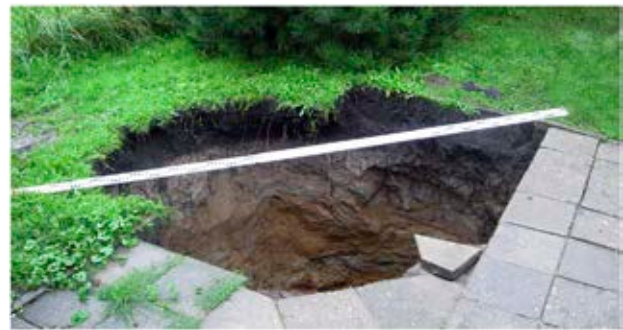
Figure 4. Sinkhole created inside the area of the building plot over the old shallow mining workings

As mentioned earlier, a sinkhole occurred on the building plot near the garage building, affecting a section of the concrete slab pavement (Figure 4). To the west of the plot stands a detached residential building. In 2011, to assess the risk of further

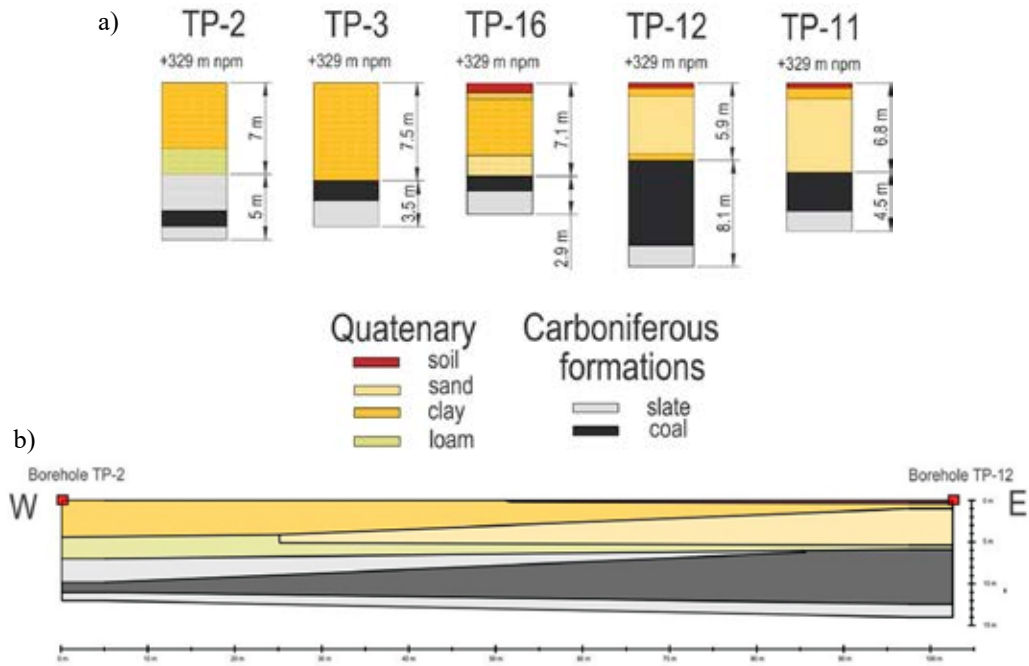
Figure 5. Geological structure of the near-surface layers in the study area (a) lithological profile of borehole: TP-2, TP-3, TP-16, TP-12, and TP-11 – (area of ERT sounding) and (b) geological cross-section W-E

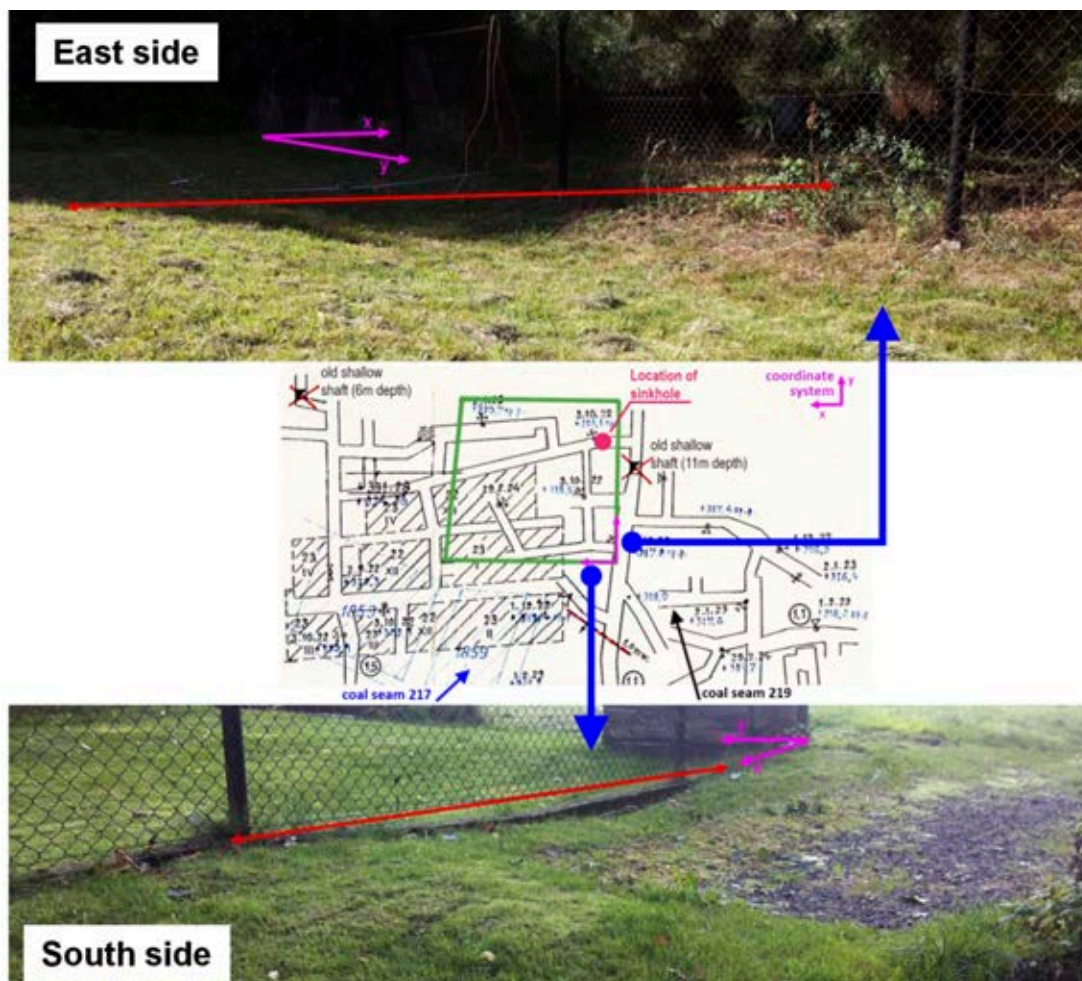
Figure 6. Deformations observed on the surface: micro-subsidence troughs (cover-subsidence sinkholes) near the border of the plot

research, apart from the sinkhole formed in 2010 (Figures 3 and 4), “pseudo-continuous deformations” are currently being created in the southern and eastern boundaries of the plot (Figure 6). They take the form of “cover-subsidence” sinkholes, resembling shallow basins (or micro-subsidence troughs) with a diameter of approximately several meters.

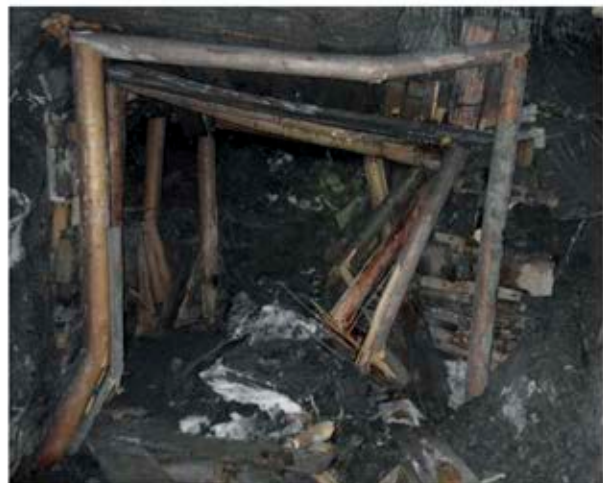
Figure 13. Collapses in the underground gallery caused by damage occurred to the timber support

- A model reproducing the state of the rock mass in the vicinity of an excavation protected by support.
- A model simulating the rock mass in the case of support destruction (in FLAC’s procedure, the removal of elements simulating the support is completed); the model assumes that in the long run, as a result of unfavorable environmental conditions, the timber support is being degraded. This leads to a decrease in its bearing capacity resulting in its total destruction. Such a situation for an exemplary excavation is presented in Figure 13.
