PROBLEMS OF TOURISM DEVELOPMENT OF SEA-COAST ZONES, AS ILLUSTRATED WITH THE EXAMPLE OF USTKA TOWN

Michał Uruszczak

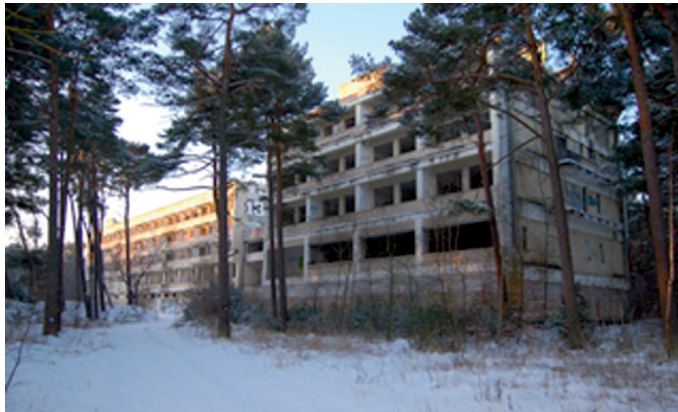
Fig. 3. The “ghost hotel” in Ustka is an unfinished building by Polish Airlines (LOT); here: the view of the seaside part

An unfinished investment project left behind an incomplete building at Wczasowa street, at the end of the seafront promenade. It is a structure that was supposed to be the Hotel of Polish Airlines (LOT). Its construction began in the 1980s. The hotel was supposed to be a modern, state-of-the-art building, in which pioneer heating systems were planned, such as heat pumps, which were a novelty at a time. It was supposed to be equipped with a swimming pool, large conference rooms and an attractive area all around. The construction of the facility was interrupted by the lack of funds in the early 1990s. The condition of the real estate property increasingly deteriorated, from one year to another. Most elements of equipment were stolen or destroyed (windows, radiators, and even tiles were looted). Currently, the building is in private hands, and its poor condition remains unchanged. For a number of years, the changing owners promised to create a water park, casinos, bowling alleys, a marina for yachts and sailboats on the site in question (Fig. 2) [Tomasik 2005]. Unfortunately, none of these promises have been actually made reality [Arszyński 2006].

From the point of view of the development strategy for the city of Ustka, the never finished building of the hotel poses a unique problem. Some of these types of objects can be called “strategic” – that is such for which radical steps must be taken in terms of their purpose, use of the surrounding space, and appearance [Uruszczak 2011]. This is also the case of the said “ghost-hotel” in Ustka, which together with the unused area around it, originally intended for tourism development, discourages walkers, tourists, patients and residents from using adjoining recreational spaces, even if these are correctly arranged. Being located at Wczasowa street, where most of the city’s exclusive hotels are also located, this has become a kind of a negative ad for Ustka town (Fig. 3–5).
