Microscopic methods for analysis of mortars from historical masonry structures

Key words: historical buildings; mortar; microscopic methods.

The objective of this paper was to characterize the microstructure of mortars collected from the walls of thirteenth century buildings. The testing was conducted using transmitted light optical microscopy and scanning microscopy combined with micro-area elemental composition analysis.

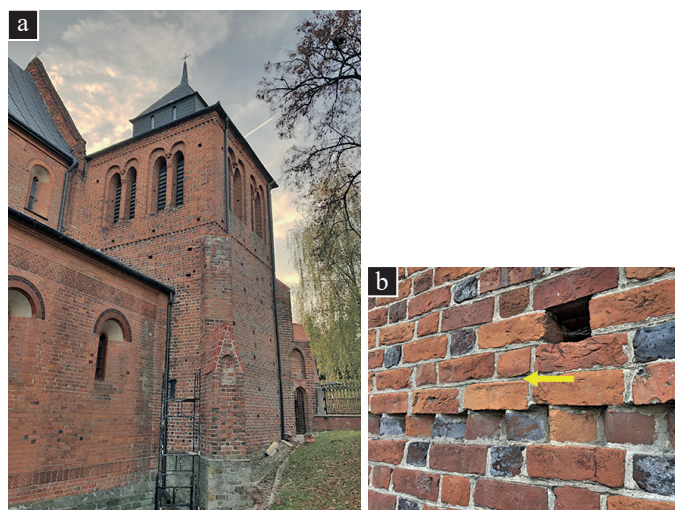
The photograph in Fig. 1a shows a belfry of the Dominican monastery in Sandomierz, added to the western wall of the Romanesque church in the 2nd half of the thirteenth century. The brick structure with a stone plinth has remained unchanged since its erection. Despite its artistic and historic value, it has never undergone any professional conservation. As a result, serious damage has been done to the original bricks and mortar joints. The mortar test samples were collected from the southern external wall at the height of 2.5 m above ground level (Fig. 1b).

Fig. 1. a) Dominican monastery belfry, Sandomierz, 1b) sampling point

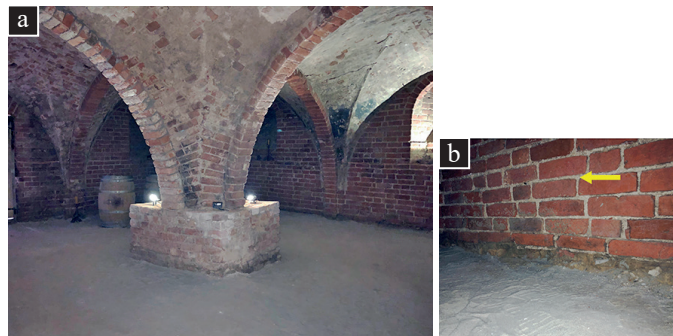
The photograph in Fig. 2a shows the Romanesque cellar of the Dominican monastery in Sandomierz. The rectangular brick structure with a cross vault supported with a central octagonal column is located in the southern part of the monastic foundation. The main structure was erected in the 2nd half of the thirteenth century. Today it is a valuable source of knowledge, providing information of significant importance for the studies of Romanesque architecture.

The mortar samples were collected from the western internal wall, 1 m above the foundation level (Fig. 2b).

Fig. 2. a) Romanesque cellar in the Dominican monastery in Sandomierz, b) sampling point
