Stand tests of a powered roof support after a long time of operation. Case study

Krzysztof Turczyński^{1a}, Jacek Gerlich¹, Jarosław Czubaszek¹, Dariusz Nowaczewski²

¹ KOMAG Institute of Mining Technology, Pszczyńska 37, 44-101 Gliwice, Poland

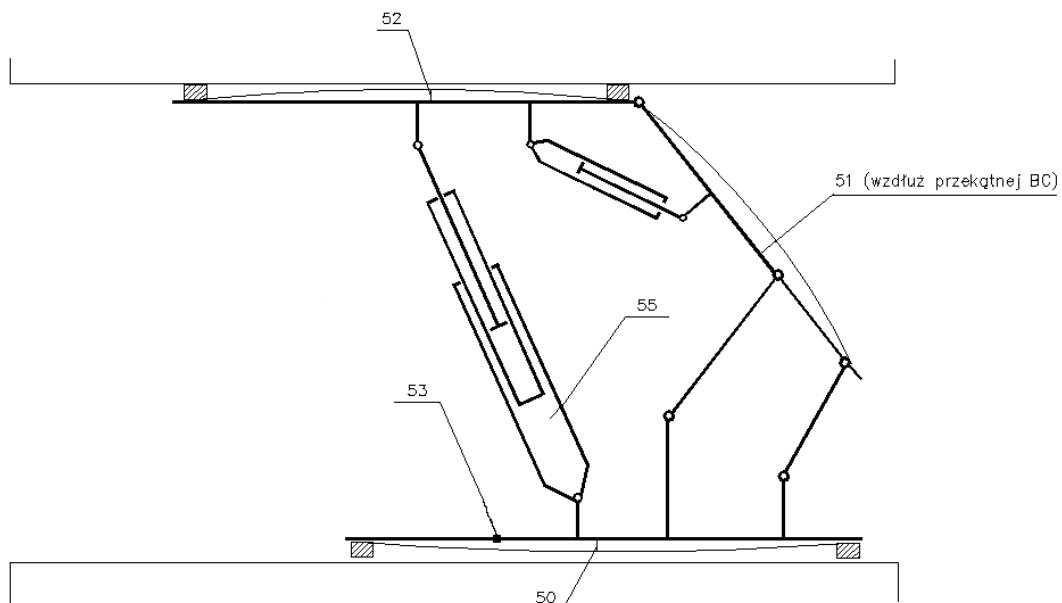
**Fig. 1.** Arrangement of the elastic and plastic deflection measuring points on the tested roof support [7]

Numbers of the measuring points specify the deflection measurement at the place of their location:

50 – base deflection – longitudinal measurements,

51 – gob shield deflection,

52 – canopy deflection,

53 – base deflection – transverse measurements (in a plane perpendicular to the object plane).

Arrangement of the elastic and plastic deflection measuring points on the roof support tested in 2020 is presented in Fig. 1.

Arrangement of the measuring points from Table 7 is shown in Fig.1.

Arrangement of the measuring points from Table 10 is shown in Fig.1.

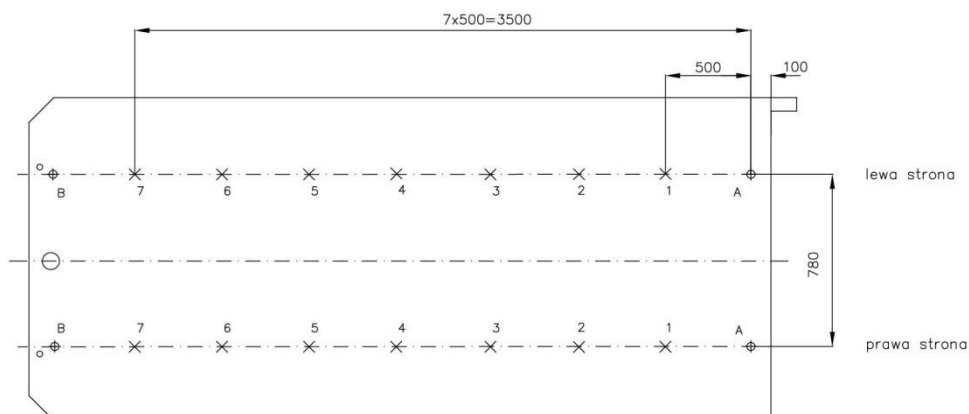
The measurements results of permanent deformations of the canopy (Fig. 2) and the gob shield (Fig. 3) are presented in Table 5 and Table 6, respectively. Measurement of permanent deformation was taken by the method developed at KOMAG Testing Laboratory using the instruments for flatness measurements being at KOMAG disposal [12]. Measurements uncertainty was estimated for the confidence level of 95% and is $U = 0.4$ mm. Measurements of flatness were made just after the roof support delivery and after the tests were completed. Points A and B are the supporting points of the measuring bar. The measuring points are 500 mm apart from each other, starting from the reference point A which is 100 mm from the edge of the tested part. The permanent deformation of the tested part is a difference between the measurements before and after the strength tests, at subsequent measuring points. The sign "+" means that the part is bent upwards, the sign "-" means that the part is bent downwards in relation to the measuring bar.

**Fig. 2.** Arrangement of the measuring points on the canopy: A and B – points of supporting the measuring bar; 1 ÷ 7 measuring point located at left and right side of the canopy [7]

The results of measurements of permanent deformations of the canopy (Fig. 2) and the gob shield (Fig. 3) are presented in Table 8 and Table 9, respectively.

The results of measurements of permanent deformations of the canopy (Fig. 2) and the gob shield (Fig. 3) are presented in Table 11 and Table 12, respectively.

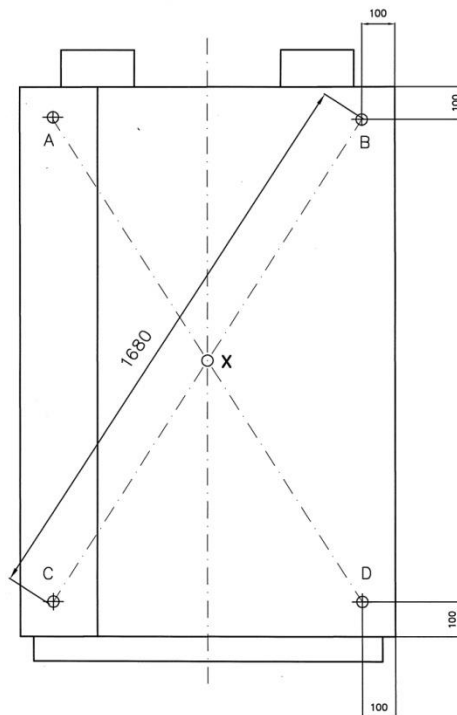
**Fig. 3.** Arrangement of the measuring points on the gob shield:

A, B, C, D - supporting points of the measuring bar; x - measuring point on the shield [7]

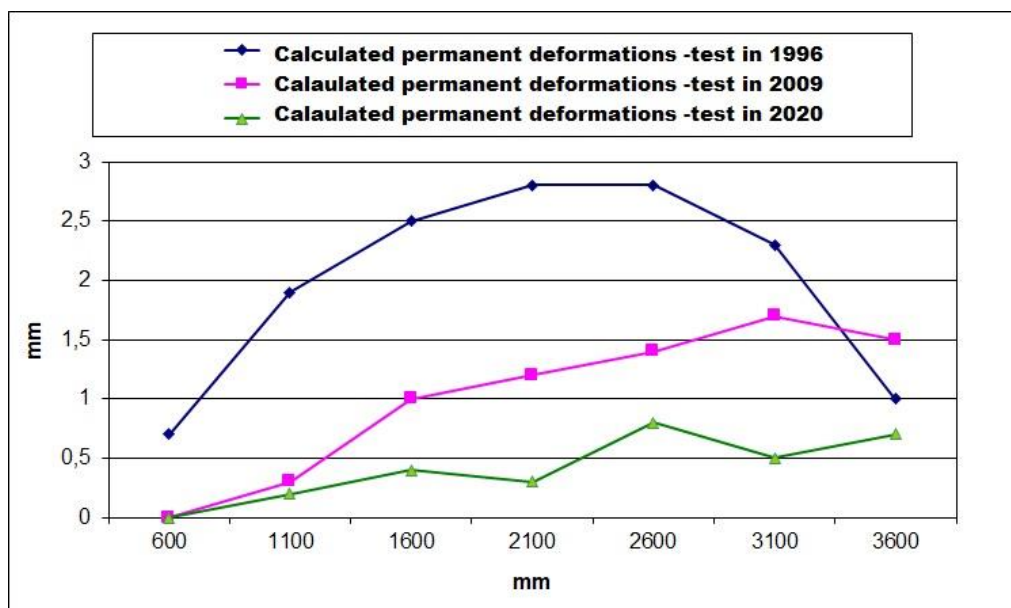
**Fig. 4.** Graph of the maximum permanent deformation of the left side of canopy (own source)

Comparing the deformations presented in Fig. 4 and 5, it has been found that the highest permanent deformation was in the canopy tested in 1996, and the lowest in the canopy tested in 2020. These may, result from the fact that in 1996 laboratory tests were conducted with greater overload required by the regulations (standards) being in force at that time.

In order to analyse elastic and plastic deflection (permanent deformations), the results, included in tables 5, 6, 8, 9, 11 and 12, were presented as graphs of the permanent deformations in a function of distance from the edge of the tested canopy part (Fig.4, and 5), as well as the permanent deformation of the gob shield (Fig. 6 and 7).

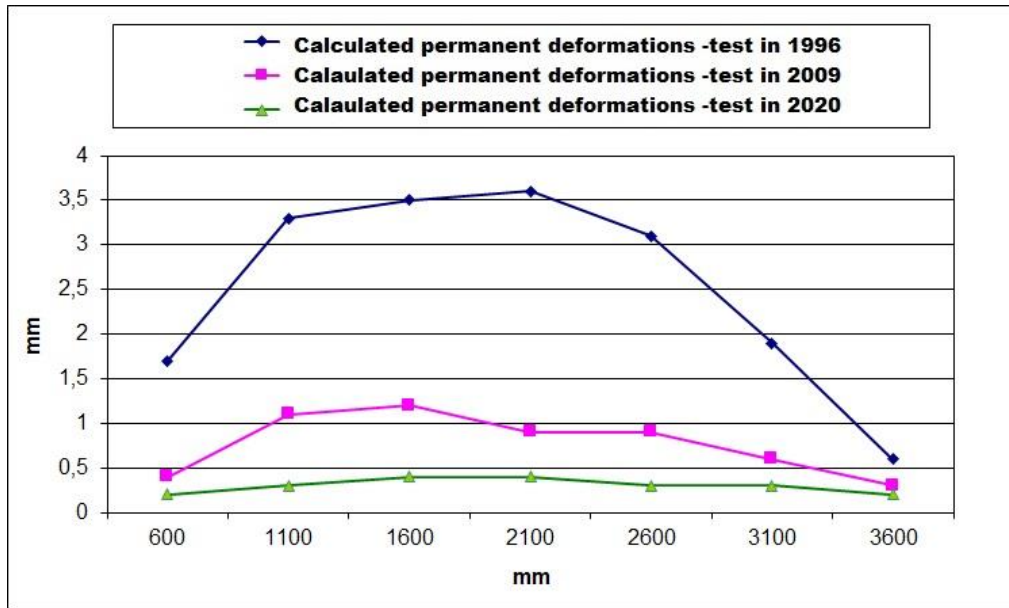
Fig. 5. Maximum permanent deformation of the right side of the canopy (own source)

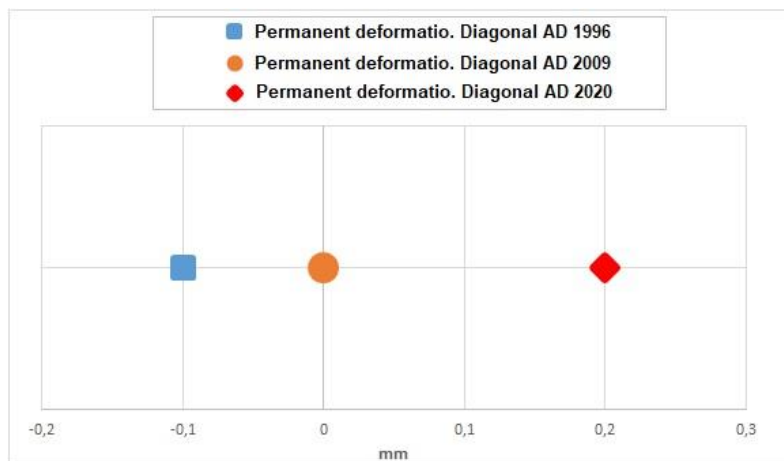
Fig. 6. Maximum permanent deformation of the gob shield – roof support diagonal AD (own source)

On the other hand, when comparing the deformations presented in Fig. 6 and 7, it is noted that the highest permanent deformation of the gob shield, both in the diagonal AD and BC, was recorded during the tests in 2020. Larger permanent deformations of the gob shield can be explained by a significant number of fatigue cycles (approximately 36,000 cycles) applied to the powered roof support over the entire 24-year of service life.

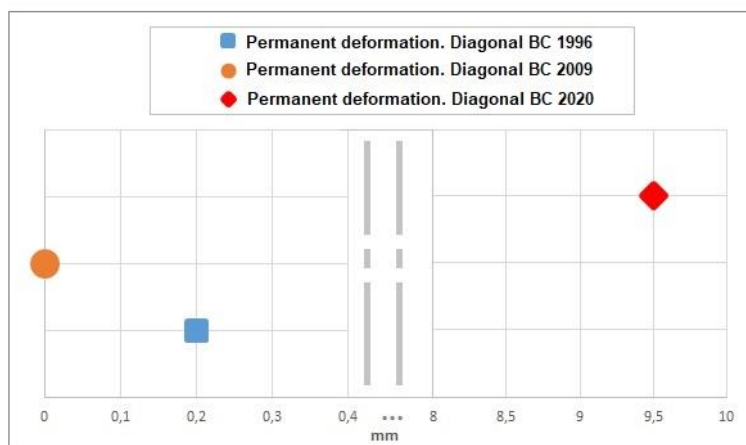
Fig. 7. Maximum permanent deformation of the gob shield – roof support diagonal BC (own source)
