Mateusz Jakubiak*, Ewa Panek*

Small Water Bodies in the Valley of the River Rudawa in Krakow – the Environmental Value**

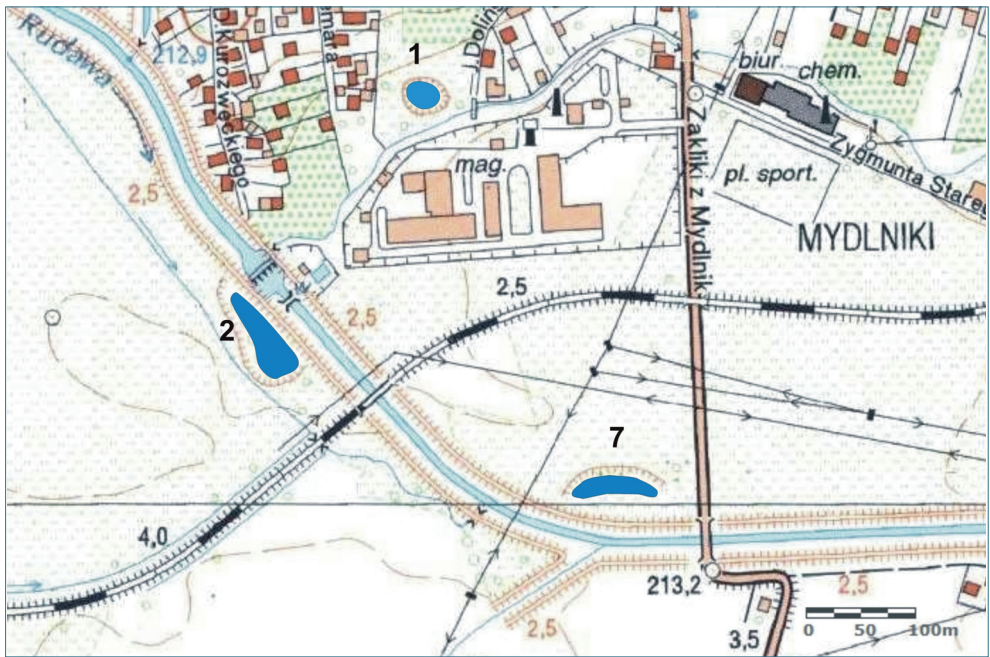
Fig. 1. Location of ponds 1, 2 and 7

The pond in Mydlniki (no. 1) is one of still existent water bodies. This SWB is located between the dried riverbed of Młynówka Królewska and the church in Mydlniki (Fig. 1). The reservoir is partly a natural pond, formed as a result of karst

Pond no. 1 in Mydlniki, between Młynówka Królewska and the church in Mydlniki, is environmentally isolated from the ponds discussed above due to its karst origin as well as distance. Although it is located within the grassland, there are ecological barriers in close proximity to the reservoir. Industrial areas (buildings, parking lots, roads) to the south and fenced building plots surrounding the pond from the north form a territorial barrier. Old willow (*Salix* sp.) and poplar (*Populus* sp.) trees increase the ecological value of the reservoir. The pond requires to be dredged and re-naturalized in order to become a valuable natural site for recreational purposes. The dry riverbed of the Młynówka Królewska is in the close vicinity of the pond. The millrace formerly was the natural connection between waterbodies as the local wildlife corridor.

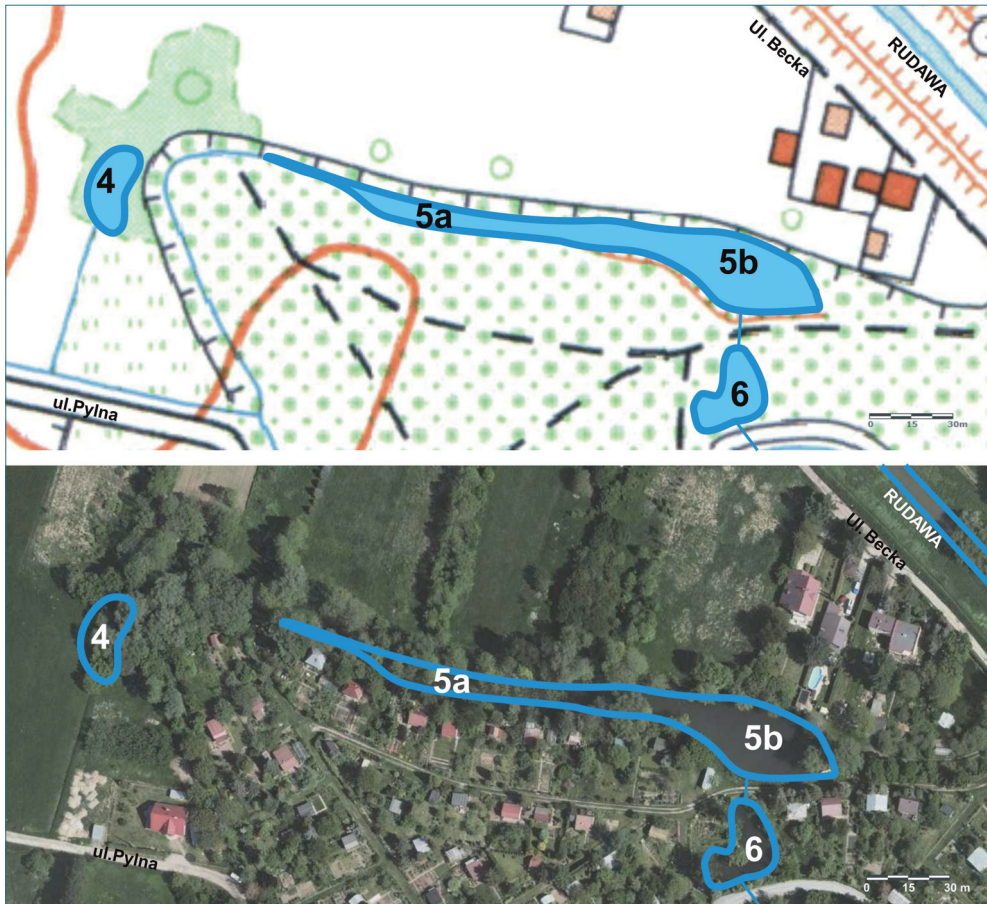
Fig. 2. River Rudawa oxbow lake complex located between Pylna and Beck Streets – location of ponds 4, 5a, 5b and 6

This oxbow lake complex is located between Pylna and Beck Streets (nos. 5 and 6). The largest pond is a central, open water reservoir (no. 5b). The reservoir no. 5a is separated from the open water by a dyke. This natural, old riverbed of the River Rudawa is partially filled with water, but in part, it is only a wetland. The smaller open water pond (no. 6), located entirely within an area of allotments, is also a remnant of a Rudawa oxbow. The pond is connected by a sluice with pond no. 5b. Another sluice, located at Marynarska Street, connects the reservoir with a drainage ditch.

The largest of the existing reservoirs (no. 5, “Oxbow lake of the Rudawa between Pylna and Beck Streets – central pond”) deserves special environmental protection. Characteristics such as: size, depth differentiation and insolation, the developed shoreline, and the shoreline vegetation represented by single, old willows (*Salix* sp.) and bushes, determine its considerable natural value. The water

connection with reservoir no. 6 (“Oxbow lake of Rudawa between Pylna and Beck Streets – east pond”) is also environmentally valuable. The location of the reservoir on a partially fenced area of allotments is convenient for conservation purposes. The western, natural, part of the reservoir requires active protection by deepening and stopping drainage works. Among the most important natural hazards are: anthropogenic destruction and backfill of the eastern part of the pond, in the vicinity of the road (Beck Street), and urban expansion (single-family houses and garden fencing). The previously mentioned infrastructure surrounding the reservoir from the north forms an ecological barrier and may ultimately lead to a loss of natural connection with the River Rudawa wildlife corridor.

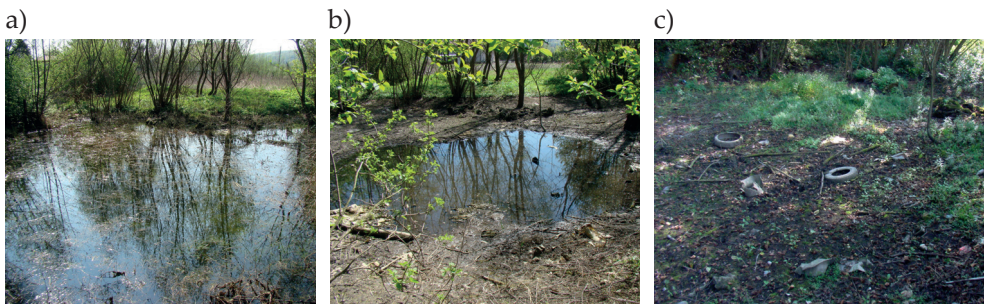
The third of the Rudawa oxbow lakes complex, between Pylna and Beck Streets, (Fig. 3) is now completely dry. Decline of the water table was observed in the years 2009–2012 [1, 16]. The pond was located about 120 m from the present Rudawa riverbed.

Fig. 3. Oxbow lake of the Rudawa between Pylna and Beck Streets – west pond; drying process of the pond in the years: 2009 (a), 2011 (b) and 2012 (c)

Small ponds are especially vulnerable to various forms of anthropogenic pressure [3, 17, 18, 21]. Only three of the ten ponds identified in the article are preserved and permanently filled with water (Tab. 1). Until recently, reservoir no. 4 “Oxbow lake of Rudawa between Pylna and Beck Streets – west pond” was periodically filled with water. Currently, the basin of the pond is shallow, dried and partly backfilled (Fig. 3).

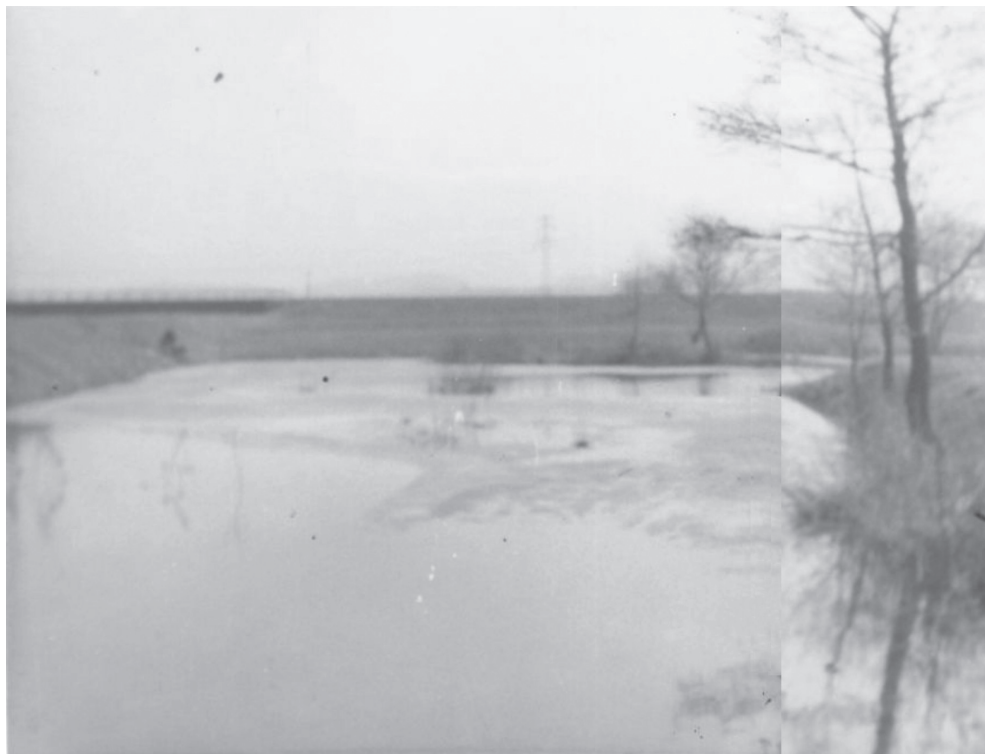
The other, no longer existing, water bodies in the study area are shallowed, dried out (no. 2 – Fig. 4, no. 4 and no. 7) and some have been backfilled (nos. 3, 8, 9 and 10). Until now only the remains of two water reservoirs have been preserved: the previously-mentioned reservoir no. 4 and the shallowed and dried basin of pond no. 9.

Fig. 4. A now non-existent oxbow lake on the right bank of the River Rudawa, near the railway track (no. 2); compilation of two archival photos from the late 60s
