## The impact of precipitation on state of the slopes surface and thermal activity of the mine waste dump – preliminary study

# The impact of precipitation on state of the slopes surface and thermal activity of the mine waste dump – preliminary study

One of the tasks carried out under the TEXMIN project (*The impact of extreme weather events on mining operations*) is to assess the impact of precipitation, especially heavy rainfall, on the condition of slopes of mining waste dumps. The aim of the preliminary studies carried out in the framework of the project was to illustrate the initial state of the tested dumping ground surfaces and the thermal state of selected slopes. The test results are the starting point for the results obtained in subsequent measuring cycles. On their basis, the changes that take place in the studied areas in relation to the occurring water erosion and possible thermal activity will be assessed. Subsequent examination of the surface of the slopes will be carried out after approx. 6 and 12 months from the first measuring cycle. Observations of the atmospheric conditions in the months after the first measurement cycle allowed to determine the occurrence of

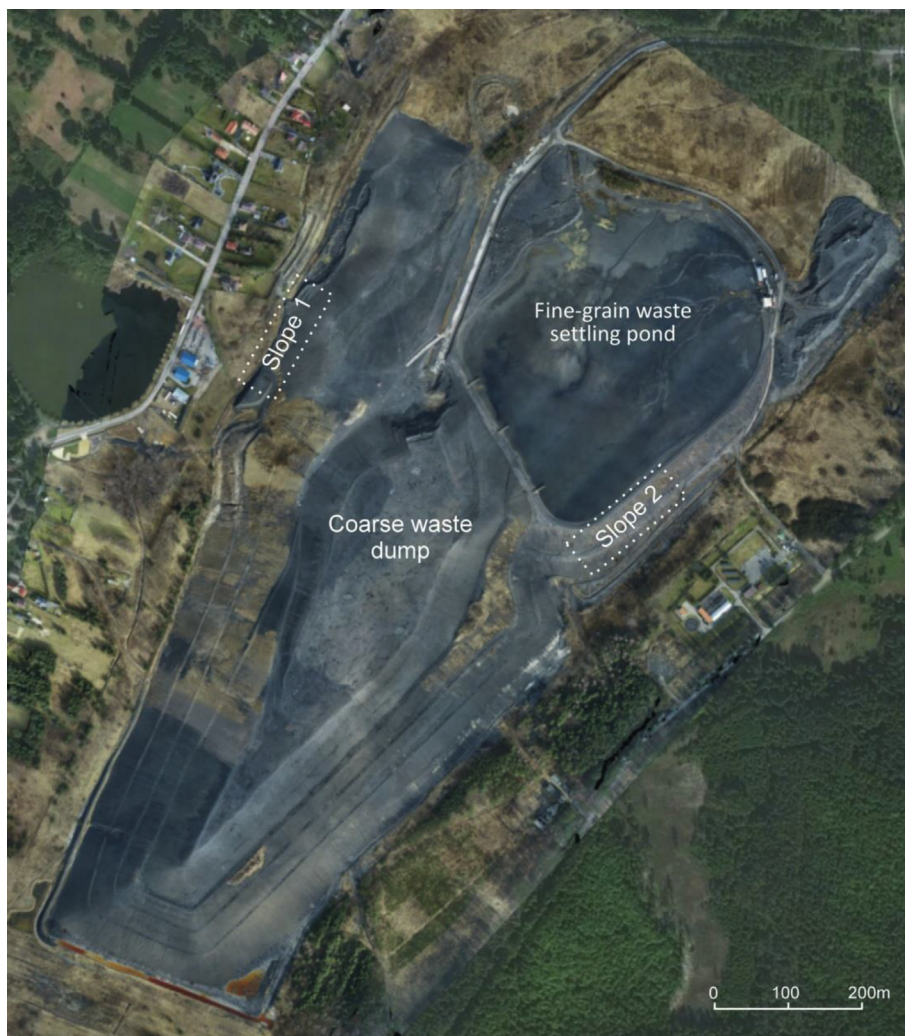
Fig. 1. The ZG Janina TAURON Wydobycie S.A. dumping ground in Libiąż and localization of analyzed slopes.

The subject of the research is the coal waste dump of ZG Janina TAURON Wydobycie S.A. The dumping ground is located in Libiąż. The object has a surface area  $33.51$  ha, and the storage capacity is approx.  $6$  million  $m^3$  (approx.  $11$  million Mg). This is an above-ground dump and contains two parts (Fig. 1):

- fine-grain waste settler along with bunds made of coal gangue,
- coarse waste (gangue) dump.

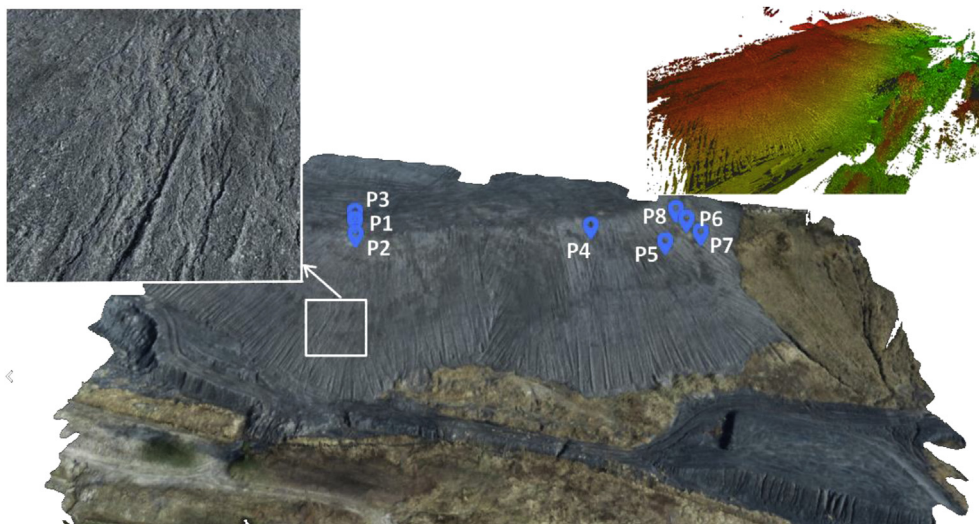
Fig. 3. Slope 1 model obtained by photogrammetry with the location of measurement points. The cloud of points obtained by TLS (top right corner).

The additional flights made over the slopes of Slope 1 and Slope 2 allowed for a more accurate representation of their geometry (Figs. 3 and 4). Since the photogrammetric flights over the slopes took place at a lower height, the density of the point cloud obtained for the examined slopes was 2 838 points per square meter and the size of the terrain

The result of TLS are also point clouds representing the geometry of both slopes. The point density and the accuracy of their location are greater than in point clouds obtained with the low-ceiling photogrammetry method. The mean point cloud density was 57 513 points per square meter. Examples are also presented in Figs. 3 and 4. The

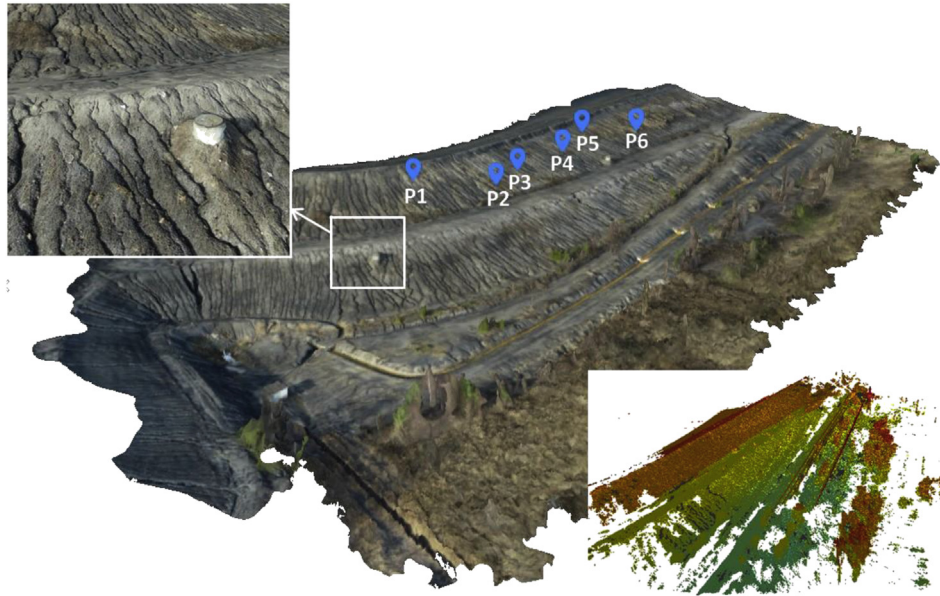
Fig. 4. Slope 2 model obtained by photogrammetry with the location of measurement points. The cloud of points obtained by TLS (bottom right corner).

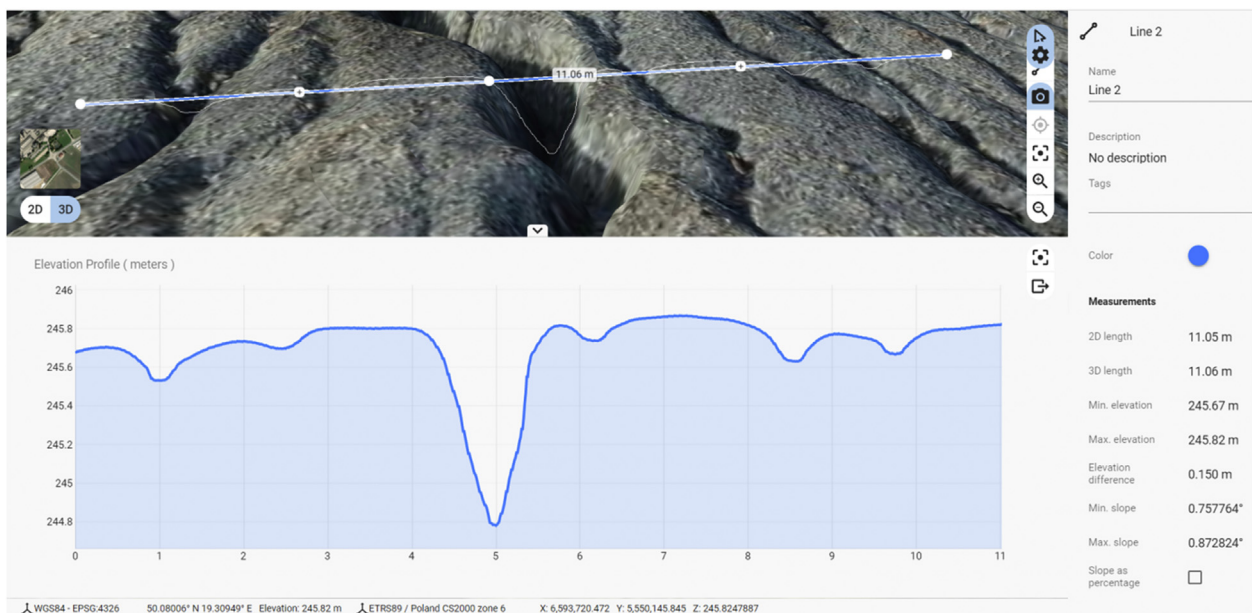
Fig. 5. Profile of a selected erosion gully on Slope 2.

pixel in the 3D model was 6.9 mm. The 3D models of both slopes allow for the analysis of their surface condition in terms of water erosion development. For a specific initial state, individual erosion gullies can be observed in detail on the models. It is possible to determine the length, width, depth and profile of the cross section along any line (Fig. 5). Numerous erosion gullies, especially on Slope 2, have been found. The largest of them were up to 1.0 m deep.

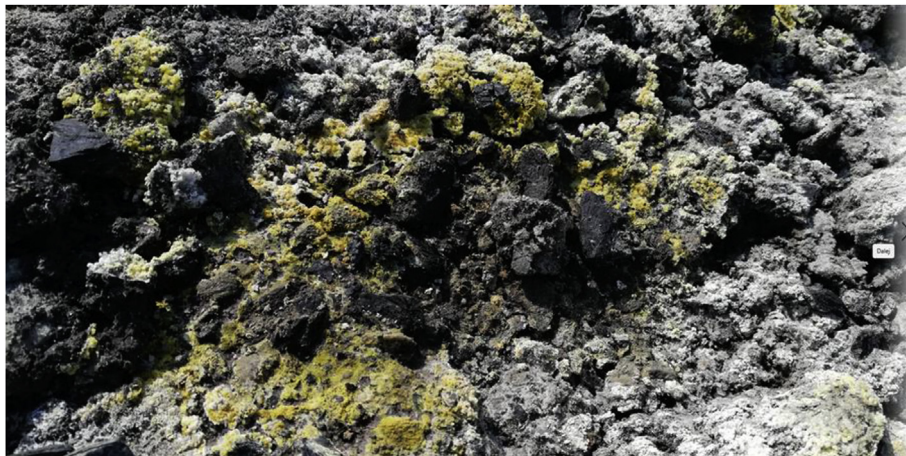
Fig. 8. Efflorescences of sulphur (yellow) and salammoniac (white) on the surface of Slope 1 in Zone 2.
