ADAPTATION OF THE SOUTH-WEST WING OF COLLEGIUM CHEMICUM OF ADAM MICKIEWICZ UNIVERSITY IN POZNAŃ FOR STORAGE FACILITIES

Jacek ŚCIGALLO¹

Poznan University of Technology,
Faculty of Civil and Environmental Engineering, Poznań, Poland

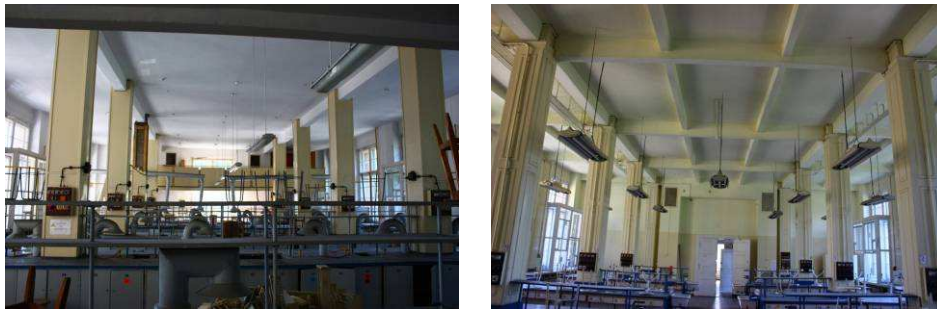
Fig. 4. The floor slab structures: over the ground floor (left) and over the 1st floor (right)

The structure of the first three floors, (basement including) consists of two eight-span, reinforced concrete frames of a longitudinal shape (Fig. 4). Monolithic ceiling beams are based on internal, reinforced concrete columns and external masonry gable walls. Monolithic, ribbed floor slabs are made of structural clay tiles. The structural thickness of floor slabs are: 0,21 m over the ground floor and 0,18 m over the basement and over the first floor. Precast concrete slabs of the basement and the ground floor are constructed as continuous, three-span slabs. The supports are provided by internal longitudinal main beams connected monolithically to the floor slab, as well as by external longitudinal masonry walls. Precast concrete slabs of the first floor rest on longitudinal beams and on internal steel beams between reinforced concrete beams.

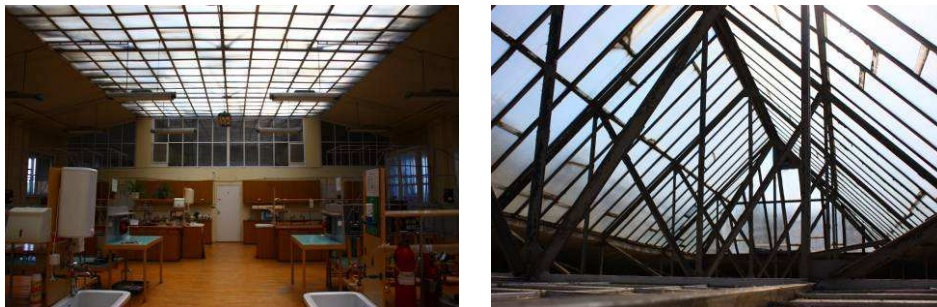
Fig. 5. The steel structure of the flat roof: the glass suspended ceiling (left) and truss girders in the transverse layout (right)

The last, fourth floor, i.e. attic, is covered in a transverse direction with a light steel truss (Fig. 5). Steel roof girders function as roof skylights, which provide light to the attic. A glass suspended ceiling was fastened to the bottom chords of the roof trusses. A gable, steel, roof trusses are based loosely on masonry pillars between windows in the longitudinal exterior walls.
