ULTRASONIC WAVES AND STRENGTH REDUCTION INDEXES FOR THE ASSESSMENT OF THE ADVANCEMENT OF DETERIORATION PROCESSES IN TRAVERTINES FROM PAMUKKALE AND HIERAPOLIS (TURKEY)

ALICJA BOBROWSKA, ANDRZEJ DOMONIK

University of Warsaw, Faculty of Geology, Department of Geomechanics, Warsaw, Poland.
E-mail: a.bobrowska@uw.edu.pl; a.domonik@uw.edu.pl

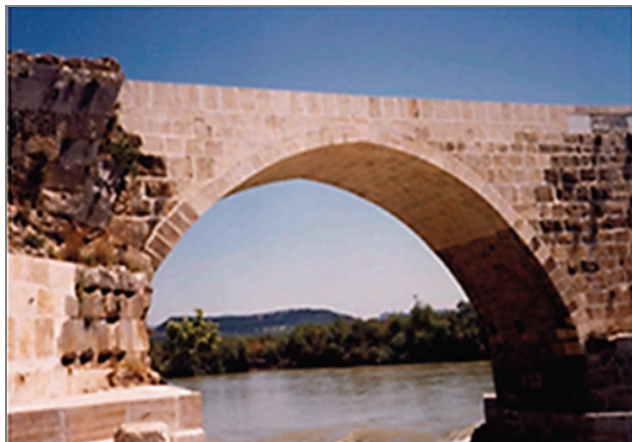
Fig. 1. Present-day use of travertine in the renovation of historical engineering objects – Belkis bridge (Turkey) (photo by J. Pinińska)

Travertines represent carbonate rocks which, despite high porosity, were used as the main constructional material in antique structures of the Mediterranean area that have survived till present. As light building stones, they are also commonly applied as facing material in every climatic zone. Moreover, this material is used in the renovation of historical objects that have been destroyed over time (Fig. 1).

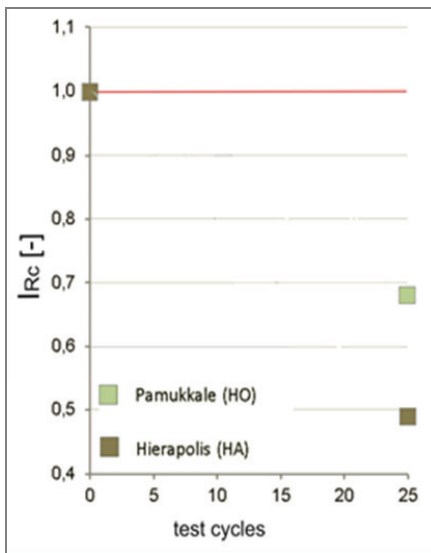
Fig. 3. Strength reduction index I_{Rc} after the impact of frost

Comparison of the I_{Rc} and I_{Vp} indexes, assuming that the material that was not subject to deterioration is characterized by the value $I = 1$, clearly indicates that the largest resistance changes take place after the impact of frost, particularly in the weathered travertine from Hierapolis, where the strength reduction index (I_{Rc}) is low and reaches 0.49. In this sample the lowest I_{Vp} index value is equal to 0.65. The stone material from Pamukkale is characterized by much higher resistance to frost, because the I_{Rc} index averagely reaches 0.68. Such high resistance is reflected in the analysis of the ultrasonic waves index I_{Vp} with values at 0.84. Low resistance of weathered travertine to the impact of frost in relation to material without seasoning is distinct on the correlation diagrams of I_{Rc} and I_{Vp} indexes (Figs. 3, 4).

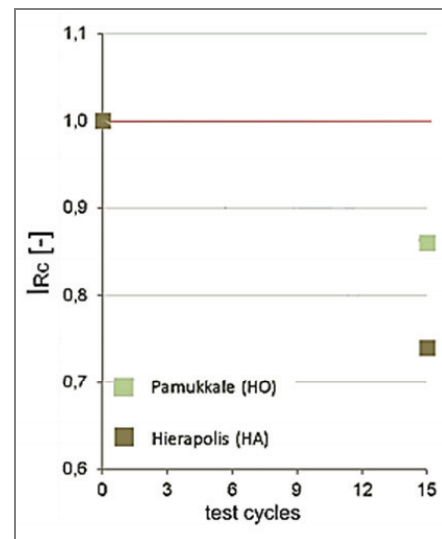
Fig. 5. Strength reduction index I_{Rc} after the impact of temperature oscillations (insolation)

Resistance prediction based on comparison of the relationships between the two indexes I_{Rc} and I_{Vp} , graphically presented in Figs. 5 and 6, indicates that resistance changes may proceed nonlinearly in the initial stages of insolation. Ultrasonic diagnosis of deterioration processes in conditions when the rock skeleton dilates as a result of increased temperature is thus more correct for the final stages of deterioration.

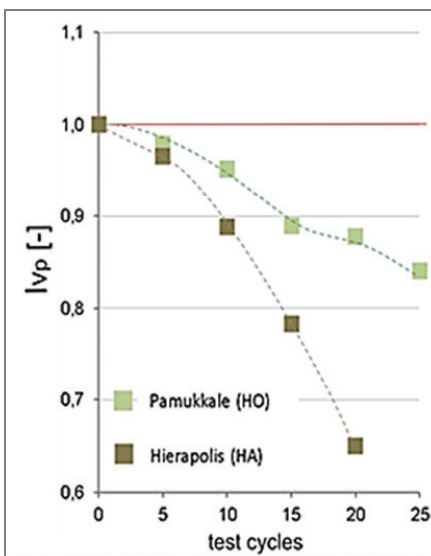
Fig. 4. Ultrasonic waves index I_{Vp} after the impact of frost

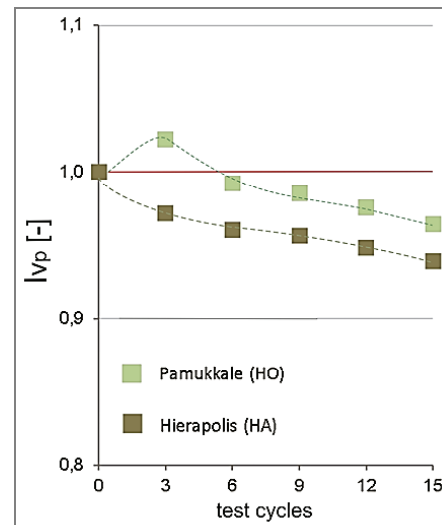
Fig. 6. Ultrasonic waves index I_{Vp} after the impact of temperature oscillations (insolation)

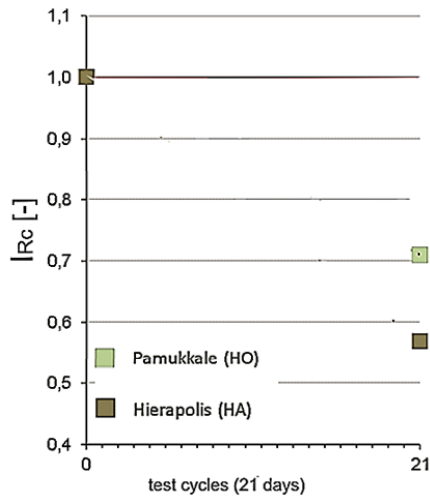
Fig. 7. Strength reduction index I_{Rc} after the impact of SO_2 in the presence of humidity

Comparison of the I_{Rc} and I_{Vp} indexes on graphs indicates significantly high diagnostic precision of ultrasonic analyses for forecasting the resistance changes during the impact of SO_2 (Figs. 7 and 8).

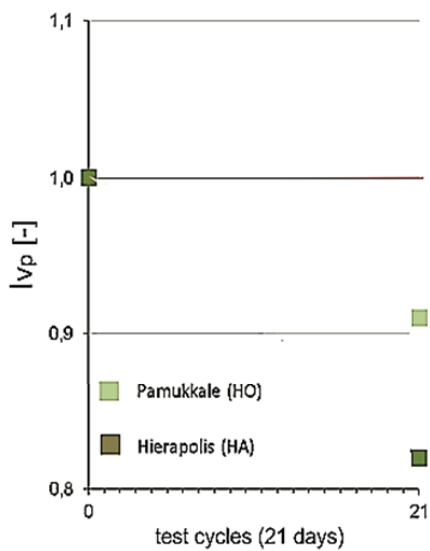
Fig. 8. Ultrasonic waves index I_{Vp} after the impact of SO_2 in the presence of humidity

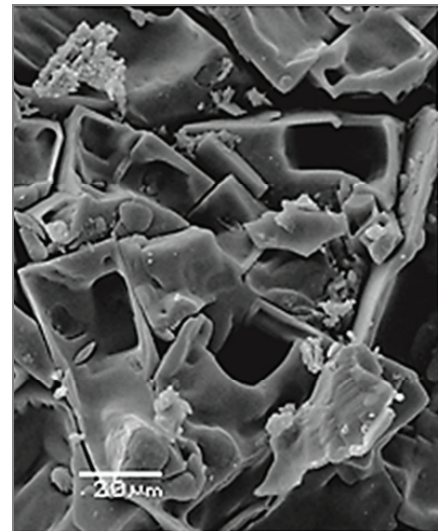
Fig. 9. Travertine pore spaces filled due to soil crystallization from solutions in the travertine from Hierapolis (with highest primary porosity)

Assessing resistance changes based on the I_{Vp} index caused by the impact of salt crystallization can be misleading, because, as indicated above, the velocity of the elastic wave registered in the initial stages of seasoning increases due to the infilling of intergranular voids by the crystallizing soil (Fig. 9).

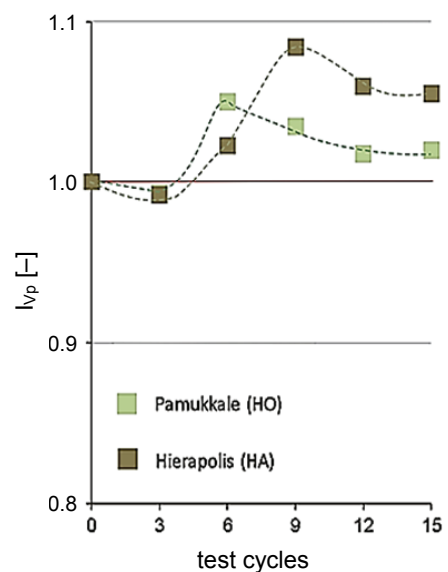
Fig. 10. Advancement of deterioration reflected in the ultrasonic waves index I_{Vp} after the impact of salt crystallization

The investigations show that after the impact of soil crystallization, the I_{Rc} index varies from 0.79 for the material from the active quarry (Pamukkale) to 0.68 from the material from a quarry active in ancient times (Hierapolis). Despite this, the values of the I_{Vp} index are equally high and reach 1.02 for the travertine from Pamukkale and 1.06 for the travertine from Hierapolis, respectively. Comparison of changes of the I_{Vp} index values in relation to the I_{Rc} index, based only on point resistance measurements, are not diagnostic enough for the structural transformations taking place in the macroporous material (Figs. 10 and 11).

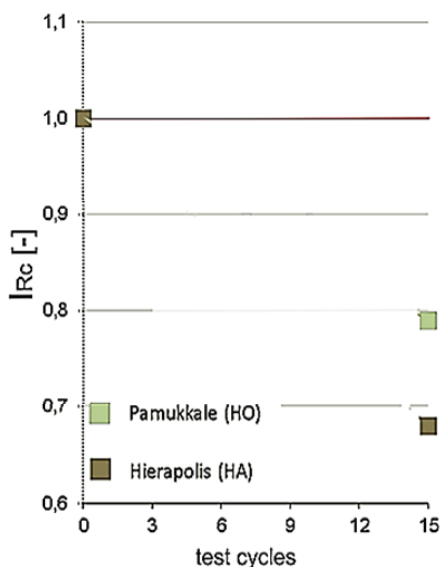
Fig. 11. Strength reduction index I_{Rc} after the impact of salt crystallization
