TOMASZ EUGENIUSZ MALEC

Faculty of Architecture, Civil Construction and Applied Arts, Academy of Silesia, Poland
Architecture Program, International University of Sarajevo, Bosnia and Herzegovina;
e-mail: tomasz.malec1@gmail.com; tmalec@ius.edu.ba

A BRIEF HISTORY OF THE RESTORATION OF THE THEODOSIAN WALLS BEFORE THE TWENTY-FIRST CENTURY

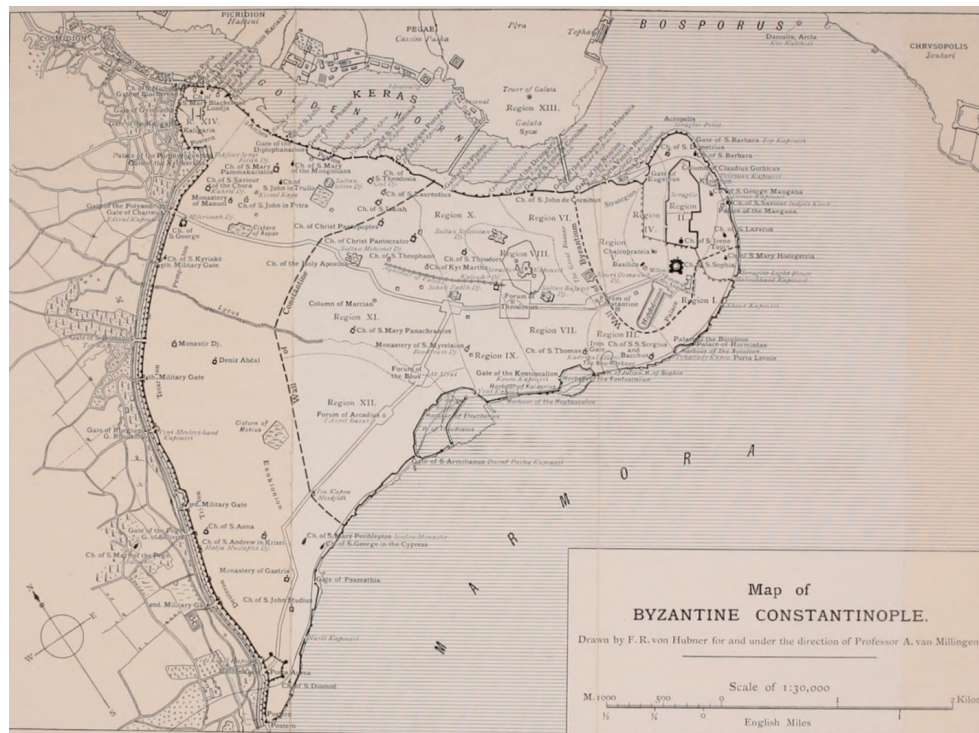
Figure 1. Map of Byzantine Constantinople with the Theodosian Walls (on the left).
Source: F. R. von Hubner, 1899, map, from Van Millingen, A.: Byzantine Constantinople, the Walls of the City and Adjoining Historical Sites. London: J. Murray.

During the rapid development of Constantinople in the second half of the fourth and early fifth centuries, the demand for a new urban space increased. However, the main reasons for the development of the defensive system were the increasing problems of the Western Roman Empire, namely the threat of invasion by barbarians including the Huns. The construction of new walls under the supervision of Flavius Anthemius, a prefect of the Praetorian Guard, began approx. 2000 m west of the existing walls of Constantine, and was finally completed during the reign of Theodosius II (408–450) (Figure 1).

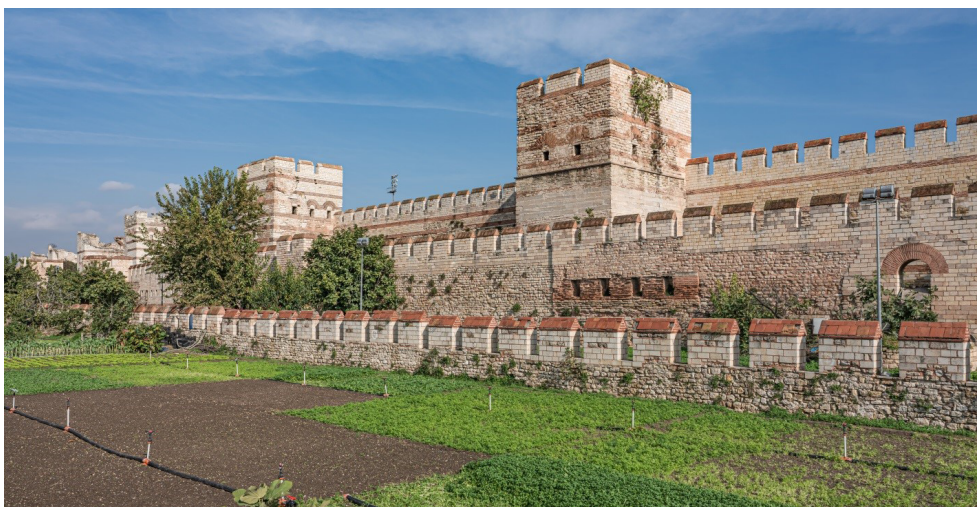
Figure 2. Three lines of fortifications of the Theodosian Walls with crenellation after the recent restorations.
Source: A. Savin, 2021, retrieved 04.20.2023 from www.upload.wikimedia.org/wikipedia/commons/4/49/Istanbul_asv2021-11_img65_Walls_of_Constantinople.jpg.

On the land, the Theodosian Walls consisted of three lines of fortifications, separated by spaces serving as communication areas (Figure 2). The strongest and most important line of defense was the inner wall, strengthened by the defensive towers. Its height was between approx. 9.50 m above exterior ground level and ca. 12 m within the city, including the battlements, whose external faces were approx. 1.5 m high. The main line of the land walls included 96 towers rising above their blanks, divided into two chambers, and positioned approx. 50 m apart. Their height was approx. 18 m [3]. In the main line of the walls, there were 10 gates, five known as 'military gates' and five public ones, including the Golden Gate, which served as the main gate to Constantinople.

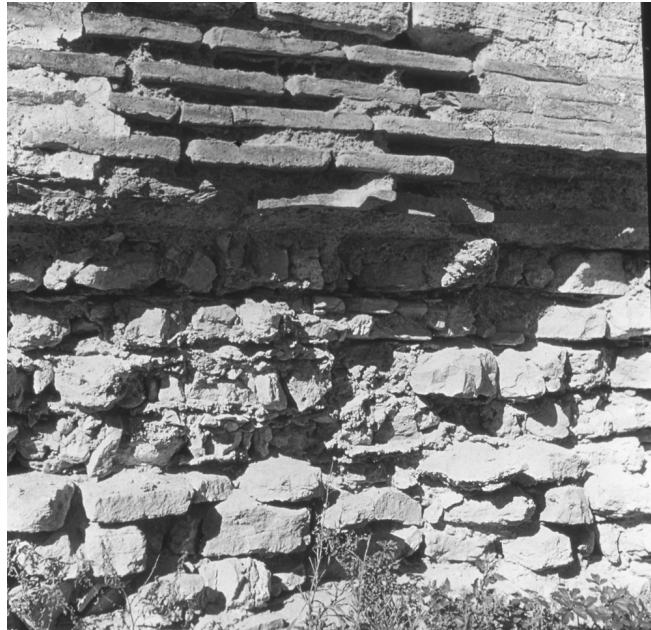
Figure 3. Detail of masonry and brickwork.
Source. N. V. Artamonoff, n.d., photograph, Image Collections and Fieldwork Archives,
Dumbarton Oaks, Trustees for Harvard University, Washington, D.C. Licensed under CC BY-NC-SA 3.0 IGO.

The walls were built using a mix of bricks and stones (Figure 3). Masonry stones interspersed with strips of red bricks ca. 35 cm in size and approx. 5 cm thick are visible in the facade. The bricks were likely produced in situ during the construction process. Inside the walls, in places corresponding to the visible location of the stones on the external elevation, debris was mixed with mortar. However, the red bricks are located in layers across the width of the wall. Importantly, the towers of the main line of the walls were constructed in the same manner and from the same materials, but probably because of the threat of earthquakes, they are detached from the walls as separate structures. However, it should be underlined that the first large-scale repair work took place in 447, shortly after the earthquake that damaged a large section of the walls, including the towers [4].

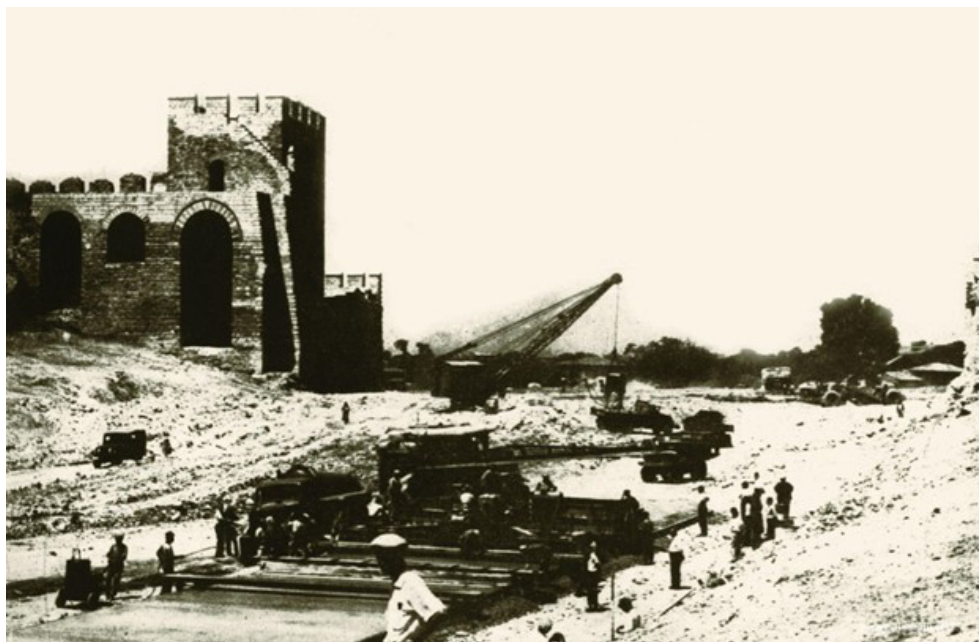
Figure 4. The concrete mixer pouring 25 cm thick concrete at the beginning of Millet Caddesi between Towers 60 and 61. Source. Unknown author, photograph, from Gül, M.: Urban planning operations and their background in Menderes period in Istanbul. In *History of Istanbul from Antiquity to 21st Century*, vol. 9 [online]. www.istanbultarihi.ist, 2000 [retrieved 04.05.2023, 12:20 CET]. Accessed at www.istanbultarihi.ist/715-urban-planning-operations-and-their-background-in-menderes-period-istanbul.

passes to the north of the Romanus Gate between Tower 71 and 73, causing a loss of 60 meters in length of the body wall in this area and of Tower 72. Moreover, the construction of Millet Caddesi, one of the main boulevards in Henri Prost's urban plan [7], entirely destroyed the body wall between Towers 60 and 61 (Figure 4). Another smaller motorway, Fevzipaşa Caddesi, did not pass through the land walls when it was originally constructed, but eventually, it was extended and connected with the outer roads in the years 1983–1989 [8]. Most of the moats became undetectable due to them being filled with debris caused by the construction of the new roads [9].

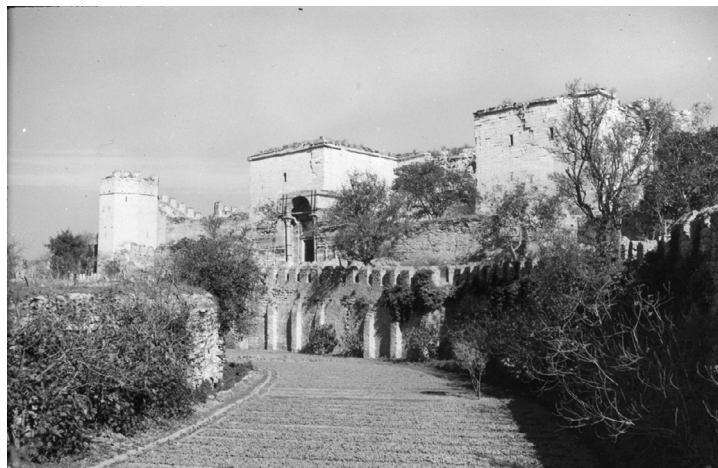
Figure 6. Golden Gate (Porta Aurea) viewed from the southwest; state from 1939.
Market garden in the moat near Yedikule and the Golden Gate.
Source. Unknown author, 1939, photograph, Image Collections and Fieldwork Archives, Dumbarton Oaks, Trustees for Harvard University, Washington, D.C. Licensed under CC BY-NC-SA 3.0 IGO.

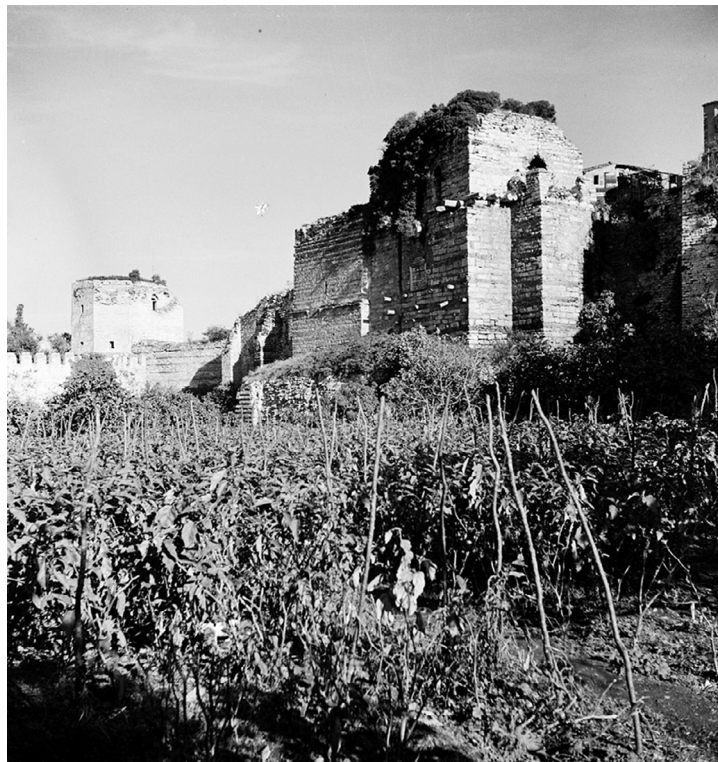
Figure 7. The tower of Isaac Angelos and the lower section of the Blachernae walls from the southwest. Market garden, possibly planted with eggplants.
Source. N. V. Artamonoff, 1936, photograph, Image Collections and Fieldwork Archives, Dumbarton Oaks, Trustees for Harvard University, Washington, D.C. Licensed under CC BY-NC-SA 3.0 IGO.

Since at least 2016, problems have also been visible in relation to new constructions of the walls and in the landscape architecture design of their foreground, which does not follow the general shape of the walls. Some of the bostans (Figure 7) – vegetable gardens established by a local community in the surroundings of the walls, a feature also known from Hama in Syria – were damaged and turned into recreational areas. Moreover, a fast increase in car traffic close to the walls is negatively affecting their technical state and touristic value. Therefore, potential intervention in the development of green areas should be based on proper recognition of the abiotic factors (including high temperature, soil drought, lack of oxygen, excess heavy metals, the salinity of the substrate, nutrient deficiency, alkalization or acidification of the substrate, and the coating of snow or ice), biotic ones (very small or an overcrowding density of trees and shrubs, lack or excess of soil microorganisms, plants, and parasites), and anthropogenic factors, such as the above-mentioned industrial and traffic pollution, soil compaction,
