Application of PiCUS® Sonic Tomograph 3 in studies on the cultural heritage of the Lublin region – restoration of the Eastern Orthodox church of the Dormition of the Blessed Virgin Mary in Uhrusk

Abstract: *Application of PiCUS® Sonic Tomograph 3 in studies on the cultural heritage of the Lublin region – restoration of the Eastern Orthodox church of the Dormition of the Blessed Virgin Mary in Uhrusk.* Uhrusk is a small town located in eastern Poland, in the Lublin region, along the border river, the Bug. The temple is situated on the outskirts of the village, on a low hill, where there was a castle founded by prince Daniel Halicki in the Middle Ages. The Orthodox church existed here before 1220, and for the first decades of its functioning it had the status of a council. Today, the existing church building was erected in 1849 as a Greek Catholic temple founded by the owner of local estate, Laura Kirsztejnowa. In 1915, the church was abandoned when the Orthodox residents of Uhrusk became refugees. In the years 1920–1927, it was renovated, due to significant losses suffered during the First World War and the Polish-Bolshevik war. The building was open again from 1920 to 1947, after

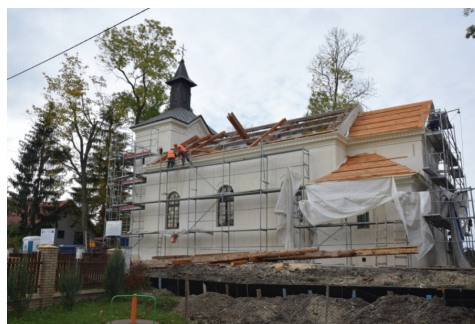
FIGURE 1. View of the south facade of the Orthodox church (photo by M. Dudkiewicz, 2017)

In 2017, the building of the temple was under renovation (Figs. 1, 2). The area of the plot is partially fenced – from the main street side there is a gate and a brick fence. Around the temple, the former Orthodox church cemetery is located, with one preserved gravestone in the south-eastern part of the plot. There are 11 trees growing within the property's boundaries, of different ages and health status.

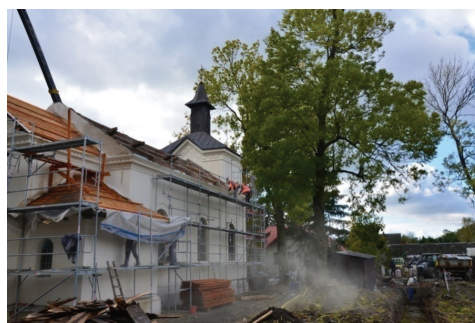
FIGURE 2. View of the east facade of the Orthodox church (photo by M. Dudkiewicz, 2017)
