# Influence of Lubrication Water Contamination by Solid Particles of Mineral Origin on Marine Strut Propeller Shafts Bearings of Ships

Gdansk University of Technology, Faculty of Mechanical Engineering and Ship Technology, Poland

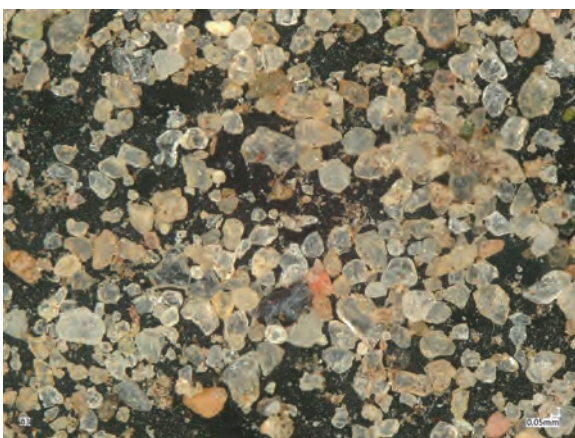
Fig. 5. Microscopic photo of solid particles of mineral origin used during the tests

A mixture of fresh water with particles of mineral origin typical of the Baltic Sea catchment area was used as a lubricant [29][30]. For this purpose, natural sedimentary material was collected from the river. It was cleaned from biological contaminant like leaves parts. The high quality, modern digital microscope was used for making pictures (Fig. 5) The dedicated software provided by manufacturer was used for analysis of the particles size. After conducting a statistical analysis after many measurements of different samples percentages of particles of various sizes figure with particles size distribution was plotted (Fig. 6).

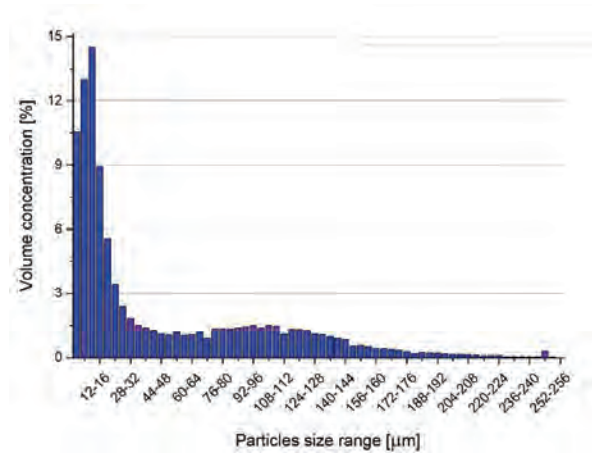
Fig. 6. Percentage size distribution of solid particles used during the tests.

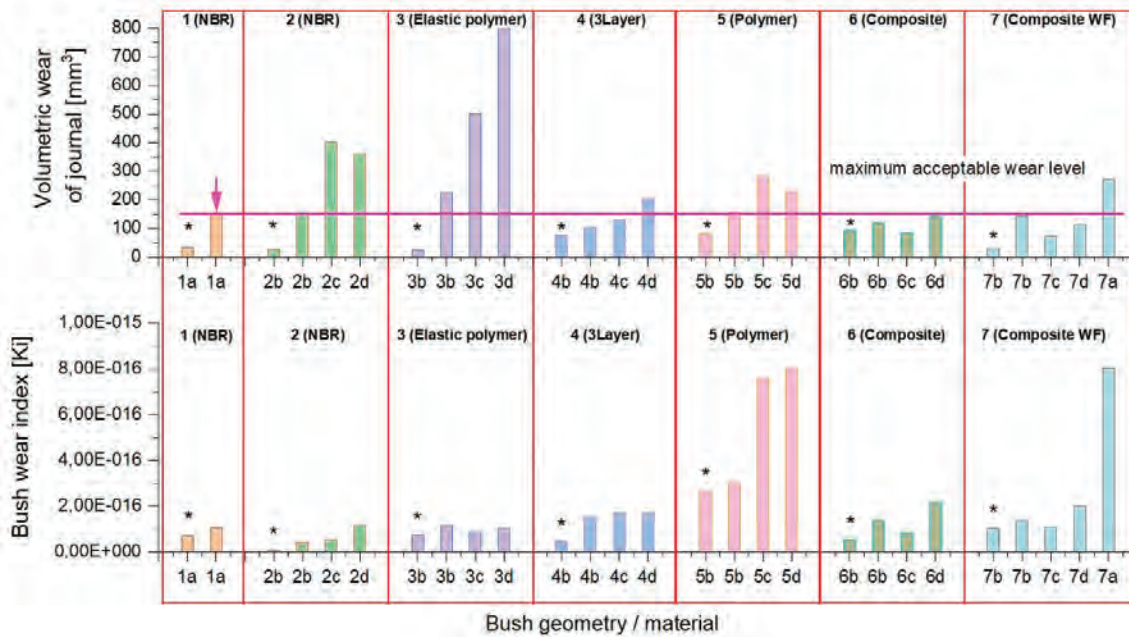
Fig. 11. Summary of wear results for shaft journals and bearing bushes, for varying sliding couples and geometries (\* indicates tests performed with clean water)

The reference line showing the maximum acceptable wear level is marked on the volumetric journal wear comparison chart above. This is conventionally used to show the level of wear recorded for the classic solution, i.e. a bearing with a rubber bushing with through lubrication grooves on the

circumference. It is known from experience that in many countries, a five-year service life for this type of bearing is considered satisfactory; after this period of time, the propeller shaft is dismantled and the bearing journals are regenerated by grinding or replaced with new ones. This is time-consuming and expensive, but it ensures reliable operation over the assumed five-year period. The overall cost of such an operational strategy is acceptable for the shipowner because the rubber bushing itself, especially if it is mounted in a composite sleeve, is not much more expensive than bronze or brass.

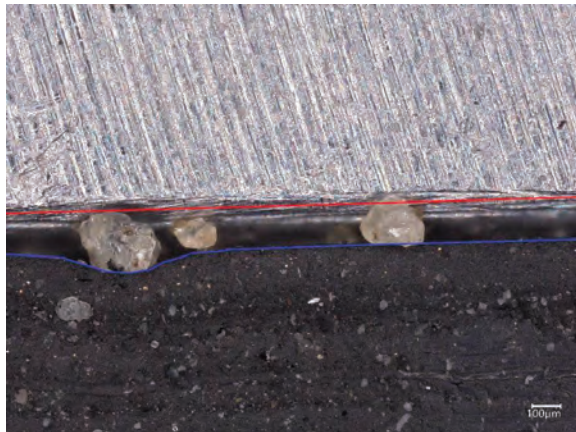
Fig. 12. Contact surface of the steel-NBR pair, with solid particles of mineral origin between them, showing the local deformation of the flexible NBR.

It was found that the forces exerted on the particle were not large enough to crush it, and that it rolled between the shaft journal and the bushing. The local deformation of the bush is shown in the microscopic photo below of a specially prepared model (Fig. 12). This concept helps to explain why on elastic bearing bushes only large scratches probably made by larger hard particle are easy to notice (fig. 13, 2b and 4b). For harder bushes process of crushing a particles results intensive wear especially when hydrodynamic properties are poor because of lubrication grooves located in lower half of the bearing bush (fig. 13, 6d and 7a).
