# Journal of POLISH CIMAC

## ANALYSIS OF SHIP SHAFT LINE COUPLING BOLTS FAILURE

**Keywords :** *ship propulsion system, shaft line, alignment, failure*

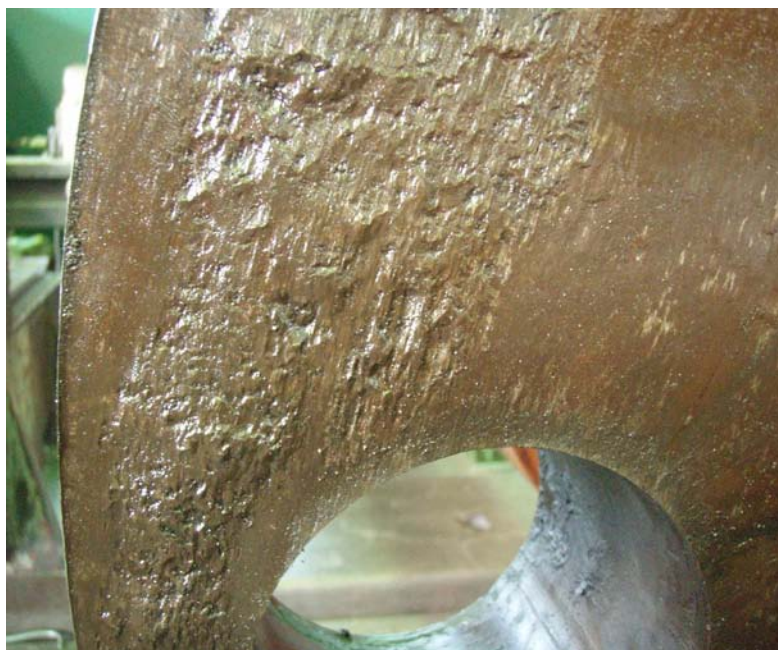
*Fig.4. An example of failure of the shaft collars and fitted bolt holes in the propulsion shaft [4].*

The presented wearing process that exists where micro displacements of adjacent surfaces are known as fretting. As a result of fretting the creation of micro notches that further could develop into fatigue cracking. With the increase of wearing area and value of collars displacements, the bolts linking the collars are subjected more to bending, that also accelerates fatigue up to final breaking. The breaking of one bolt, leads to the increase of loading of the remaining bolts and further breaks of collar bolts up to total lost of the shaft integrity. The view of shaft collar where fitted bolts were broken is presented in Fig 4.

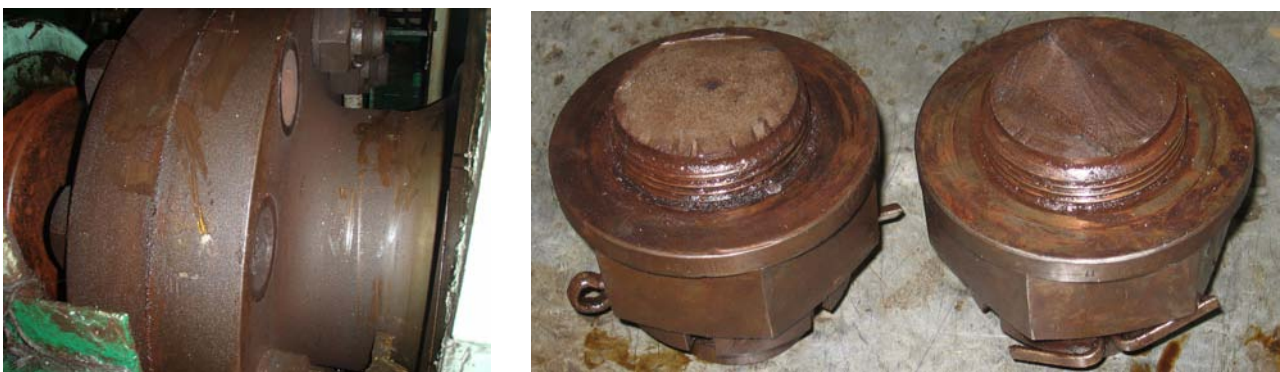
Fig. 8. The view intermediate shaft collar with broken bolts and fractures cross-section of the failed bolts with nuts. [4]

As an example, the shaft bending or bearing that is not aligned correctly with the shaft line axis could generate shaft bending loads leading to the permanent change of shaft geometry and in a consequence it will result in variable loading of the coupling bolts in shaft line collars. In the worse case, the coupling bolts could be broken by the fatigue. A characteristic feature of that type of failure is that it could have place during normal sailing conditions and quite probably not all the bolts could fail at once. Most frequent situation will be the case where the highest loaded bolt could break first or failure will happen to two neighbouring bolts. Consequently, the stiffness of the shafts joint will be decreased and bending stresses in other bolts will be lowered due to bending. An example of bolts destruction due to that type of failure a partly presented in the Fig 8. The contact area of the collars as well as fitted bolts and their holes were worn substantially. It is non disputable in that case, that failure was accompanied by mutual displacements of mating parts as well as by fretting.
