Remarks on the Automatic Cylinder Oil Mixing System for Two Stroke Dual Fuel Crosshead Marine Engines

Włodzimierz Markiewicz
ORCID ID: 0000-0002-2283-3375
BP plc, **United Kingdom**

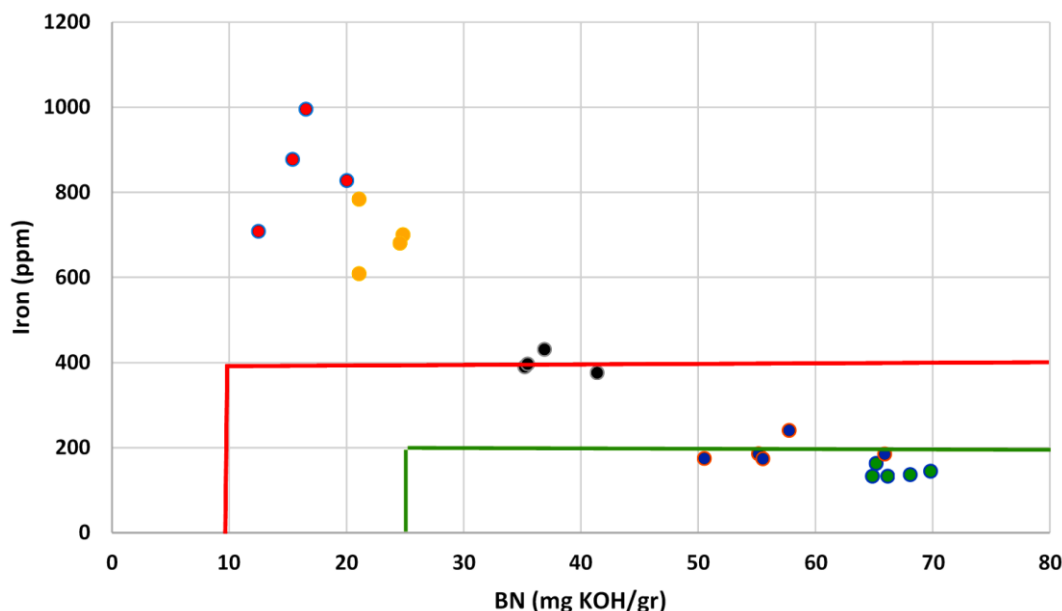
Fig. 13 Scatter graph of the values obtained through five days of sweep test (green line – normal limit, red line – warning)
Source: (Castrol, 2020)

Analysis of the sweep test results indicate feed rates of 1.38 g/kWh and 1.22 g/kWh as close to optimal for HFO with Sulphur content of 2.97. Any further reduction will increase risk of corrosive wear.

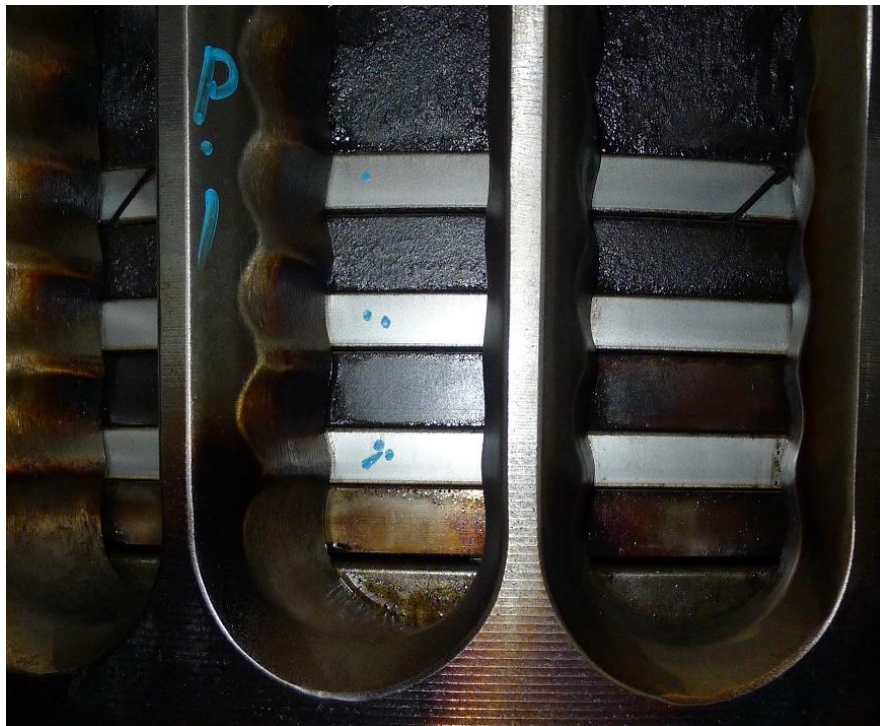
Fig. 16 Feed rate of 0.6 g/kWh with CLO BN 40
Source: Author's own Nov 2018

Figure 16 displays cylinder unit in excellent condition, operating in gas mode for over 10K running hours. Deposits on first ring land indicate a need for period of high BN operation. Trialled procedure calls for three days run with CLO 100 BN.
