Embankments Stability of an Opencast Mine with the Proposal of a New Mining Method For its Reopening (Kef Essennoun, Algeria)

Abstract

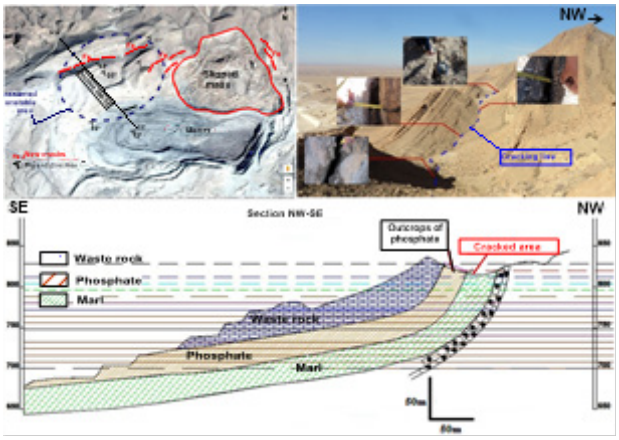
Fig. 2. Location of new cracks on the NW edge of the Kef Essennoun quarry
Rys. 2. Lokalizacja nowych pęknięć na NW krawędzi kamieniołomu Kef Essennoun

wards the South, West and Northwest of the deposit. This solution, which seems suitable for the continued extraction of the ore, was hampered by the appearance, in 2013, of new cracks at the top of the Northwest edge of the new exploitation pit. These cracks are located at the phosphate/marl interface (Fig. 2).

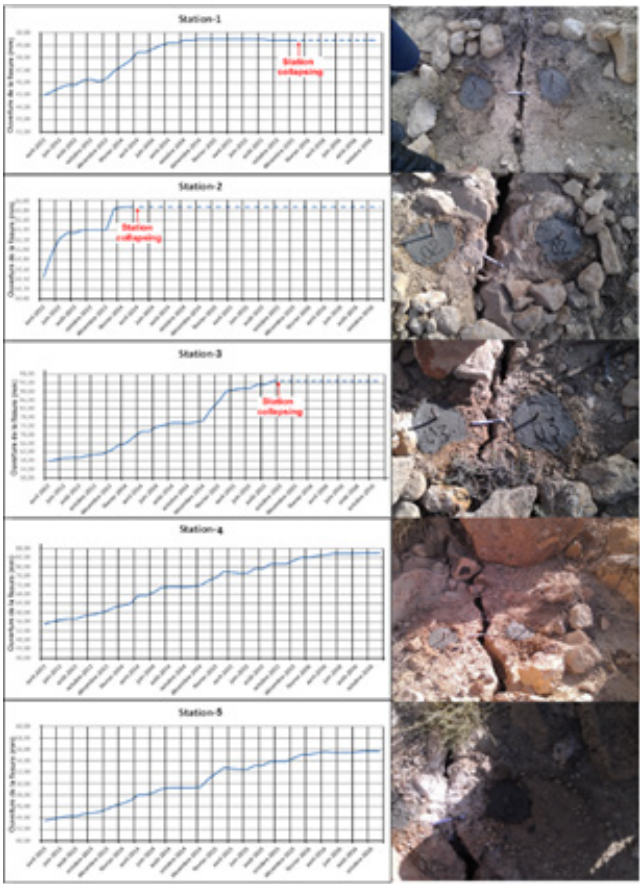
Fig. 3. Control stations from N°01 to 05 with the registration
Rys. 3. Stacje kontrolne od nr 01 do 05 wraz z rejestracją

- The cracks diverge with a maximum speed of 14 cm/yr, recorded at the station number three (ST-3). Therefore, this area is unstable (Fig. 3);
- The progression of the cracking line follows the

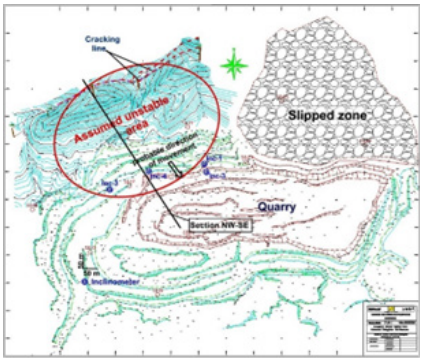
Fig. 4. Characteristics of the supposedly unstable area
Rys. 4. Charakterystyka rzekomo niestabilnego obszaru

Figure 4 shows a survey plan of the Kef Essennoun phosphate mine, updated in January 2016. The unstable zone is

located in the Northwestern part of the new exploitation pit and extends over a surface area of more than 20 hectares with a total volume exceeding 10 million cubic meters, which risks being in motion.

This area is bounded at the bottom by the operating benches (free surface), at the top by the cracking line and to the left and right by a few thalwegs. Therefore, the only probable direction of the slide is from the North-West to the South-East (towards the feet of the benches).

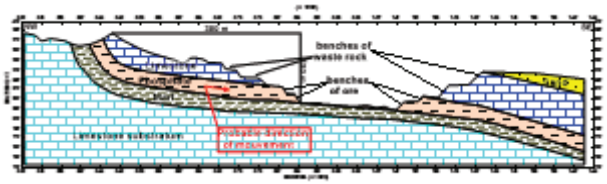
Fig. 5. Geometrical model adopted for the numerical modeling
Rys. 5. Model geometryczny przyjęty do modelowania numerycznego

The overall model adopted to calculate the safety factor with Geo-Studio software is an edge more than 150 m high with a spacing of 380 m, and a slope varying between 20° to 22°, consisting of five benches: two benches in the phosphate layer (H ~15 m and α = 75 to 85°) and three benches in the waste rock (H ~10 m and α = 70 to 80°). This heterogeneous edge is made up of four main layers: Limestone, Phosphate, Marl and limestone as the substratum (Fig. 5).

The calculation of the security factor (FS) of the Northwestern edge of the Kef Essennoun quarry was carried out on the basis of the geometrical model defined previously (Fig. 5). The main conditions of the calculation are the geomechanical parameters of the rocks (Tab. 3) and the anthropogenic seismicity due to blasting operations, represented by two horizontal and vertical components, (kh = 0.05 and kv= 0.0125). To this end, two approaches were considered, without and with the

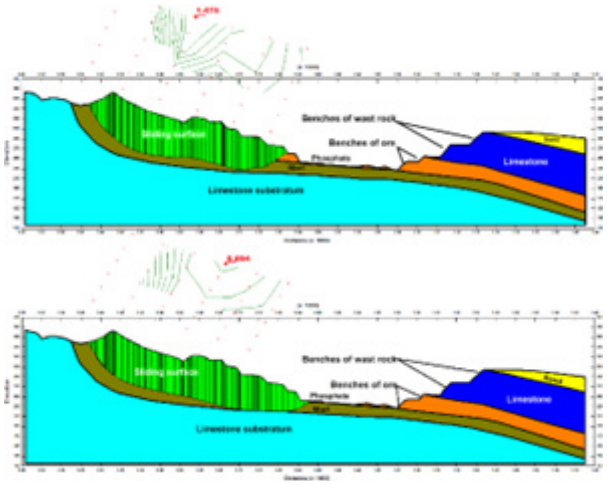
Fig. 6. Sliding surface (hatched in green) for the minimal factor of safety for both approaches: A) without the blasting effects; B) with the blasting effects
Rys. 6. Powierzchnia ślizgowa (zakreskowana na zielono) dla minimalnego współczynnika bezpieczeństwa dla obu podejść: A) bez efektów wybuchowych; B) z efektami wybuchowymi

Approach-1: All security factors calculated by the different methods are greater than the minimum tolerated threshold for the slope stability (FS>1), with a minimum safety factor of 1.312, obtained by the Janbu method. Thus, the edge is stable.

Approach-2: All safety factors are critical (FS ≤1), with a minimum safety factor of 0.806, also obtained by the Janbu method. Thus, the edge is unstable.

The sliding surfaces given by these two approaches have a non-circular (polygonal) shape and located in the marly layer, with a slight difference in the volume of the unstable rock mass (Fig. 6) between the two approaches.

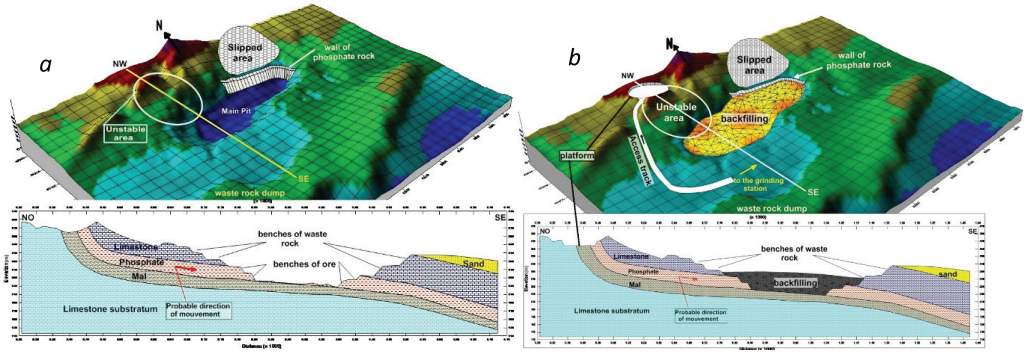
Fig. 7. Current situation of the phosphate quarry (a) and Condition of the quarry after backfilling and reopening of the initial platform (b)

by a wall of phosphate rock (security barrier). In the North-western side, we find the unstable zone and to the south the waste rock dump (Fig. 7-a).

Backfilling of the pit. In order to stabilize the walls of the mine, we found it very useful to backfill the main mining pit. The economic and technical feasibility of this operation requires us to study carefully the surface and height to be backfilled, the type and volume of the backfill and the distance between the backfill and the pit. For this purpose, we recommend:

- Partial backfilling of the pit which affects only the first two benches with a height of 30 m and a volume of 4.6 million m^3 (Tab. 5).
- The use, as backfill, of the waste rock stored to the south of the quarry (dump), consisting mainly of limestones, dolomites and marly limestone.

Access track and working platform. After the backfilling work of the main exploitation pit, we will reopen the deposit by creating of another access track to the upper levels and re-opening a new working platform in the outcrop of the phosphates layer (Fig. 7-b).

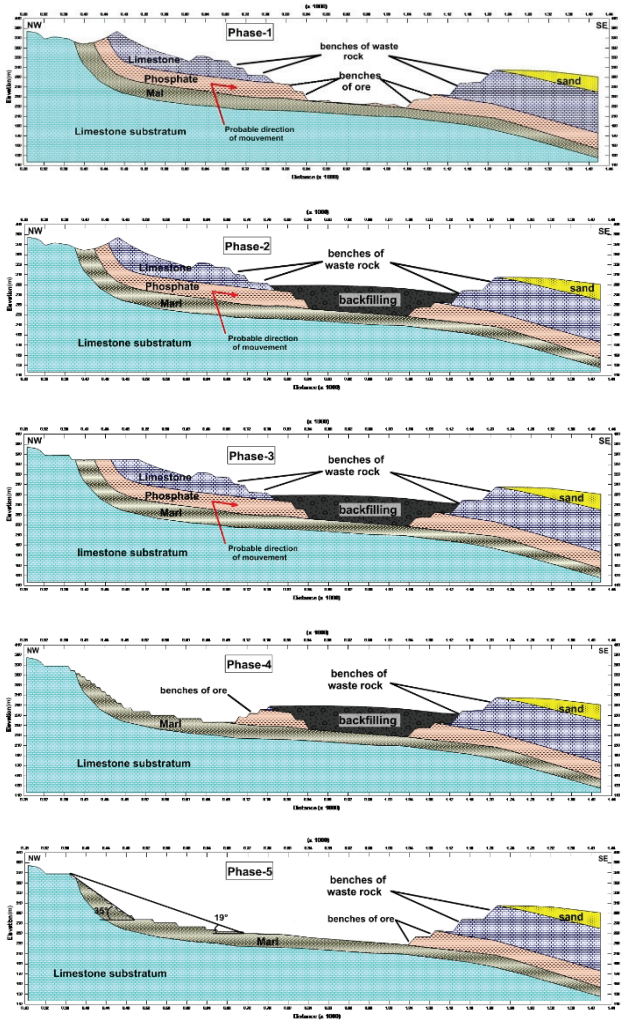
Fig. 8. Development stages of the mining exploitation of Kef Essennoun deposit
Rys. 8. Etapy rozwoju eksploatacji górniczej złoża Kef Essennoun

- The reopening of an initial platform and the elimination of the overlying waste rock (hill), in order to reduce the load above the unstable zone (Fig. 10, 11; Phase 3).
- The continuation of the mining exploitation from the top to the bottom, level by level, in the dip direction of the phosphate layer, with bleachers not exceeding 12 m in height and an inclination βg of 70°. Regarding the security and cleaning berms (bs, bn) we take a minimum width of 8 m, these parameters give us a maximum ultimate edge which does not exceed 35° (Fig. 8, Phase 4, 5).

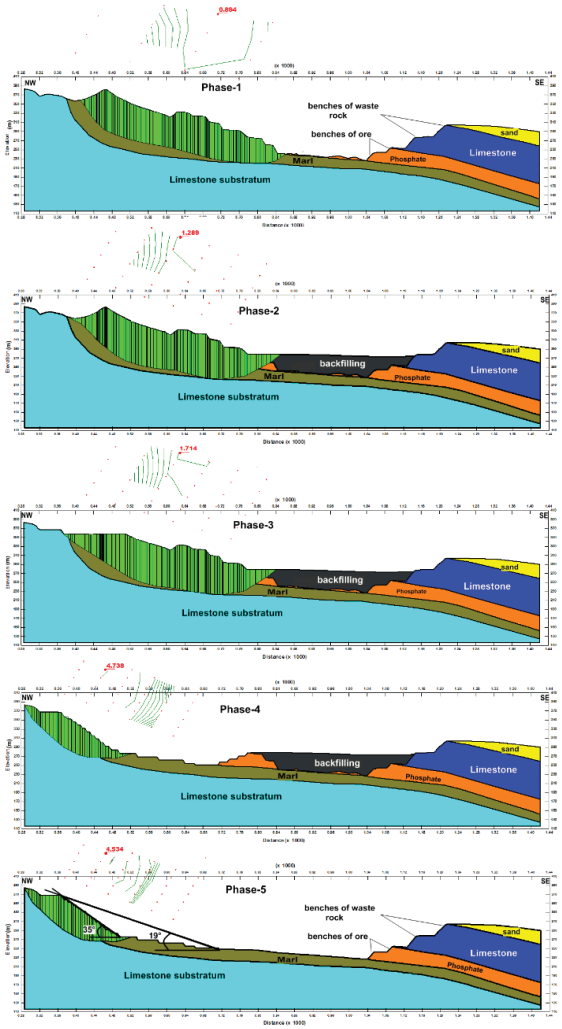
Fig. 9. Sliding surfaces for the minimum safety factor for the development phases of the Kef Essennoun quarry

- The remarkable influence of the backfill operation on the stability of the Northwestern side of the Kef Essennoun quarry, where the safety factors were increased at a rate of over 30% after backfilling.
- After the backfilling of the pit, all the safety factors calculated by the different methods are much greater than 1 (FS>1), which means that the edge is stabilized.
- For the different development phases of the deposit (Phase 3, 4 and 5) (Tab. 6), all the safety factors are greater than 1 (FS> 1). Therefore, there will be no risk of instability at during mining operations, provided that we comply with the recommended technical and technological parameters (hg ≤ 12 m, βg ≤ 70°, bs, bn ≥ 8 m) and under current blasting conditions.
