JERZY STOJEK [*]

APPLICATION OF TIME-FREQUENCY ANALYSIS FOR DIAGNOSTICS OF VALVE PLATE WEAR IN AXIAL-PISTON PUMP

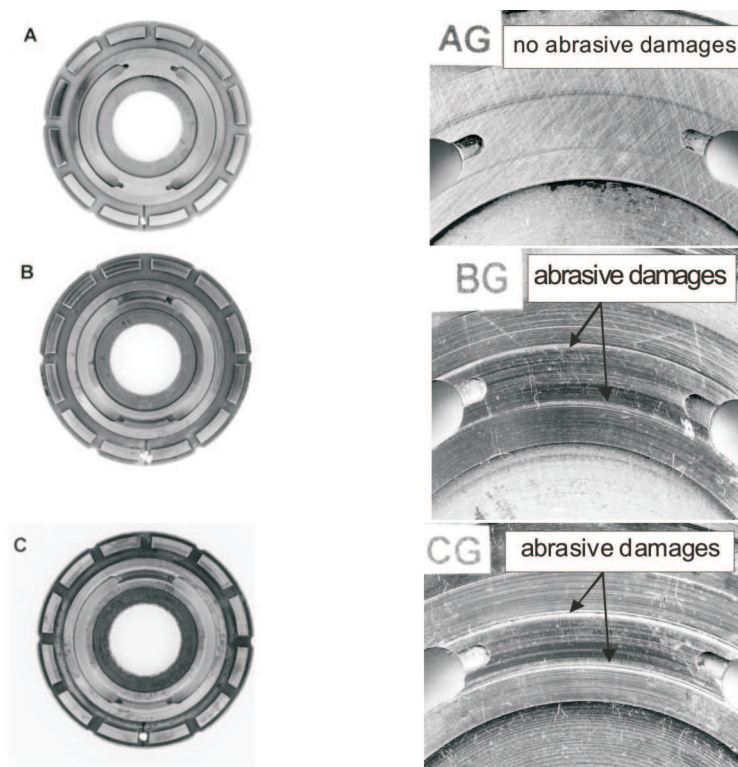
Decay of lubrication layer between impeller face and stable surface of the pump plate is the major cause of the micro-channel formation on the plate surface. Insufficient thickness of the lubrication layer can result from improper exploitation of hydraulic system, for example too high operational temperature and the associated critical reduction of the working fluid viscosity. Hard particles of the oil impurities that appear in result of insufficient filtration, additionally contribute to degradation of the plate surface. All these factors, combined with high operational pressure of the pomp, lead

to the occurrence of mixed or dry friction, and consequently friction wear of mating parts. Additionally, in the case when axial piston pump is utilized with negative overlap of valve plate, the transition zone between the suction hole and the compression hole is highly exposed to cavitation. Examples of photographs of valve plates of an efficient element, and two worn elements, are shown in Fig. 2.

Fig. 2. Valve plates with magnified wear zone: a) plate without wear (type A), b) plate with wear of the depth of 0.01 mm (type B), c) with wear of the depth of 0.05 mm (type C)

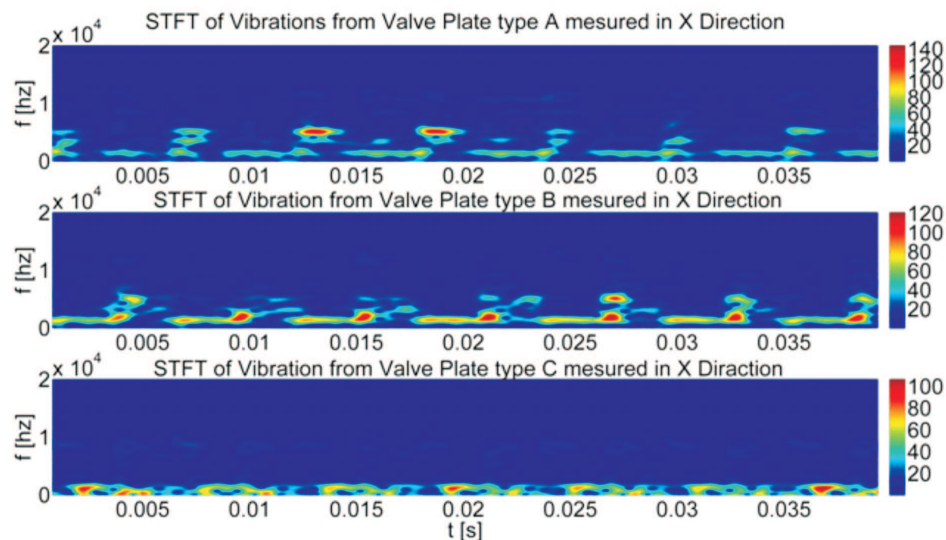
Fig. 5. Time-frequency representation STFT of signals measured along the axis X for: a) unworn valve plate, b) worn valve plate - depth = 0.01mm, c) worn valve plate - depth = 0.05mm

• The analysis of *STFT* courses (Fig. 5) obtained in the axis *X* indicates
that the increase in valve plate wear is accompanied by a shift of the
signal spectrum towards lower frequencies, with simultaneous decrease
in its amplitude. This effect has also been proven by the analysis of *WVD*
representation (Fig. 8). Quantitative analysis of distribution of the root
mean square of the *STFT* spectra (Fig. 11) indicates that the assessments
of valve plate wear was somehow imprecise within the frequency range
up to 2 kHz, but already in the range from 4 to 6 kHz we can observe
evident tendency of a decrease in the spectrum amplitude and its shift

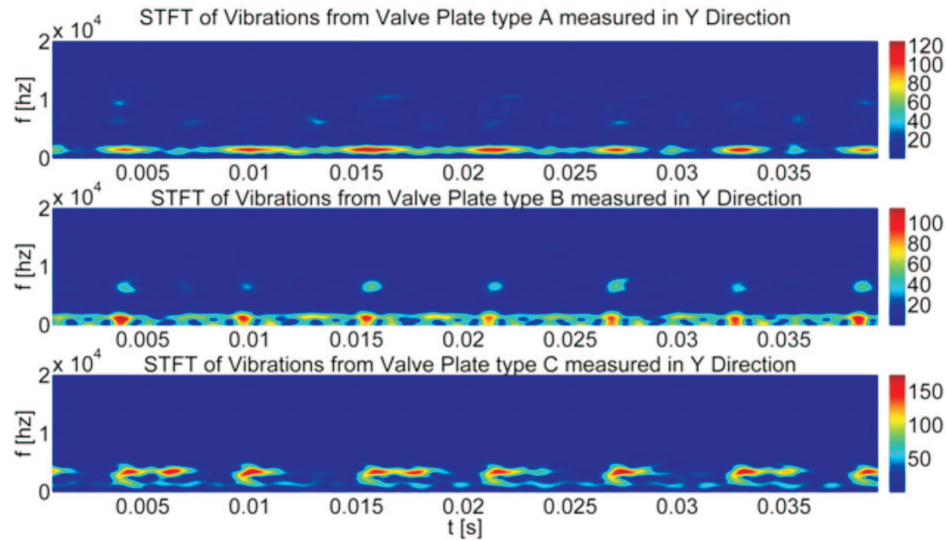
Fig. 6. Time-frequency representation STFT of signals measured along the axis Y for: a) unworn valve plate, b) worn valve plate - depth = 0.01mm, c) worn valve plate - depth = 0.05mm

- The analysis of *STFT* courses (Fig. 6) obtained in the axis Y shows not quite explicit shift of the signal spectrum towards higher frequencies, which results from a greater wear of the valve plate. The rise in the spectrum amplitude in the case of valve plate with the greatest wear (C type plate) is also observed. However, based on the analysis of *WVD* distributions (Fig. 9), we can notice that, in the result of wear of this element, there appear side lobes in the spectrum, and the amplitude of these side lobes increases with the plate wear. In the case of quantitative analysis of *STFT* distributions, for which the values of root mean square of the *STFT* spectrum were determined in the function of frequency (Fig. 12), one observes a reduction in spectrum amplitude with the plated wear (for f~1.8kHz) accompanied with an evident increase of amplitude of the spectrum. In the case of the most worn plate (C type plate) the whole spectrum is shifted towards higher frequencies.

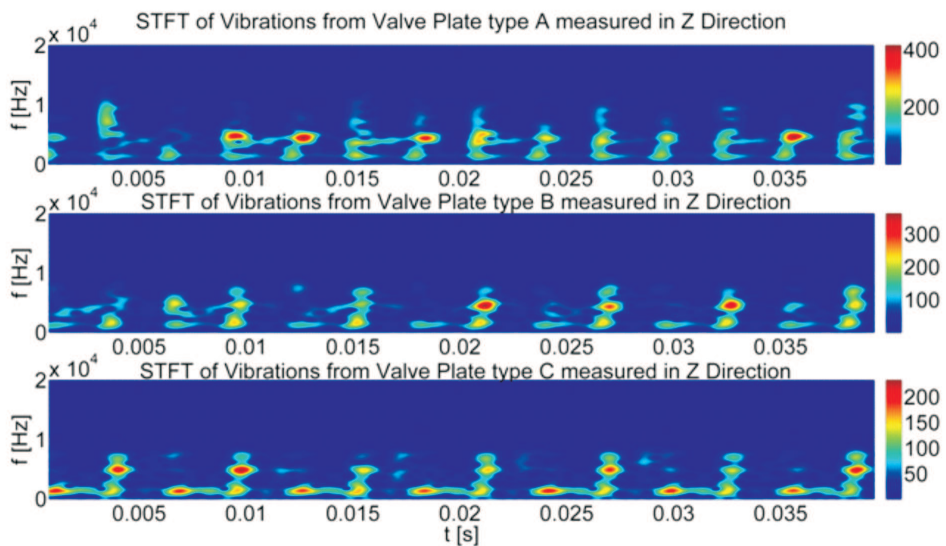
Fig. 7. Time-frequency representation STFT of signals measured along the axis Z for: a) unworn valve plate, b) worn valve plate - depth = 0.01mm, c) worn valve plate - depth = 0.05mm

- Based on the quality analysis of *STFT* and *WVD* distributions obtained in the Z axis, one can note that the increase in the valve plate wear does not cause any significant shift of the signal spectrum toward lower or higher frequencies (Fig. 7 and 10). The tendency of the spectrum amplitude to drop, resulting from the plate wear, is also noticeable (it is particularly well seen in the case of *WVD* distributions). The performed quantitative analysis of root mean square of the *STFT* spectra (Fig. 13) evidently confirms that the spectrum shifts toward higher frequencies (f from the range of 4 to 6 kHZ), which is associated with a reduction in spectrum amplitude increasing with the plate's wear.

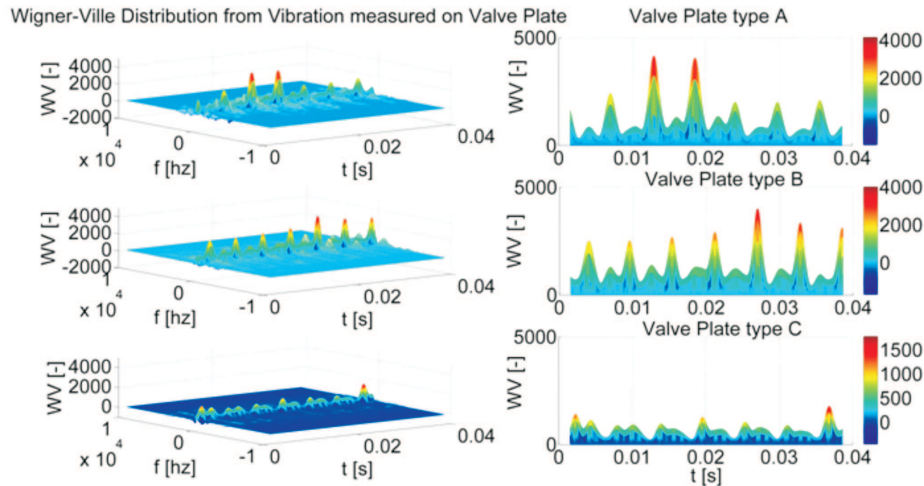
Fig. 8. Representation of time-frequency WVD of vibration signals measured along axis X for
a) unworn valve plate, b) worn valve plate - depth = 0.01mm, c) worn valve plate - depth =

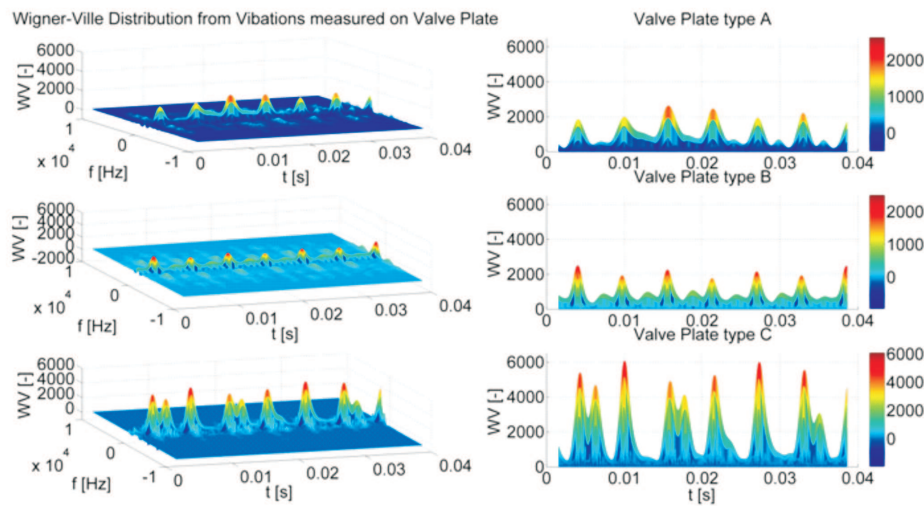
Fig. 9. Representation of time-frequency WVD of vibration signals measured along axis Y for
a) unworn valve plate, b) worn valve plate - depth = 0.01mm, c) worn valve plate - depth =
0.05mm

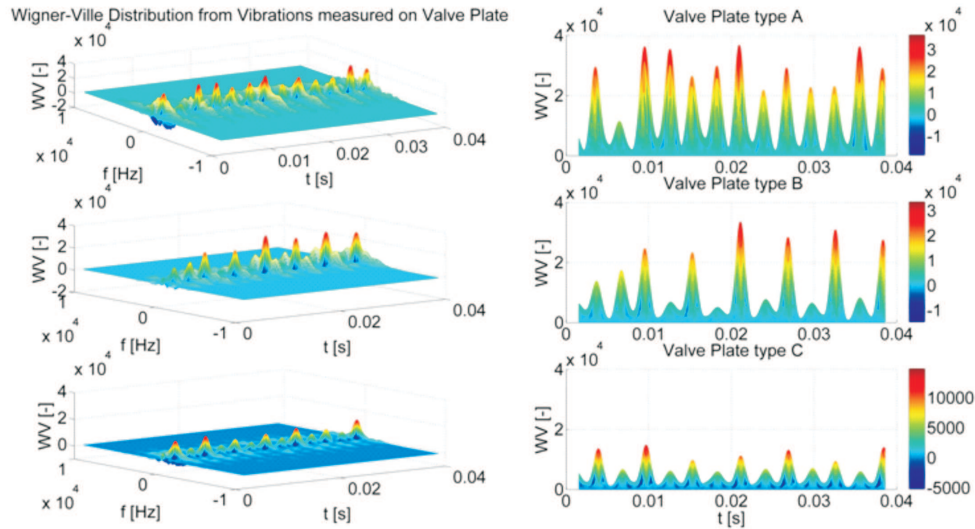
Fig. 10. Representation of time-frequency WVD of vibration signals measured along axis Z for
a) unworn valve plate, b) worn valve plate - depth = 0.01mm, c) worn valve plate - depth =
0.05mm

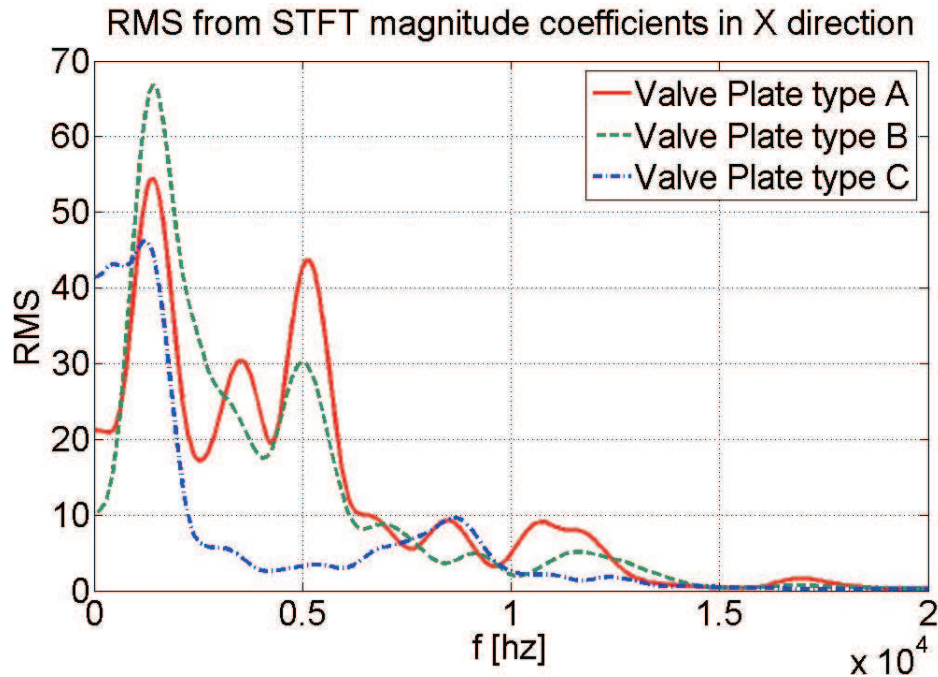
Fig. 11. Course of root mean square of amplitude spectra *STFT* determined from signals
measured in axis X for tested valve plates

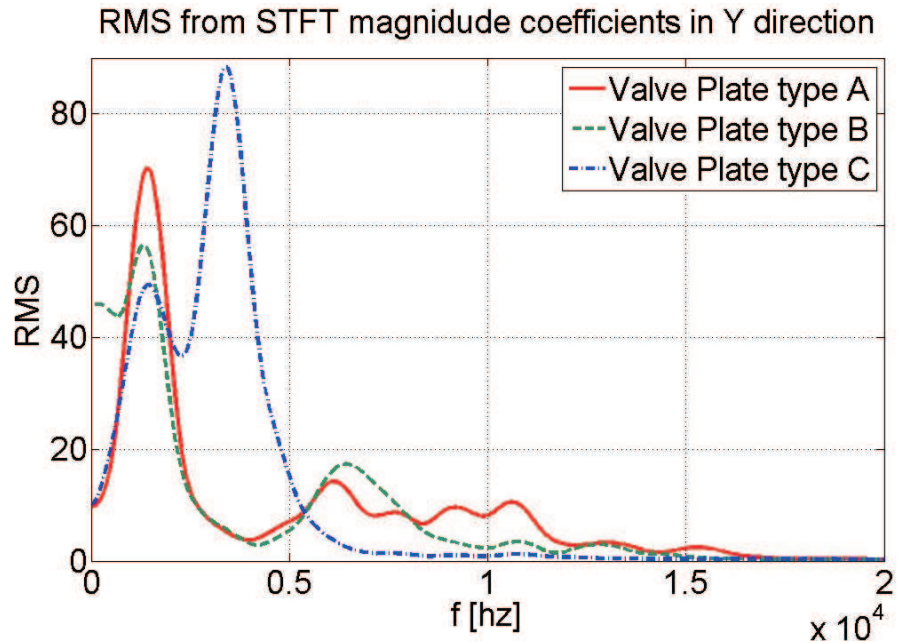
Fig. 12. Course of the root mean square of amplitude spectra determined for signals measured in

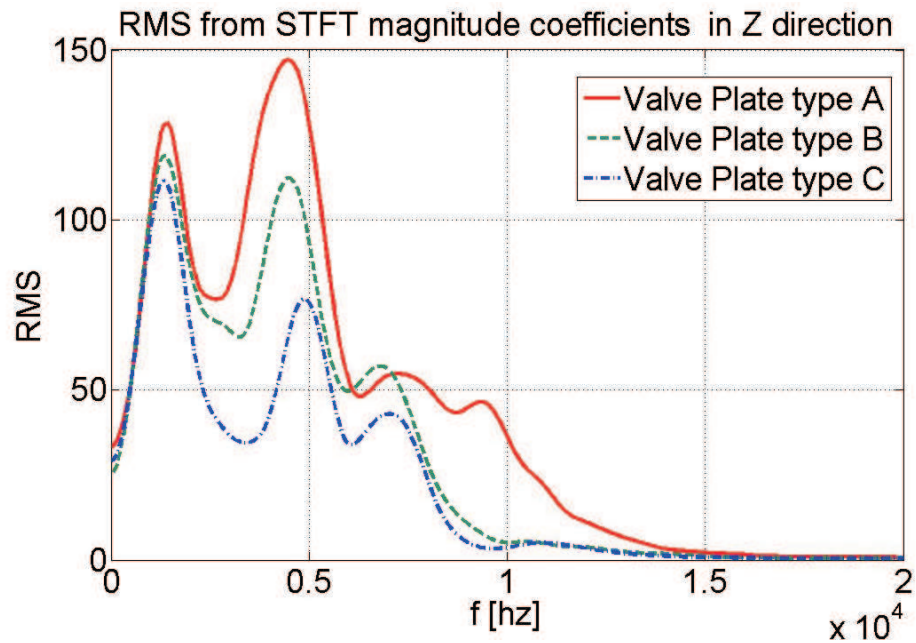
Fig. 13. Course of root mean square of amplitude spectra determined from signals measured in
the axis Z of the tested valve plates
