MECHANISM OF THE FATIGUE CRACKS DEVELOPMENT IN BEARING SLIDE LAYER

Jan Sikora, Jan Kłopocki, Wojciech Majewski

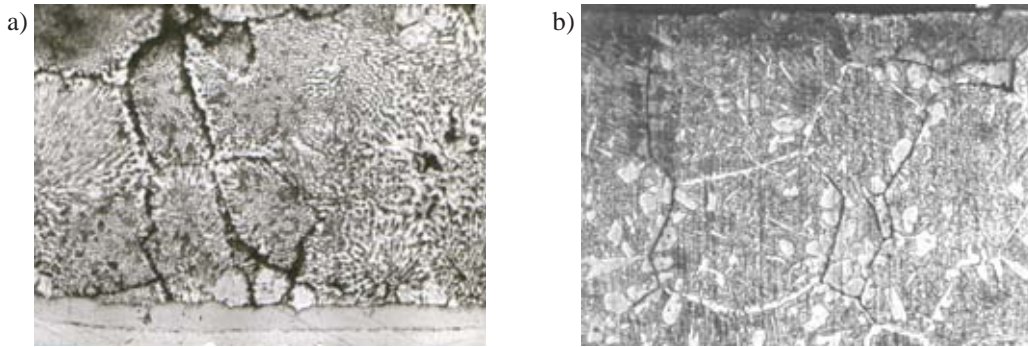
For the structural cracks (Fig. 1) the generation of the microscopic fracture is associated with forming the connections of the weak joining of the layer structure (eg. soft big cells of the bearing layer, voids and heterogeneity in bearing material). The net of the structural cracks is rather randomly distributed (as to the density and directions).

Fig. 1. Structural cracks (cross-section of the bearing surface layer): a) in bearing alloy of CdZn X4 (magnified 200x), b) in bearing of CuZnX20 brass (magnified 300x)

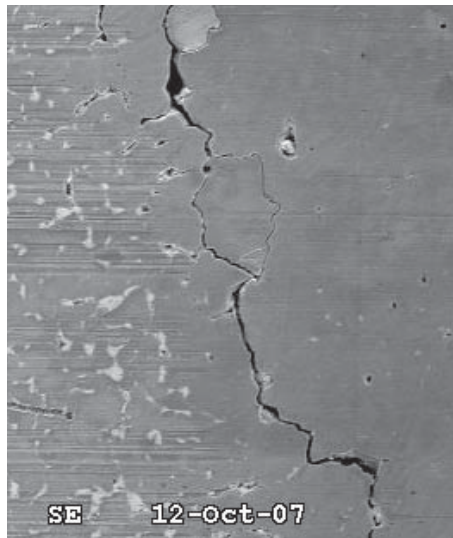
The magistral type of fatigue cracks can be observed as development of single thin sections that are usually starting at the surface (Fig. 2) and propagate perpendicularly to the slide surface (Fig. 3). Nucleation of these cracks is taking place at the area of slide surface defects, concentration of the

Fig. 2. Fracture of magistral type (on the surface of the bearing) almost perpendicular to the circular direction of the bush for the lining made of CuPb22Sn4 alloy (magnified 100x)

In general the slide layer is subject to the action of the stresses that are dependent on the initial assembly loading stresses, heat stresses and the hydrodynamic dynamic pressure. All of these components have been of compression nature so it could be justified if the cracks are visible at the 45 angle degree to the slide surface as effect of compression stresses action. Since in practice cracks are rather (especially in case of magistral cracks) generated perpendicularly to the slide surface (Fig. 2) one can expect existence of the tensional stresses in this region.

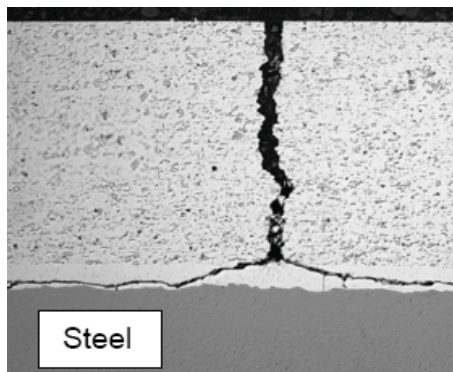
Fig. 3. Fracture of magistral type (in cross-section of the bearing surface layer) for the lining made of AlSn20 alloy (magnified 100x)

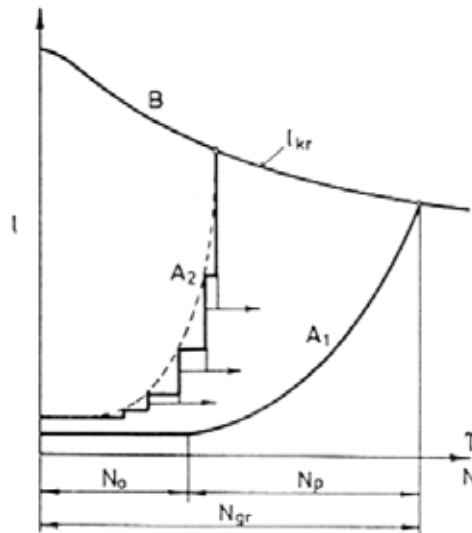
Fig. 4. Fatigue durability for various types of fracture developments [1]

In the Fig. 4 the relative fatigue damage versus the time of the bearing operation is presented. Fatigue process in material, in classical model, is always related to the number of loading cycles while in case of Nemec's bearing model [1], elaborated in 70-ties of XX century, one should consider not only effects of variable mechanical loading but also the effects of creep, ageing, wear, corrosion and microcavitation of the bearing alloy. In this fatigue development model the relative measure of failure D is the ratio of crack length "l" to the critical length of crack "l_{cr}" (D = l/l_{cr}). Critical length (l_{cr}) of the cracks is understood as a value, which is sufficient to start spontaneous increase in the fracture length. In case if the critical crack length, calculated from the formulae of the mechanics of fracture, is bigger than the bearing layer thickness then this layer thickness is treated as the critical length "l_{cr}". It is also the case for multilayer bearing design. Curve "A" in the Fig. 3 is demonstrating the cracks development and its transition from micro to macro-crack fracture.

Developing of these cracks is often associated with corrosion and micro-cavitation in lubricating oil environment. "A_1" curve (Fig.4) presents uniform process of magistral type of fracture that is of plastic deformation type and blunted tip. Interaction with other sort of defects and influence of the initial structure are less important.

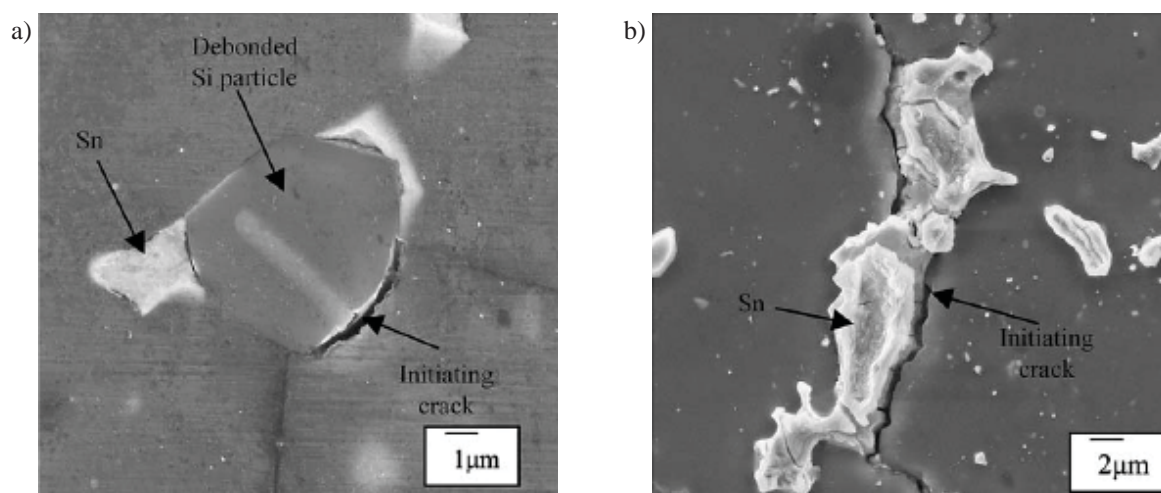
Some of bearing alloys investigations were dealing with the effects of micro component characteristic properties on the fatigue crack developments. In particular AlSn20 and AlSn12Si4 were investigated [4, 5]. It has been proved that nucleation's of crack were started because of decohesion at the boundary region of the inclusions such as silicon Si particles (Fig.5b) or grains of the intermetallic compounds (Fig. 6).

The reason for breakage demonstrated in Fig. 5 might be the differences in variable deformation of the alloy components.

Fig. 5. Fractures on the boundary of Si particle in AlSn12 Si4 alloy (a) and Sn particle in AlSn20 alloy (b)[4]

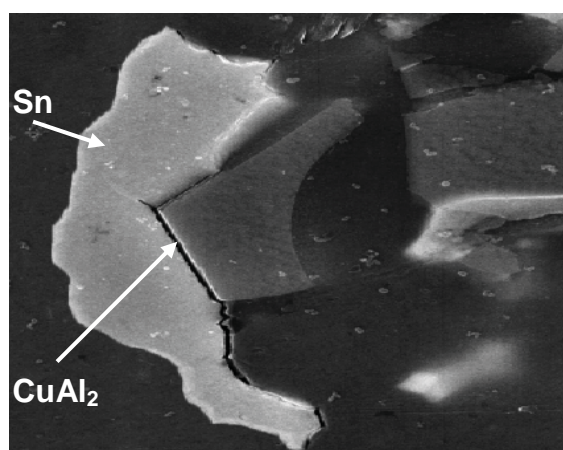
Fig. 6. Fractures on the boundary of the intermetallic compound grain CuAl₂ in AlSn20 alloy [4]
