The study of physicochemical properties of stabilizing plates removed from the body after treatment of pectus excavatum

Anita Kajzer[1]*, Wojciech Kajzer[1], Józef Dzielicki[2], Dawid Matejczyk[1]

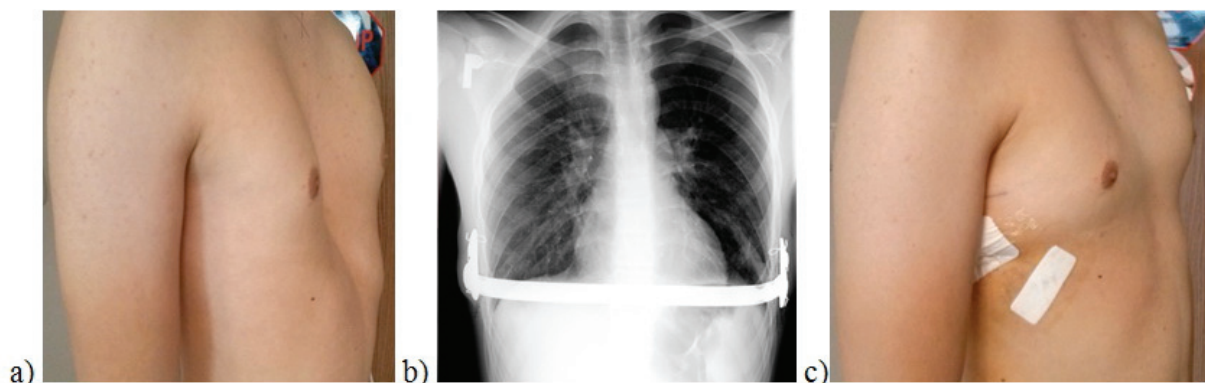
Fig. 1. The exemplary images of pectus excavatum: (a) before, (b), (c) after surgery

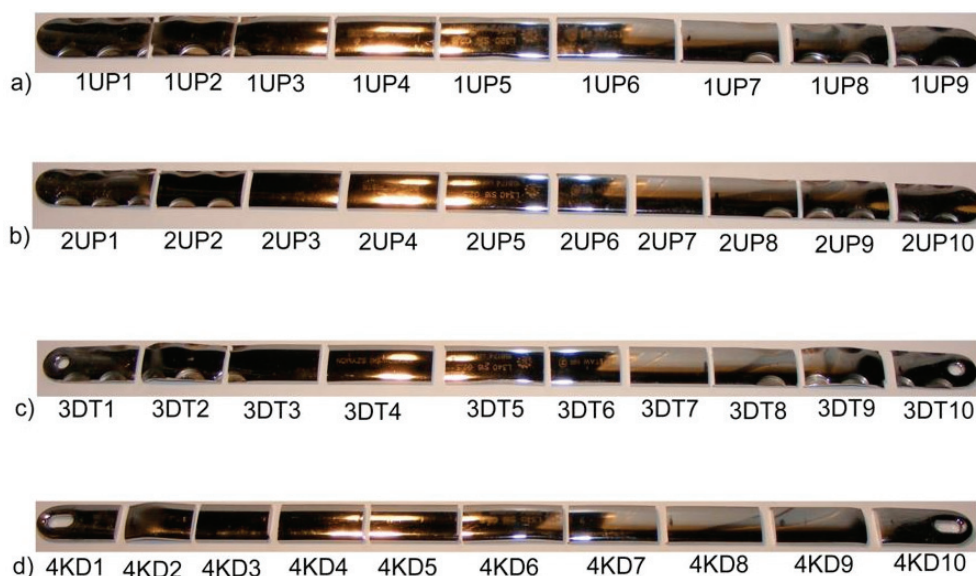
Fig. 2. Marking of test samples

Tests were carried out on plates of modified construction made of stainless Cr-Ni-Mo steel of a chemical composition and mechanical properties consistent with the recommendations of the ISO 5832-1 standard removed from the body: two plates after 20 months time and two 25 months after implantation, Fig. 2. The plates were subsequently cut into samples using a Bakelite disc with ceramic abradant (Al_2O_3), constituting the equipment of a Discotom-6 mechanical cutter manufactured by Struers. Water cooling was applied during cutting. This prevented overheating of the samples, which could lead to local changes in their structure. The material for testing was divided into three groups: the first sample contained surface defects in the form of numerous scratches, the second contained samples with undamaged surface, while the third group contained samples with engraving on the surface made for identification. The following were performed during the study: macroscopic surface assessment, roughness and surface wettability measurement and the test of resistance to pitting corrosion.

The last stage of the analysis consisted in testing the resistance to pitting corrosion of the samples selected on the basis of macroscopic evaluation, from the areas with visible surface damage (the first group) occurring in places of laser marking (third group) and for comparison in the areas without any mechanical damage (second group). The study was performed by recording potentiodynamic polarization curves according to PN-EN ISO 10993-15 standard recommendations. The measuring set consisted of a VoltaLab PGP201 potentiostat, reference electrode (NEK KP-113 saturated calomel electrode), the auxiliary electrode (platinum electrode type PtP-201), anode (the test sample) and

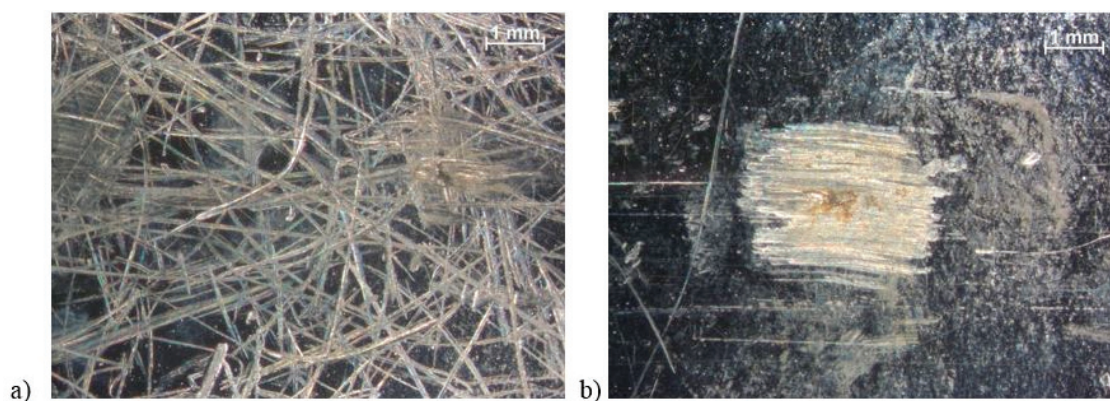
On the basis of observations with a stereoscopic microscope, it was found that in most of the analyzed areas on the external surfaces of the plates, there are numerous instances of mechanical damage in the form of scratches of varying depth and width (the first group). These may have occurred during the preoperative modelling of the plates to the anatomical curvature of the chest, as well as at the time of their removal, Fig. 3. In contrast, the inner surfaces, which

Fig. 3. Example of mechanical damage to the outer surface of the plates:

(a) 2UP, (b) 4kD, stereoscopic microscope, magnification 10×

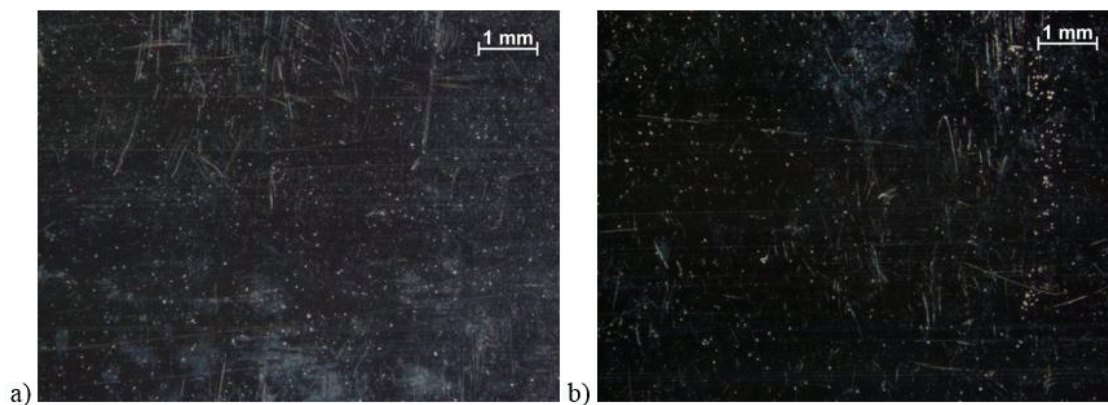
Fig. 4. Examples of mechanical damage to the inner surface of the plates:

(a) 1UP, (b) 4kD, stereoscopic microscope, magnification 10×

were represented by the samples of the second group, were characterized by a mirror polish with no apparent mechanical defects, Fig. 4. Engraving was made in the middle part, which enabled identification of each of the implanted plates (third group), Fig. 5.

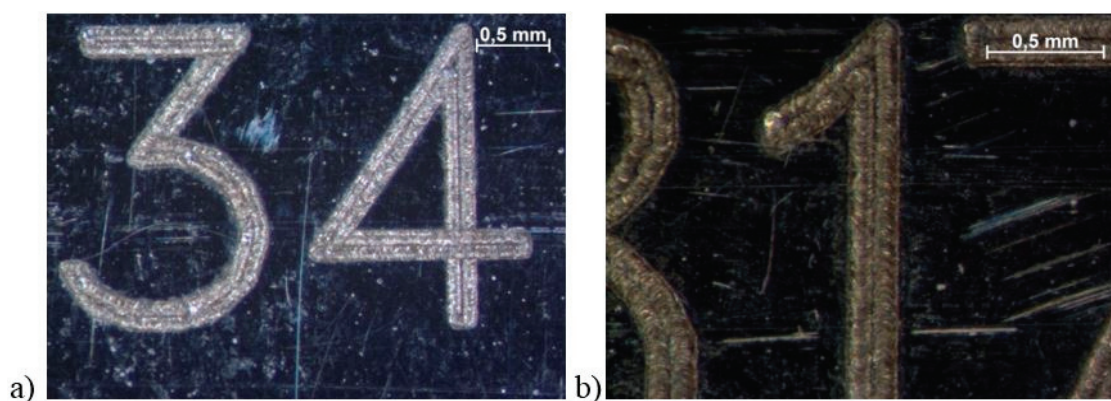
Fig. 5. Example of engraving in the central part of the plate:
(a) 3DT5, magnification 25×, (b) 2UP5, magnification 40×, stereoscopic microscope

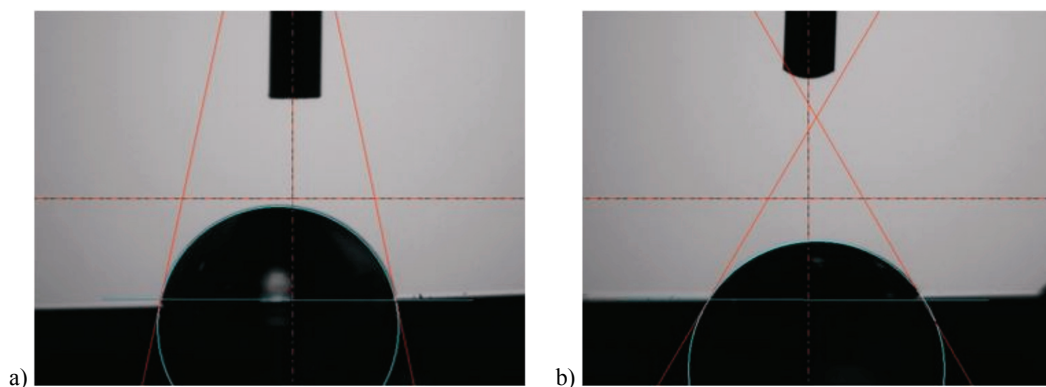
The highest contact angle values of the samples being tested were obtained from plate 3DT7 ($\theta = 81.95°$). Other samples, 1UP6, 2UP8 and 4KD8, representing a particular plate, acquired respectively the mean value of the contact angle $\theta = 76.44°$, $\theta = 76.75°$ and $\theta = 79.12°$. An exemplary photograph of the sample of distilled water and a drop of diiodomethane applied to the outer surface of the plate is shown in Fig. 6. On the other hand, the mean values of θ for the contact angle of diiodomethane (Table 3) were similar in sequence to plates 1, 2, 3 and 4 and were as follows: $\theta = 58.91°$, $\theta = 56.51°$, $\theta = 56.28°$, $\theta = 57.23°$. Contact angle values obtained during the test using distilled water and then diiodomethane constituted the basis for further studies of the surface energy. As a result, the surface energy values γS were obtained. For samples from plates 1, 2, 3 and 4, they were close to each other and were 31.44 mJ/m^2, 32.22 mJ/m^2, 31.08 mJ/m^2 and 31.24 mJ/m^2, respectively.

Fig. 6. Sample of drops: (a) distilled water, (b) diiodomethane deposited on the sample surface

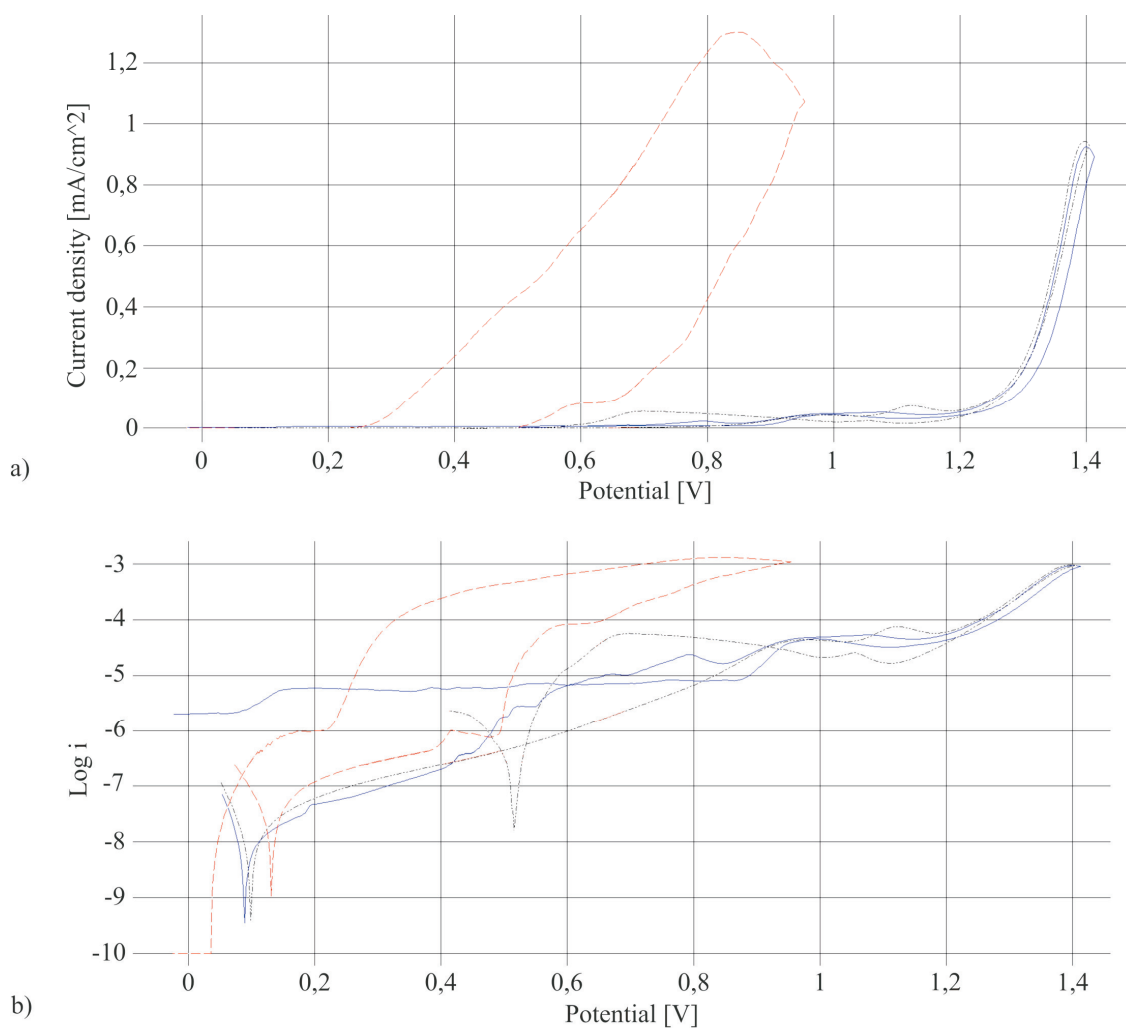
Following the analysis of surface wettability, studies of resistance to pitting corrosion were performed. Examples of test results in the form of conventional and logarithmic polarization curves are shown in Fig. 7.

Fig. 7. Examples of polarization curves: (a) classical chart, (b) logarithmic graph:
first group – solid line, second group – line dot-dash, third group – line dash-dash

surface of the plates which were laser marked (samples of the third group) we observed hysteresis loop, demonstrating the development of pitting corrosion. For these samples the breakdown potential was recorded, which varied from E_{np} = 768 mV, up to E_{np} = 1130 mV, repassivation potential E_{cp} from 19 mV up to 141 mV, with the corrosion potential E_{corr} from 68 mV up to 141 mV and polarization resistance R_p from 423 kOhm·cm^2 up to 1180 kOhm·cm^2. For the samples from the first and second groups a transpassivation potential was determined that ranged from E_{tr} = 1265 mV to E_{tr} = 1307 mV, the corrosion poten-

tial E_{corr} from +148 mV up to –108 mV, while the polarization resistance R_p varied from 270 kOhm·cm^2 to 2000 kOhm·cm^2. These values indicate a good resistance to pitting corrosion of the analyzed plate areas.
