Impact of Grenfell Tower fire disaster on polyisocyanurate industry^{*})

Grazyna Mitchener¹⁾

Abstract: The paper summarizes commonly available information on the fire of the Grenfell Tower, which took place in Central London on 14 June 2017. The fire was very similar in its nature to several other spectacular fires at tall buildings, which have happened around the world since 1999 but unlike the previous one, the London fire claimed an enormous number of victims – 71. The tragic outcome of the fire was blamed on a combination of several human and natural factors: faulty evacuation procedures, unsuitable fire extinguishing equipment, mistakes by the housing association managing the building, lacking fire safety provisions in the tower, weather, confusing building regulations, *etc.* However it was established that the main reason for so tragic an outcome of this fire was the speed of fire spread *via* decorative aluminum composite materials (ACM) containing polyethylene (PE), installed on the outer of a building as a part of a rain-screen cladding system. The other part of the system was polyisocyanurate (PIR) thermal insulation. The paper focuses on the role of PIR in this fire a

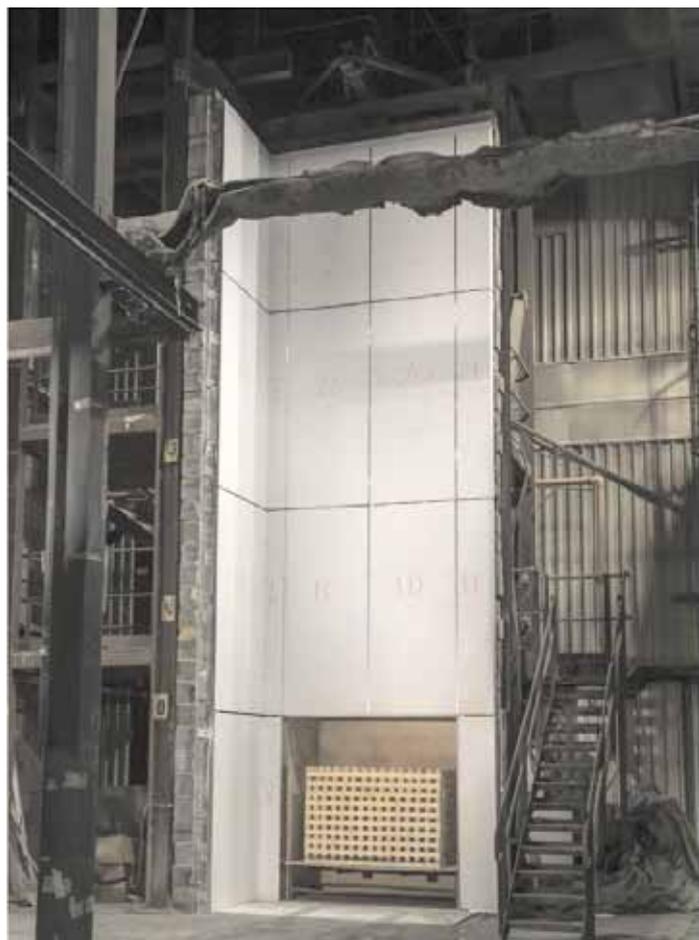
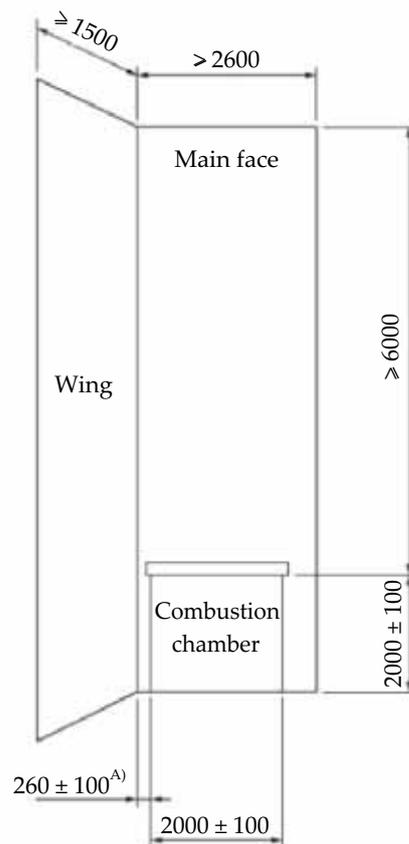
Fig. 3. The test rig for the fire test BS8414 (from https://www.gov.uk/government/uploads/system/uploads/attachment_data/file/639357/DCLGtest7_BS8414_Part_1_test_report_Issue_2_0.pdf)

The British Standard BS8414 fire test was designed to certify fire behavior of wall cladding systems on buildings over 18 m high. Figure 3 shows the BS8414 test rig and its dimensions. The test lasted up to 60 minutes and had 3 pass/fail criteria:

1. The temperature measured on the external face of the building (measured at a point approximately 1 storey above the fire floor), or
2. The temperature measured on the internal face of the building (measured at a point approximately 1 storey above the fire floor), could not exceed 600 °C for 30 seconds or more during the initial 15 minutes of the test.
3. Mechanical performance determined by an assessment of the system collapse, spalling, delamination, flaming debris or pool fires. This criterion was not specified in detail by the standard, leaving the pass/fail decision to the discretion of the test executors.
