## Techniczne aspekty odbudowy i utrzymania obiektów zespołu pokamedulskiego w Wigrach

### Technical aspects of reconstruction and preservation of the former Camaldolese monastery in Wigry

**Key words:** Wigry Hill, buildings and structures of the Hill, damage and deformation, technical condition, displacement monitoring, research and protection

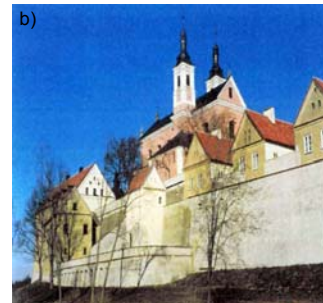
Ryc. 5. Zrekonstruowany kościół i południowo-zachodnia część ściany oporowej w 1967 roku oraz widok północno-zachodni budynków Wzgórza z 2006 r.  
 Fig. 5. The reconstructed church and south-west part of the retaining wall in 1967. North-west panorama of the monastery in 2006

All monastic buildings, excepting a few minor buildings, have been reconstructed as shown in fig. 5. At the same time, a process of progressive degradation and damage can be observed. New materials and technologies used in reconstruction were found in some cases not to have benefited historic building preservation. Initially, main processes of degradation and destruction were observed in the erems of the Bottom Terrace. Leaks from a faulty water supply and sewage system wrought considerable damage to the erems. Other buildings and structures were also damaged by cracks and fissures (fig. 8) and significant displacements were observed, especially near window lintels and quoins and where adjacent buildings join together. These observations enable specific renovation and repair work to be undertaken in line with the renovation and repair concept and strategy developed for the monastery as a whole [11].

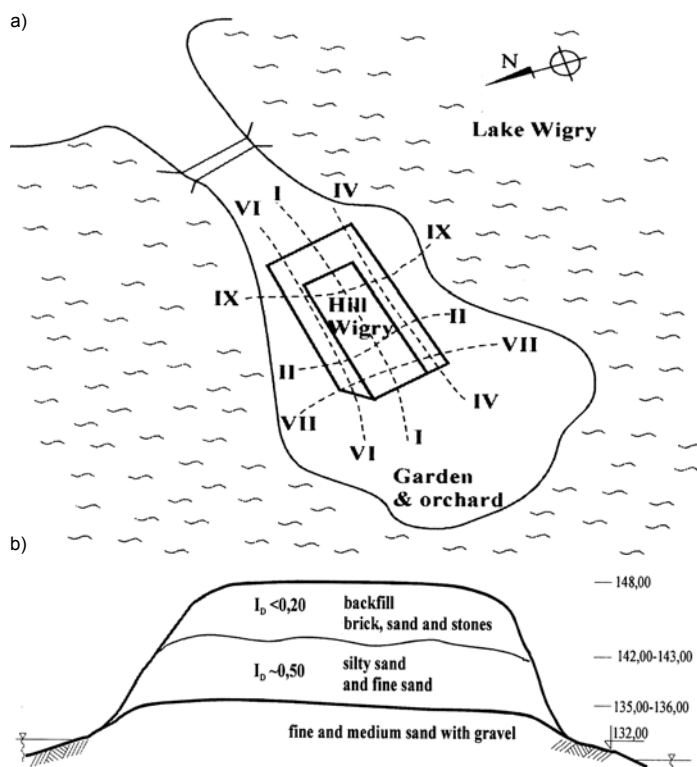
The geological analysis of the multilayer grounds constituting the Hill was carried out through a system of boreholes put into place systematically according to a grid shown in fig. 6a. According to the geotechnical report, the upper layers of the Hill consist of embankment formations of low compaction.

Ryc. 6. Budowa geologiczna wzgórz: a) plan wierceń z zaznaczonymi otworami badawczymi i przekrojami geotechnicznymi, b) warstwy podłoża  
 Fig. 6. Geological structure of the Hill: a) borehole grid with research holes and geotechnical sections, b) ground layers

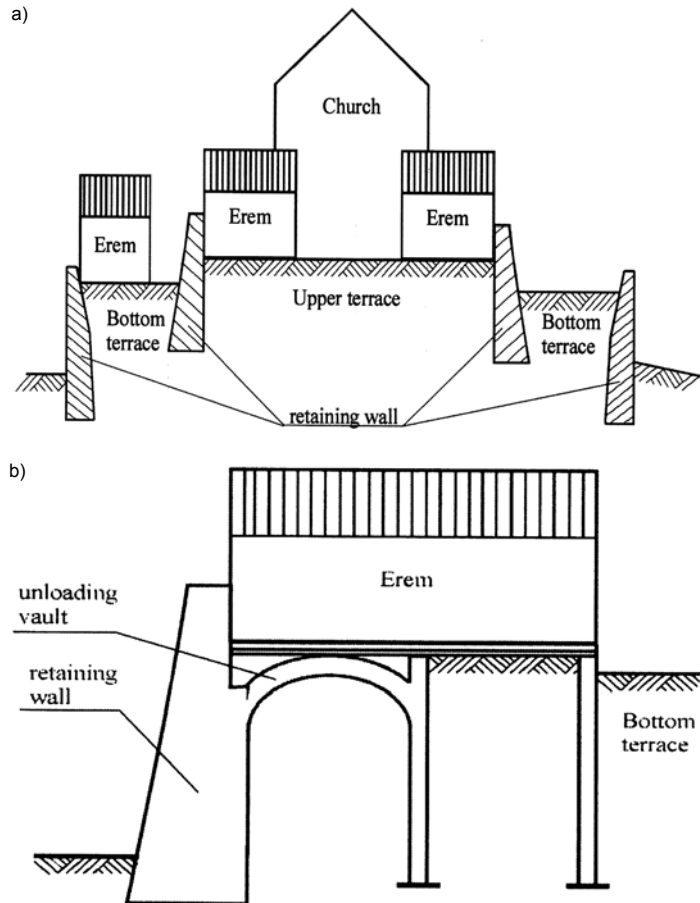
Changes in the foundation setting have impacted safety and stability of retaining walls and erems. The original retaining walls were supported with unloading vaults designed to reduce horizontal pressure of the ground and groundwater as presented in fig. 7b. Vaulted cellars, galleries and tunnels were used as storage spaces, baths and cells. Reconstruction work, along with earlier wartime military operations, has served to destroy vaults and underground corridors along retaining walls. This means that the load on the retaining walls has been significantly increased, changing also the original static behaviour of the building.

Ryc. 7. Przekrój poprzeczny Wzgórza z konstrukcjami podziemnymi: a) schemat tarasów, b) schemat pierwotnych konstrukcji podziemnych

Fig. 7. Cross-section of the Hill and its underground structures: a) terraces; b) original underground structures
