Vladimir DEKYS¹, Ondrej DVOULETY²

AN CONTRIBUTION TO THE CONDITION MONITORING OF FANS

Summary. One reason for failure of fan is suppression to float a shaft's bearing in the bearing housings. As a result of this disorder leads to blocking axial displacement of bearing, thrust to the growth of the forces acting on the bearing, and then to his accident. The article deals with the identification of the symptoms of this condition in the data from diagnostic measurements and presents the results of practice.

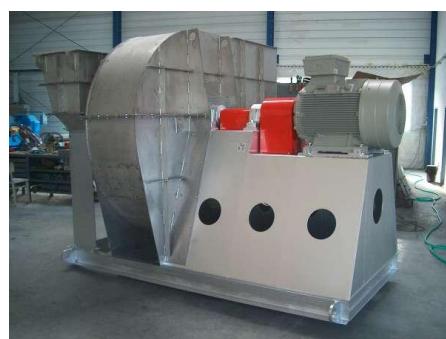
Fig. 1. Overhung centrifugal fans
Rys. 1. Wentylator odśrodkowy

At the Fig. 1 is object of our measurement – overhung centrifugal fan exhausts of gas from the filter.
