STRUCTURE AND MECHANICAL PROPERTIES OF 21HMF STEEL STEAM TURBINE ROTOR MATERIALS AFTER LONG-TERM OPERATION FOR A TIME SIGNIFICANTLY EXCEEDING THE DESIGN TIME

The article presents the results of tests of materials for steam turbine rotors with various degrees of depletion in order to determine the suitability of these components for further operation after significantly exceeding the design working time on the basis of the assessment of the microstructure condition and a set of functional properties.

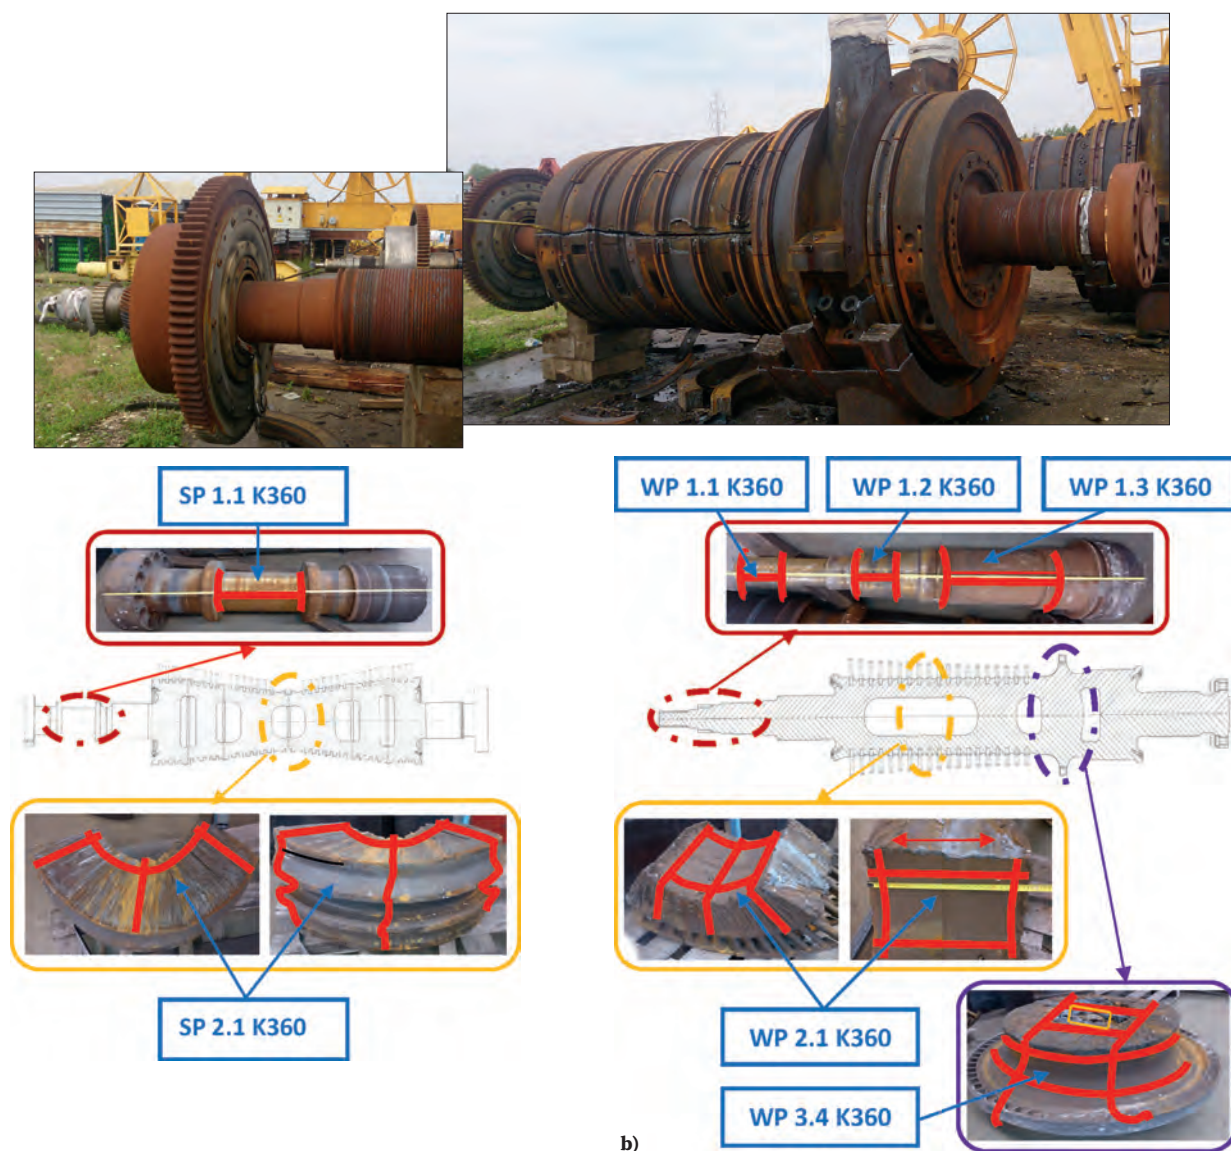
Fig. 1. Method and location of collecting the material for testing on the example of the SP medium-pressure part and WP high-pressure part of a turbine rotor of a 18K360 power unit with a nominal power of 360 MW after approx. 220,000 operating hours: a) from SP medium-pressure part, b) from WP high-pressure part

The areas of the rotors from which the material for testing was taken and their operating parameters are summarised in Table 1 and, on the example of a 360 MW unit rotor after 220,000 operating hours, shown in Fig. 1. The test sites were selected in such a way as to obtain the differentiation of the material state from close to the initial state to the state corresponding to operation significantly above the limit temperature, for which creep is the dominant destruction process.
