RENOVATION AND MODERNISATION OF A POSTINDUSTRIAL FACILITY IN POZNAŃ

Tomasz BŁASZCZYŃSKI*, Przemysław WIELENTEJCZYK,
Maciej BŁASZCZYŃSKI, Filip PIJANOWSKI
Institute of Building Structures, Poznań University of Technology

The paper presents a renovation process of a historic postindustrial building situated on premises of Gazownia Poznańska. An unprepared team of designers made a lot of mistakes and negligences, which led to additional work, repairs including. The increased scope of work also led to a substantial increase in the cost of the carried out renovations. The modernisation process was realised with the use of modern technologies, some of which for the first time in Poznan.

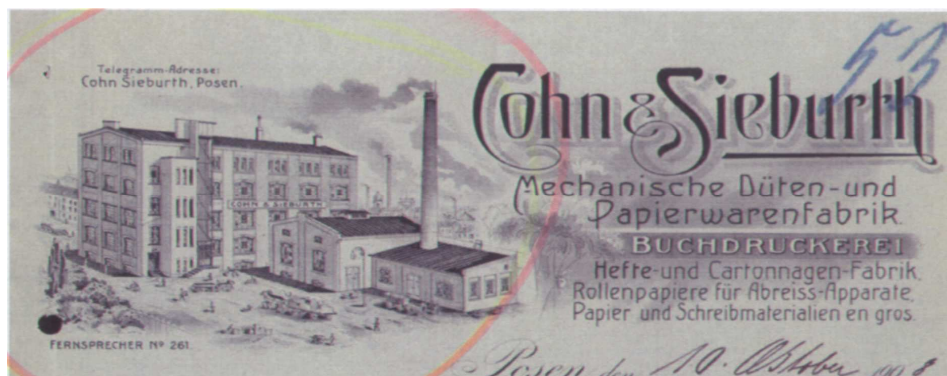
Fig. 3. A view of the dressing room – bath on the company's letterhead, 1908 r.

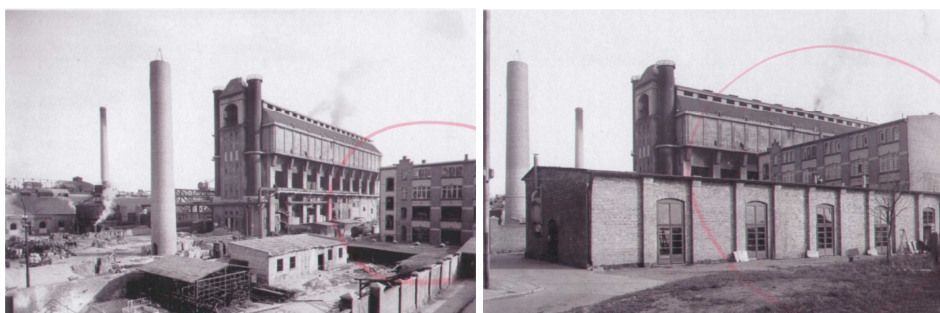
In probably 1973, after 117 years of operation, the Gasworks was extinguish, there was Koppers' boiler building in immediate vicinity of analyzed building. After the war damages, Koppers' boiler building was rebuilt and in the 50s expanded (fig. 4, 5).

Fig. 4, 5. Koppers' boiler room building, view of 1916 during the construction of the chimney in the 50's

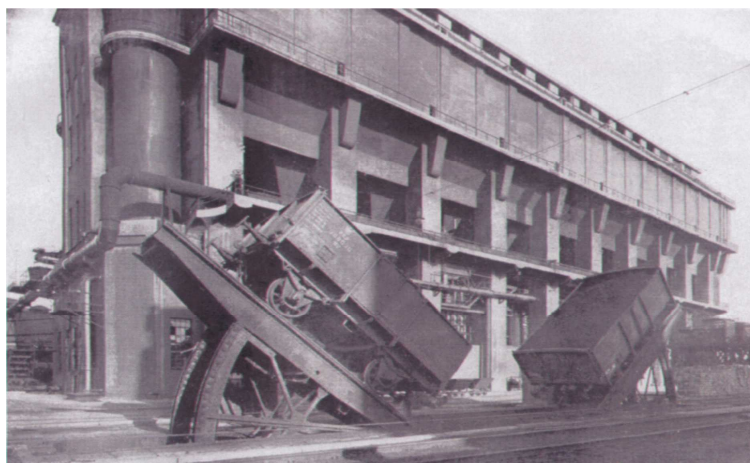
On the north side of the dressing room-bath building, there was a wagon discharger where wagons of coal were emptied and then the coal was transported to the boiler room on conveyor belts (fig. 6).

Fig. 6. Wagon discharger, view at the south wall of the the Koppers' boiler room building

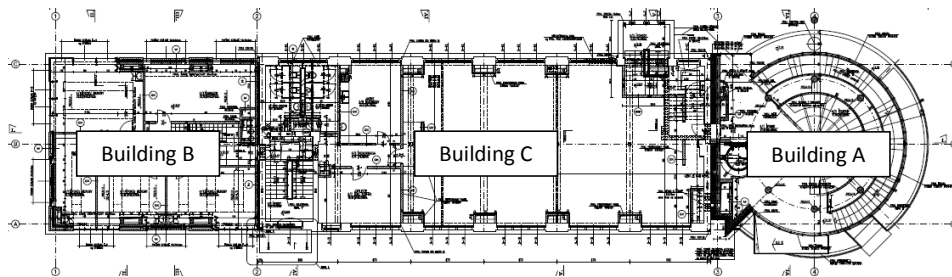
Fig. 10. A layout of the modernized facility together with the northern and southern parts

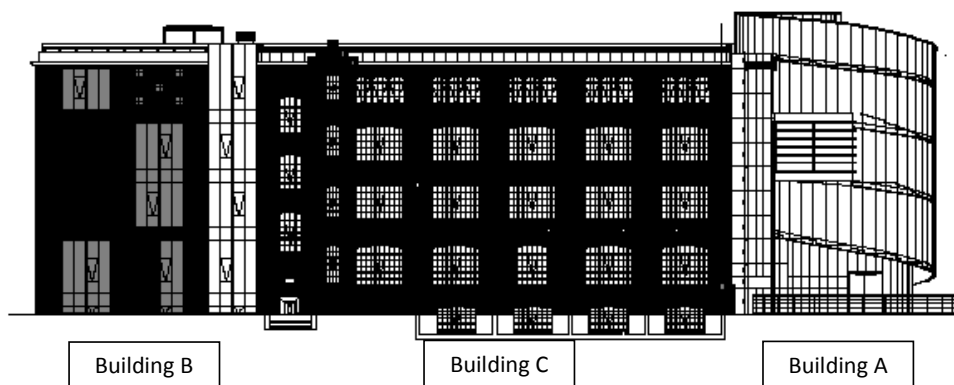
Fig. 11. View of the modernized facility together with the northern and southern parts

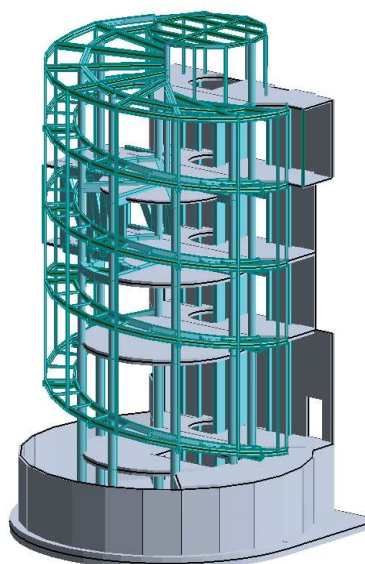
In addition, an extension was planned to be built, which was supposed to consist of two parts: a northern part (Building B) and a southern part (Building A). The northern part was planned to maintain the vertical divisions of the elevation. Fields between the pilasters were to be filled with large glazings referring to the existing building. This part was to be crowned with a bay window with panoramic views of the valley of the River Warta and Ostrów Tumski. The southern part was glazed and based on the circle, referring with its shape to the gas tanks. Building A is a spatial keystone and a dominant in the scale of a quarter (fig. 10, 11). This part houses two conference rooms and a foyer of a large hall on the last floor. The rooms are connected by fan stairs and ramps that run along the outer side of the glass shell (fig. 12). The traffic areas are dedicated to exhibit gas technologies.

Fig. 12. A model of the structural system of Building A
