Measurement of surface subsidence and ground collapse caused by underground mining in the Boleo Copper District, Mexico

Jong-Gwan Kim

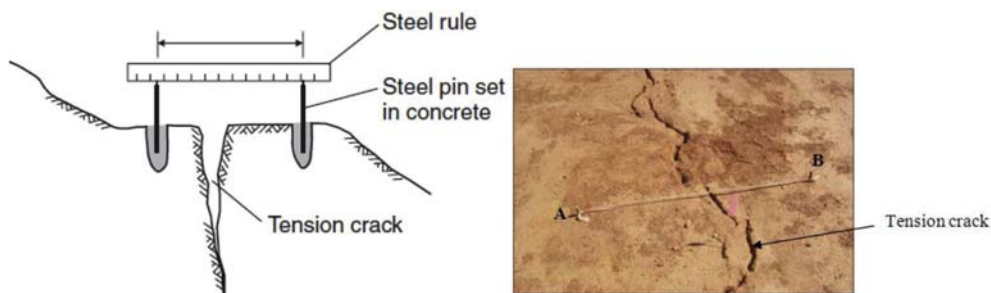
Fig. 6. Pin crack meter measuring crack displacement.

Measurement of width of the crack developed due tensile failure of the ground is a reliable and inexpensive means of monitoring ground movement. Fig. 6 shows the method of measuring crack widths. The simplest procedure is to install a pair of pins on either side of the crack and measure the distance between them with a steel tape.
