Żaneta Anna MIERZEJEWSKA
Paulina KUPTTEL
Jarosław SIDUN

ANALYSIS OF THE SURFACE CONDITION OF REMOVED BONE IMPLANTS ANALIZA STANU POWIERZCHNI USUNIĘTYCH IMPLANTÓW KOSTNYCH*

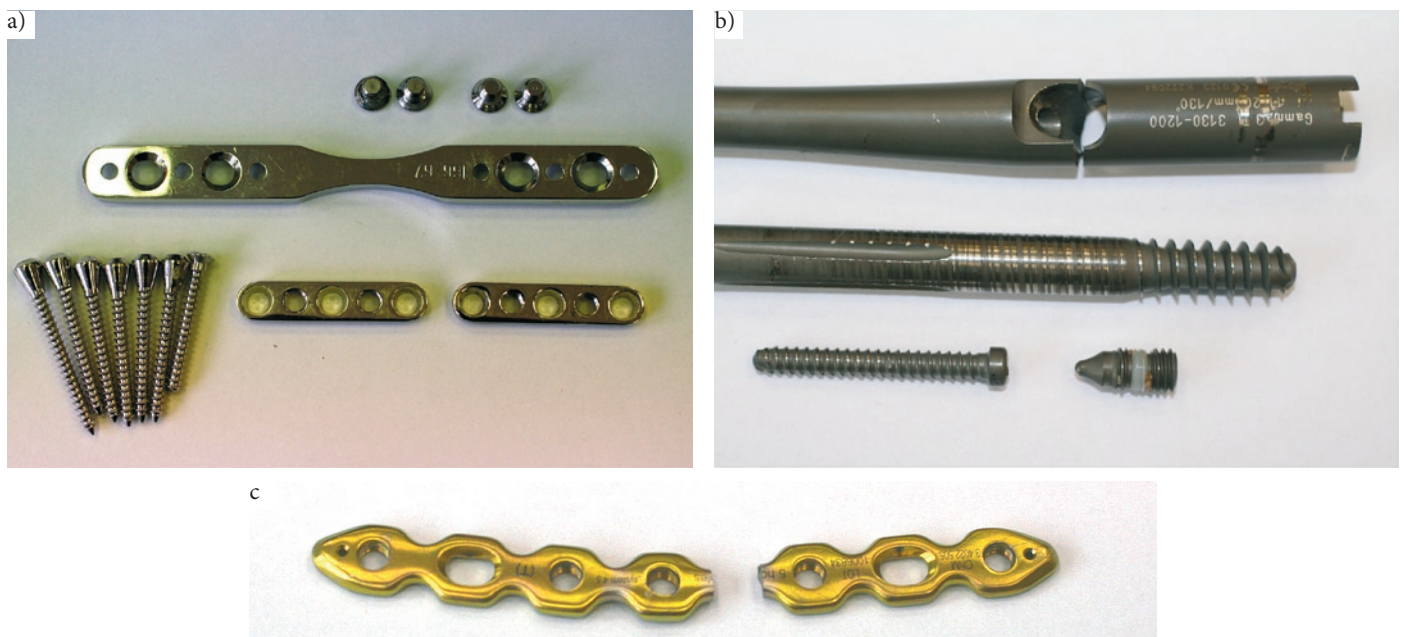
Three groups of metallic orthopedic implants for bone grafts (Fig. 1), which were present in the human body for a period of approx. 6 months, were studied. Investigations of surface changes were carried out on the following elements:

- set for stabilization of long bones used for osseosynthesis of the femur shaft, consisting of a load-bearing plate, clamping plate, as well as joining screws and cortical screws (316L austenitic steel),
- set for intramedullary nail insertion for grafts of femur bone fractures (Ti6Al4V titanium alloy),
- straight reconstruction plate used to graft bones of the forearm (anodized Ti6Al4V titanium alloy).

Fig. 1. Research materials: a) set for stabilization of long bones, b) set for intraosseous stabilization, c) straight reconstruction plate

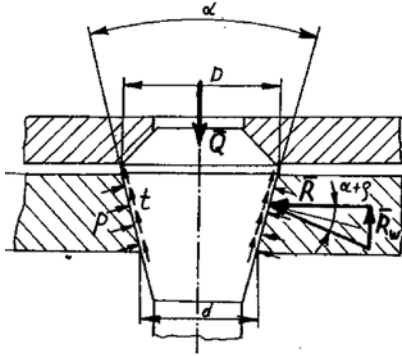
Wear processes occurring near the screw head are already initiated during the surgical procedure, when the stabilizer is implanted. As the screw is fastened, its head is pressed down to the tapered seat, and because actual unit pressures are large, galling may occur when the screw is rotated. After initial installation of the stabilizer, final tightening of bone screws is performed. A diagram of the distribution of forces in the tapered joint: bone screw head – plate has been presented in figure 5.

Fig. 5. Distribution of forces in the tapered joint: bone screw head – plate: Q – force of tapered joint assembly, R – radial pressure on contact surface, p – unit pressure on contact surface, t – infinitesimal friction force, R_w – push-in force: $R_w = R \tan(\rho + \alpha)$ [16]
